Accident Report

Bounty

Fire & Subsequent Loss

7 May 2006

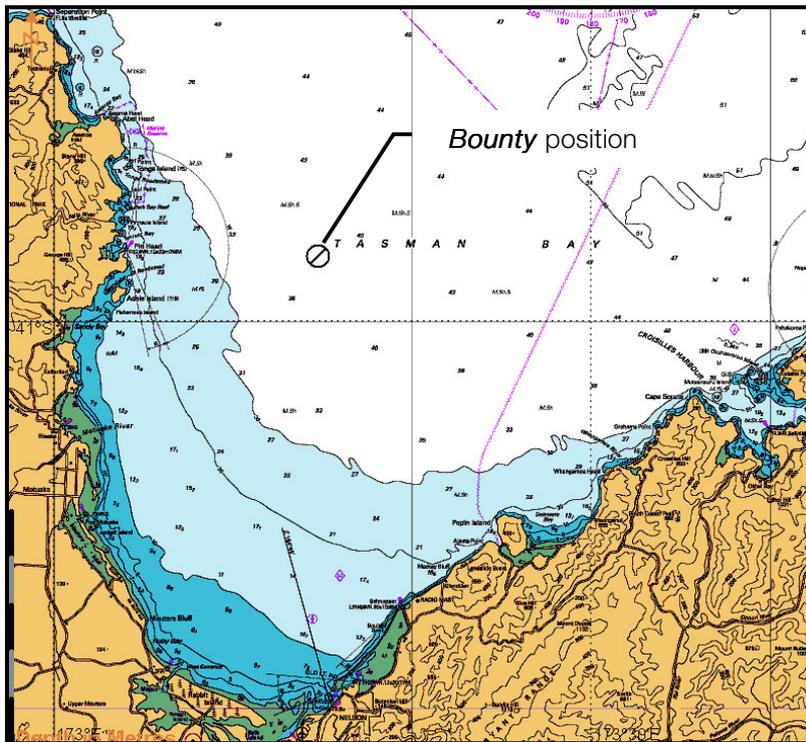
Figure 1

Bounty sank at about 1030 hours, on 7 May 2006 in position 40° 57.22 ' S and 173° 14.760' E (See *Figure 1*).

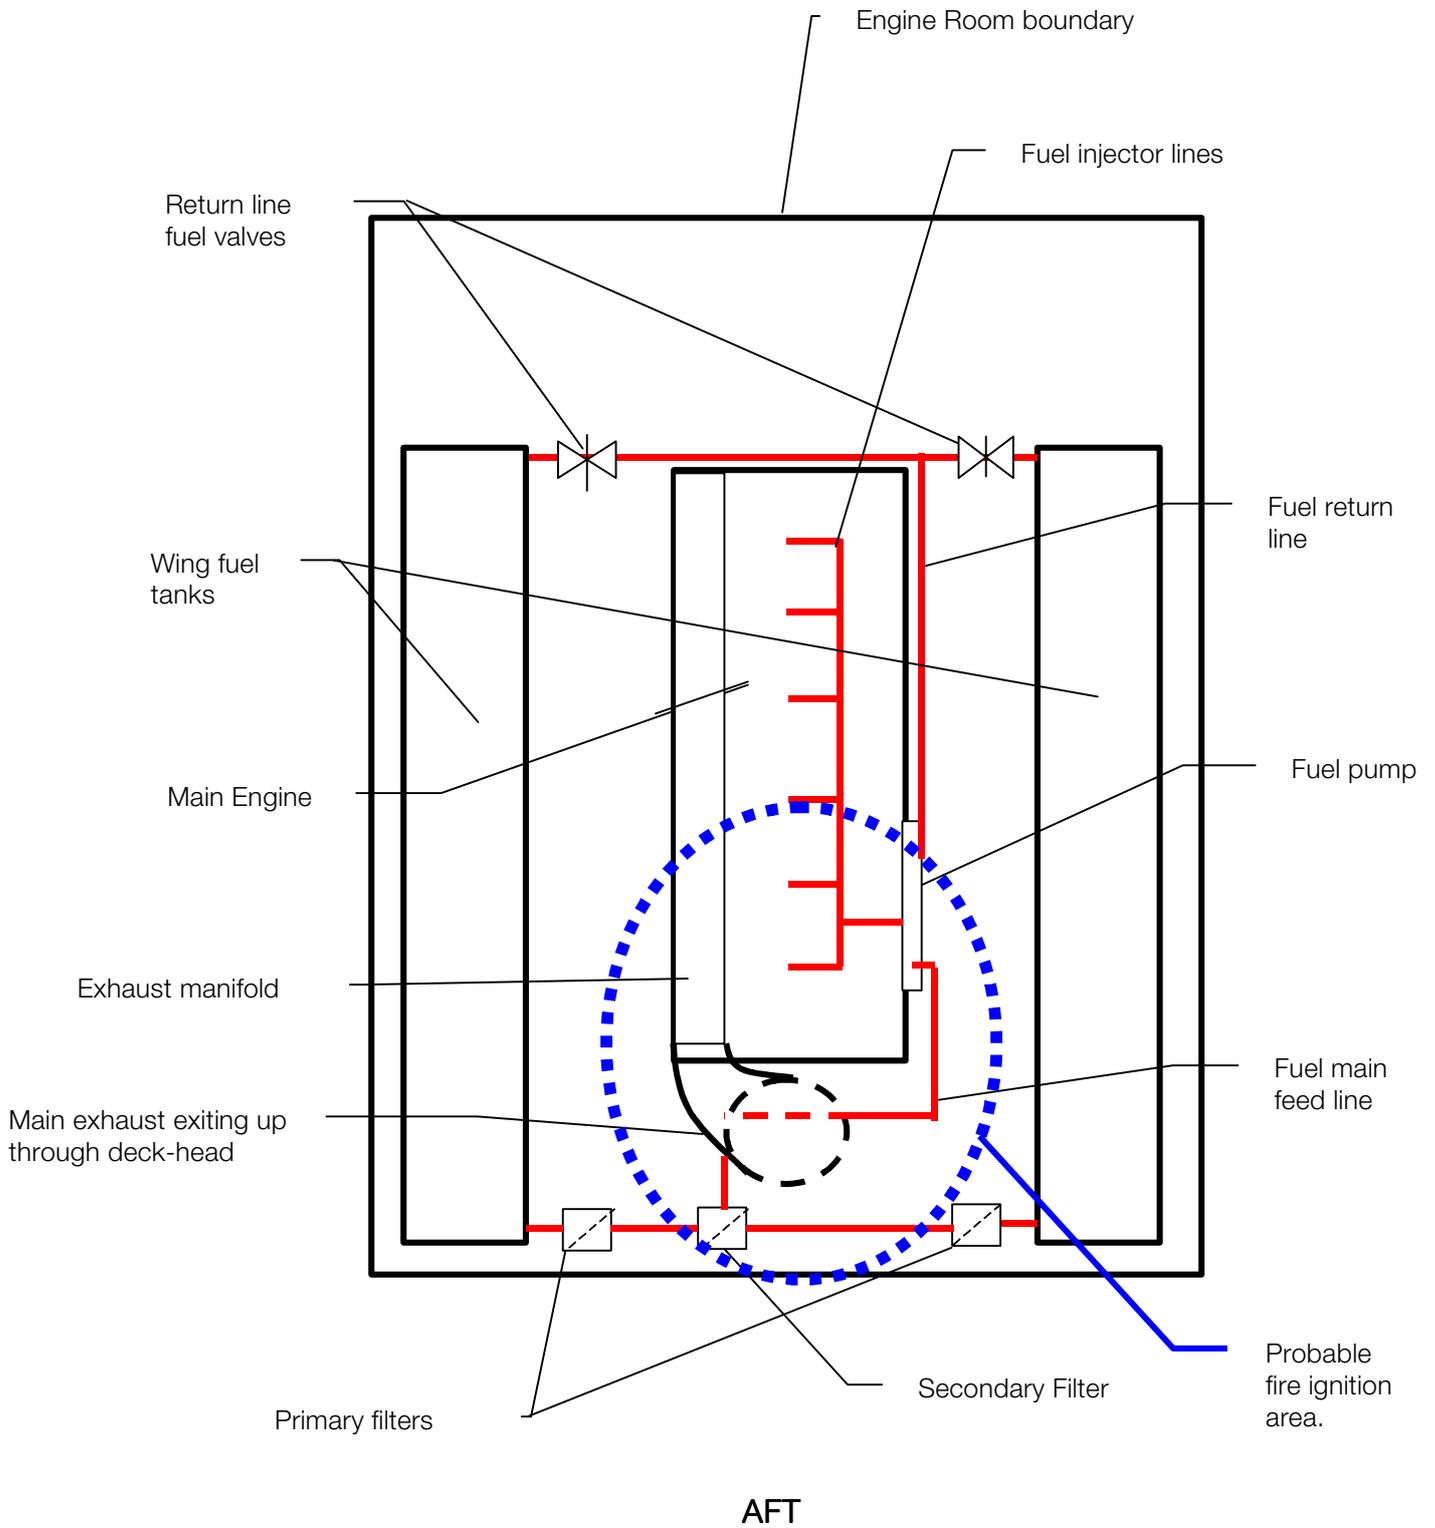
FORWARD

One crewmember stated that he had been able to get into the ER in the very early stages of the fire but he was not able to see much due to the amount of smoke at that time. He did however observe some sparking or flame activity along the aft bulkhead of the ER. This is where the main fuel lines from each wing tank 'T' into a primary filter and then onto the main engine fuel system.

The main engine could not be shut off from a remote station in the wheelhouse. Instead a governor lever had to be depressed in the ER on the main engine. There was no remote shut off for the fuel tanks.
