Accident Report
Capella Voyager
Grounding in the Approaches to
Whangarei on 16 April 2003

REPORT NO.: 03 3177

VESSEL NAME: CAPELLA VOYAGER

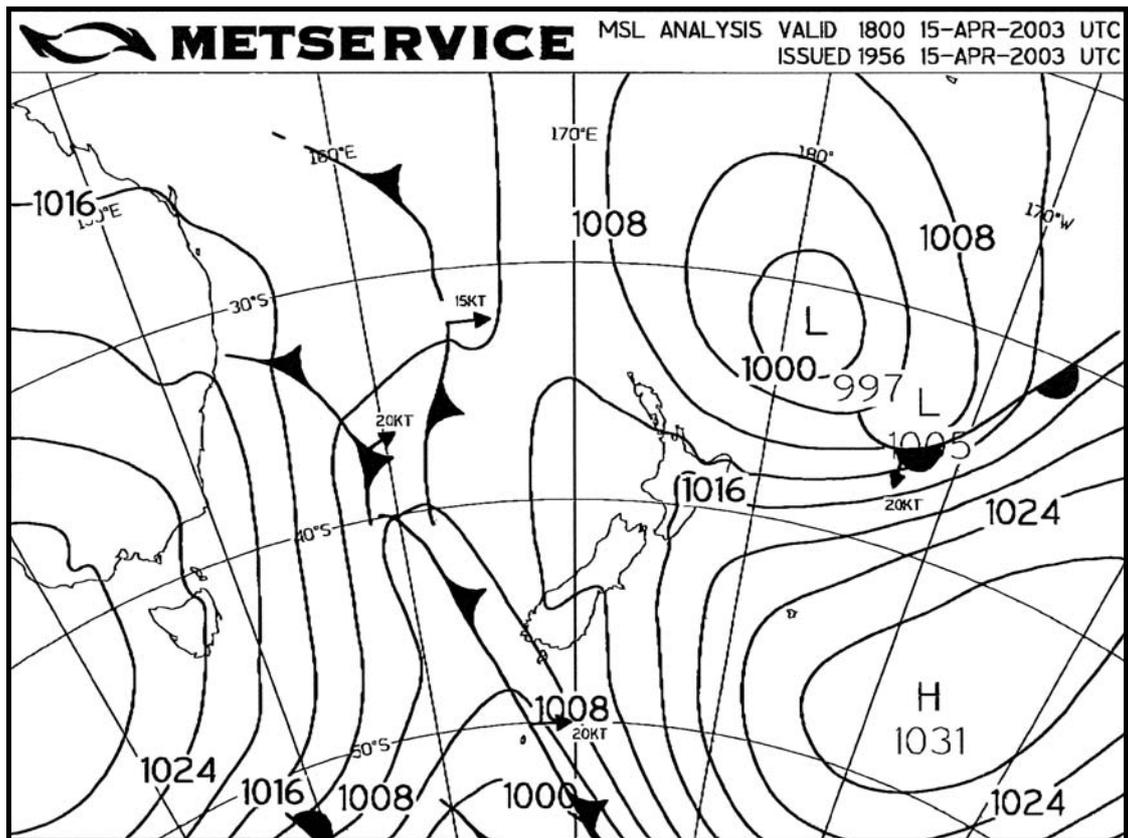
2.10.5 The last MetService weather-fax that was issued before the grounding was at 0756 hours NZST (1956 hours Co-ordinated Universal Time (UTC)), on 16 April. A copy of this weather fax is set out below:

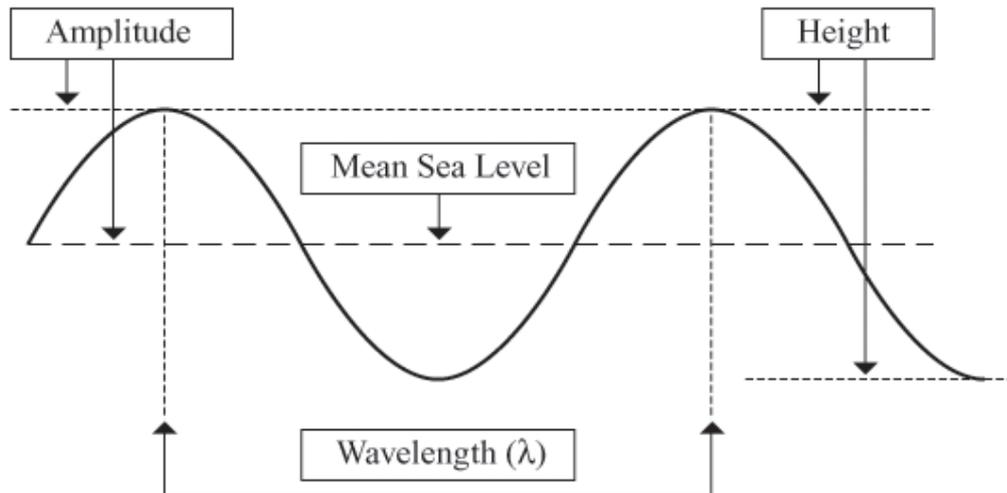
- 2.12.2 Swell is a type of wave which has been propagated outside its generating fetch - it is no longer under active generation. It can be generated by a weather system that can be some distance from where swell conditions may first develop. Other waves that are generated locally are often referred to as 'wind waves'. They can be superimposed onto swells thereby increasing the overall height of the wave, or the vertical distance between the wave's peak and its trough. Other significant measurements of any wave are its wavelength or the horizontal distance between wave peaks, and period (the time between peaks passing a fixed point). In Northern Europe, according to NIWA, a period of more than 10 seconds is the threshold beyond which a wave is defined as being swell. Locally generated waves have a shorter period, and generally do not greatly influence ship motions on large vessels. Swells which have the longer period cause the most significant vessel motions.

- 2.12.3 When any wave encounters a shoaling seabed, its wavelength will decrease, its period will remain the same and its height will increase.
- 2.12.4 There is also a change in velocity which produces a refraction effect, so that waves 'bend' from their initial direction towards the direction in which the shoaling occurs. In this instance, the shoaling was broadly to the north east of the general swell direction, so the waves would have tended to refract slightly in that direction.
