ASSESSMENT  
Heavy Weather Passage  
*Challenger (Kaitaki)*  
24 October 2006

# INTRODUCTION

On 24 October 2006, the Cook Strait ferry **Challenger** sailed from Picton to Wellington encountering storm force conditions. The voyage, which took nearly ten hours, was an uncomfortable crossing.

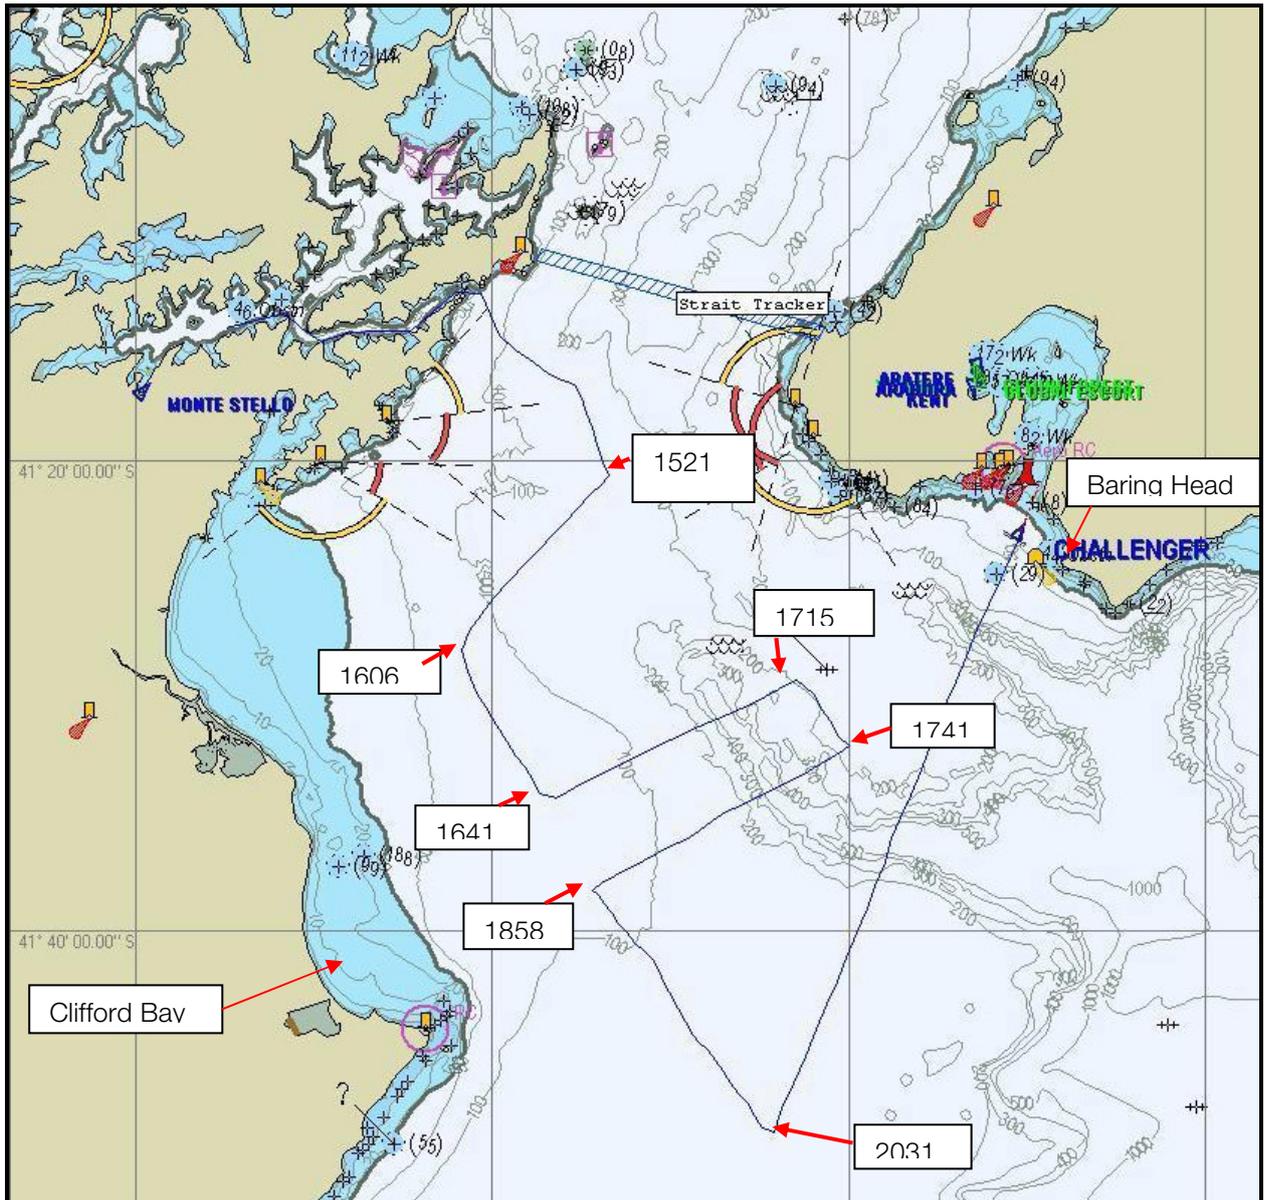
Due to the prevailing weather conditions, the Master decided to head in the direction of Clifford Bay, situated on the northern coastline of the South Island (see *Figure 1*). It was his intention, having approached closer to the land and obtained a lee from the prevailing weather conditions, that he would be able to turn safely to port and run up towards the entrance to Wellington Harbour with the seas and swell on the vessel's starboard quarter.

At 1521, the Master altered course onto a south westerly heading in the direction of Clifford Bay (see *Figure 1*).

At 1606, whilst still endeavouring to keep in the lee of the South Island, the Master altered course onto a south easterly heading in order to make more 'southing' before altering course towards the entrance to Wellington Harbour (see *Figure 1*).

At 1641, the Master altered the vessel's course onto a broadly east north easterly heading towards the approaches to Wellington Harbour entrance, putting the sea and swell on the starboard quarter (see *Figure 1*).

Following a discussion with the bridge team about the reported sea conditions at the entrance to Wellington Harbour, the Master decided to abort the approach to Wellington. The Master then altered course to starboard onto a broadly south easterly heading and put the seas and swell on the starboard bow (see *Figure 1*).

Due to the weather conditions causing the intermittent activation of the engine mechanical over speed trips, the Master decided to alter course to starboard onto a broadly south westerly heading and head back in the direction of Clifford Bay (see *Figure 1*). He informed the engine room of his intentions and said that he would not be taking the vessel into Wellington until the weather conditions had improved.

At 1858, the wind and swell conditions had eased sufficiently for the Master to decide to alter course to port and head in a south easterly direction so as to make more 'southing' before eventually turning to port and heading towards Wellington (see *Figure 1*).

Figure 1 - Automatic Identification System recording of *Challenger's* track over the ground in Cook Strait
