Accident Report  
Fire aboard *Cleansweep*  
13 February 2008

**Maritime New Zealand**

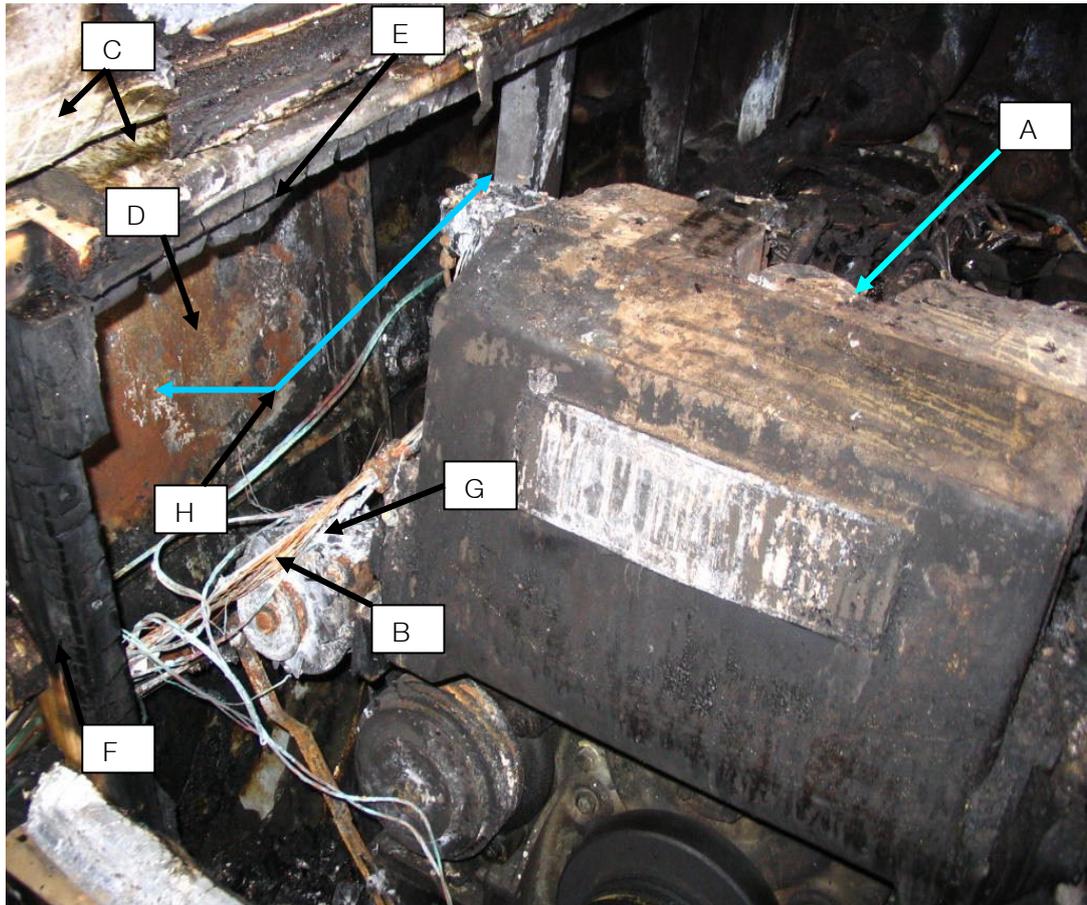
**Figure 2**

9. The exact cause of the fire is indeterminable, however, there are several common indicators that show the fire originated in an area containing the alternator and a bundle of wires that lead to the battery bank. These indicators include a classic “V” burn pattern visible on the inside of the hull and a heavy oxidation pattern on the outside of the hull.

10. It is common in a structural fire that V patterns are generated by a plume of flame spreading vertically from the base of the fire, and this, in consideration with all the other factors, is a commonly accepted technique used in determining the seat of a fire. On **Cleansweep** some oxidation is also present on the alternator, and there is no indication of this occurring elsewhere within the engine bay. Oxidation on a metal surface is known to indicate an area where the surface has been exposed to high heat or flame.

11. The area of heaviest charring is situated on the wooden framework above the alternator, with the top of this structure suffering only smoke damage. This indicates that the heat source came from beneath and the depth of the charring indicates that it burnt for some time.

12. The vertical engine bay framing situated near the alternator has suffered charring on the interior, with an area of undamaged framework visible on the exterior. This again indicates that the fire originated near the alternator and wrapped around the framework before travelling vertically along the framing.

13. Overall, the area containing the alternator and bundle of wires is the area with the most damage, with the remainder of the engine bay suffering only secondary heat and smoke damage.

14. The plastic coating of the bundle of wires lying on the alternator has completely burnt away, up to an area where it extends from a hole in the wooden framework. From then on the wire is undamaged, suggesting that this area was protected from the fire. Some oxidation is present on the exposed wiring. These factors again indicate that this area was the seat of the fire.

- a) Heat damage caused from heat being reflected downwards from insulated hatch cover
- b) Bundle of wires leading to battery bank
- c) Smoke damage only
- d) Oxidation on hull, indicating the height of the fire
- e) Area of heaviest charring
- f) Undamaged area, indicating the fire originated from the other side at around this height and wrapped around before travelling vertically along this beam
- g) Alternator, showing an area of oxidation
- h) The blue arrows show the V pattern and direction of the fire spread, which lead back to the seat of the fire

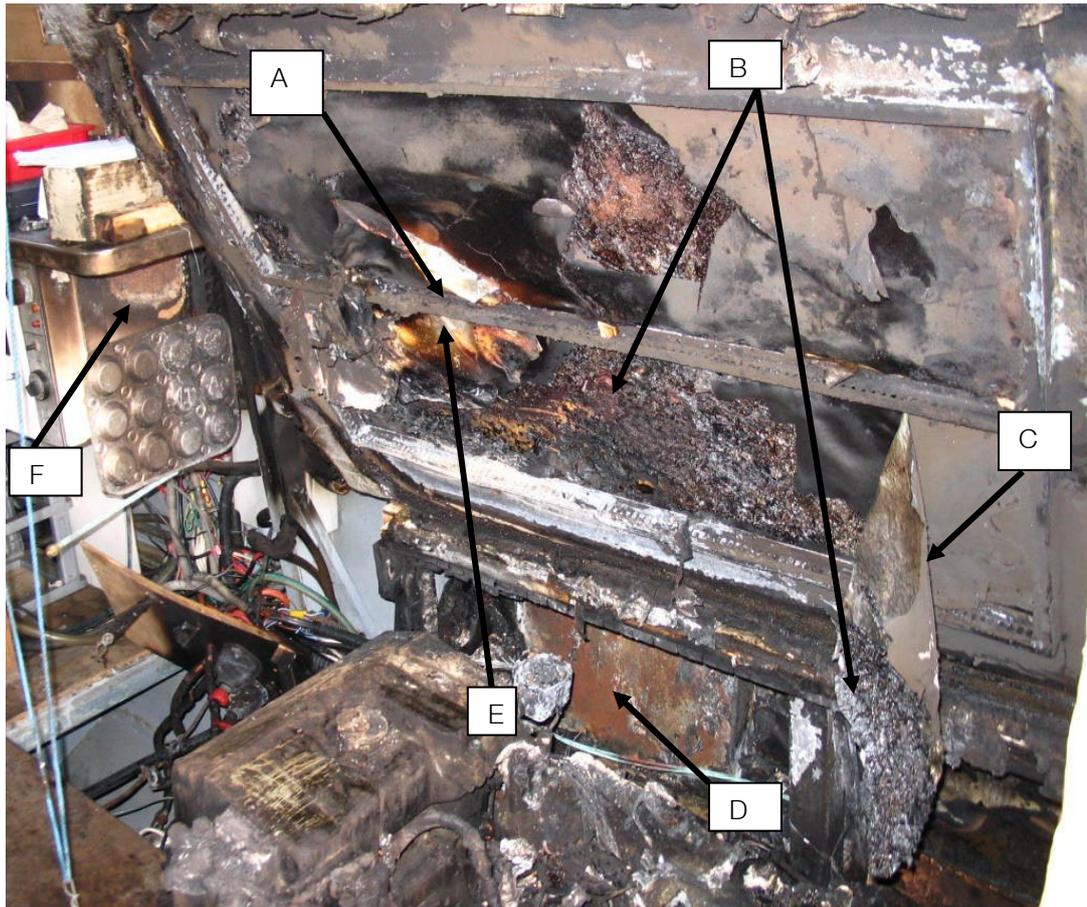
**Figure 2**

15. Most telling is the damage shown in figure 2, which shows an area of high heat damage situated directly above the alternator area. This supports the conclusion that this was the seat of the fire. Figure 2 also shows the way in which the noise insulation burnt away. A thin metal support beam divides the noise insulation, creating a join where the insulation meets the beam. A join like this creates a gap through which fire can penetrate and ignite rubber backing. It is highly likely that this occurred, as the seat of the fire was directly below the join.

16. It is apparent that the silver foil of the insulation remained intact, although it appears to have suffered some minimal charring around the edges while peeling away from the rubber foam backing, which was destroyed.

20. In either scenario, it is clear that the fire then penetrated the join in the noise insulation, igniting the rubber backing and producing the dense toxic smoke. This may have occurred before or after the cover was lifted. It is most likely, however, that the sudden intake of oxygen when the cover was lifted would have greatly intensified the fire and the rate in which it was spreading.

- a) Join in insulation running along structural beam where fire may have penetrated to ignite rubber backing
- b) Burnt rubber backing
- c) Silver lining peeled away from rubber foam backing
- d) General seat of fire, indicated by oxidation on hull
- e) Area of high heat damage, indicating the source of the fire was directly below
- f) Secondary damage, most likely to have occurred when cover was open
