Accident Report

Collision

Deep Star & Red Pepper

14 January 2006

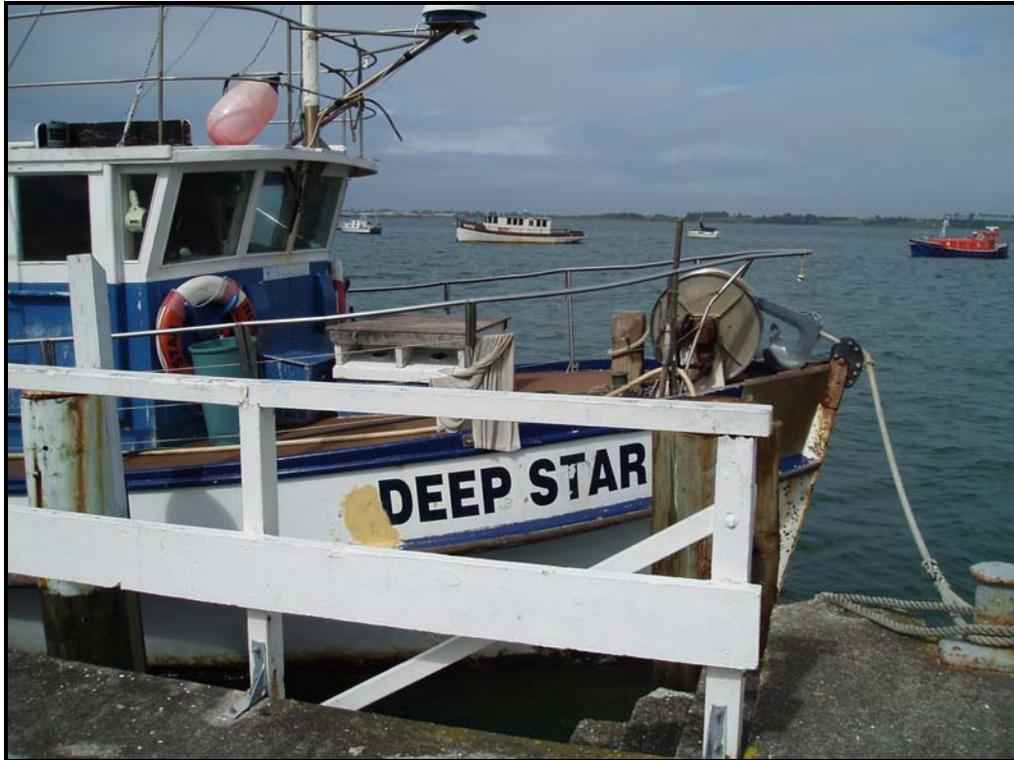
Photograph 1
Deep Star alongside Coronation Pier, Tauranga

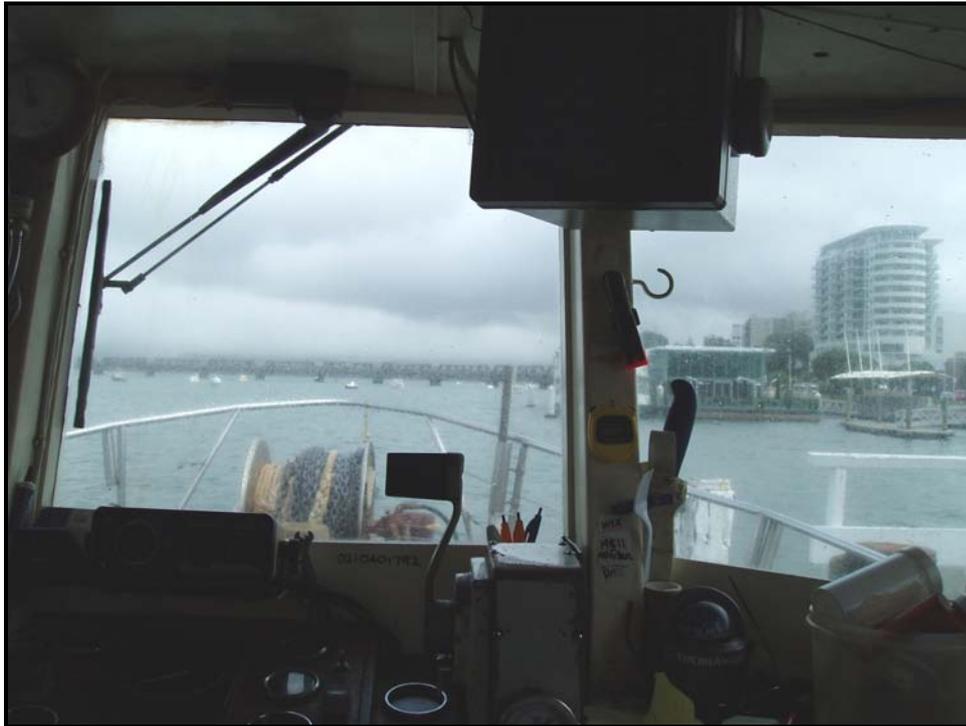
Photograph 2

Deep Star was making a speed of about 7.5 knots. The weather was good with a 20 knot south-west wind and a short choppy sea. The sun was on the starboard bow. Although it was glinting off the sea, it was not in the Skipper's eyes. The view ahead from the Skipper's seat was reasonably unobstructed as shown in *Photograph 2*. Spray, coming over the bows, may have reduced his visibility.

View from the Skipper's seat of *Deep Star*

The Skipper of *Deep Star* could not explain why he failed to see *Red Pepper*. He said he was in the wheelhouse, keeping a lookout while navigating visually and using GPS and an electronic chart. He had operated the vessel without incident since 1993 and made frequent trips to the same area.

1. It is recommended that Maritime New Zealand censure the Skipper of **Deep Star** for failing to keep a proper lookout. The letter of censure should suggest the following ways to improve the lookout:
 - Making the lookout a priority and giving it the full attention required.
 - Moving about to ensure the view is not obscured by window frames or the boat's fittings.
 - More use of radar.
 - Using binoculars to scan the horizon.

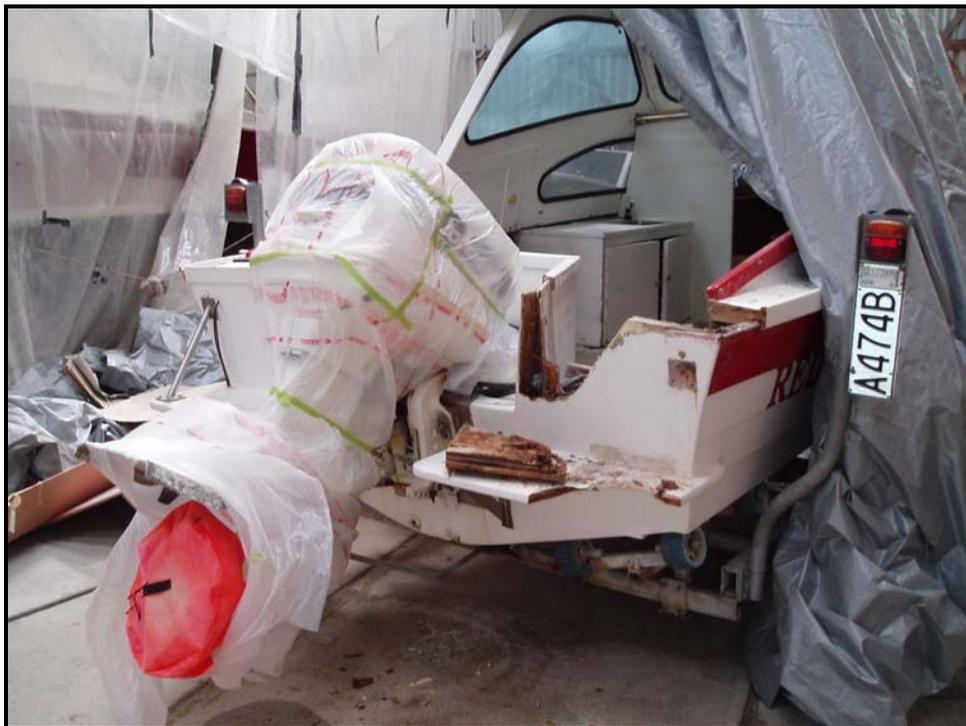
Damage to *Red Pepper* was as follows:

- Cracks to the structure by the bunks, internally
- The cabin was racked and was cracked
- The transom was damaged
- The outboard bracket was broken and the auxiliary outboard engine lost
- The casing of the main outboard engine was damaged
- Damage to the gearbox was suspected
- The bilge pump would not work
- The steering was stiff
- Various articles, such as fishing rods and a wallet were lost.

Photograph 3
Damage to the transom of *Red Pepper*
