Accident Report
Serious Harm Injury to Passenger
aboard Dolphin Discovery V
4 January 2010

Maritime New Zealand

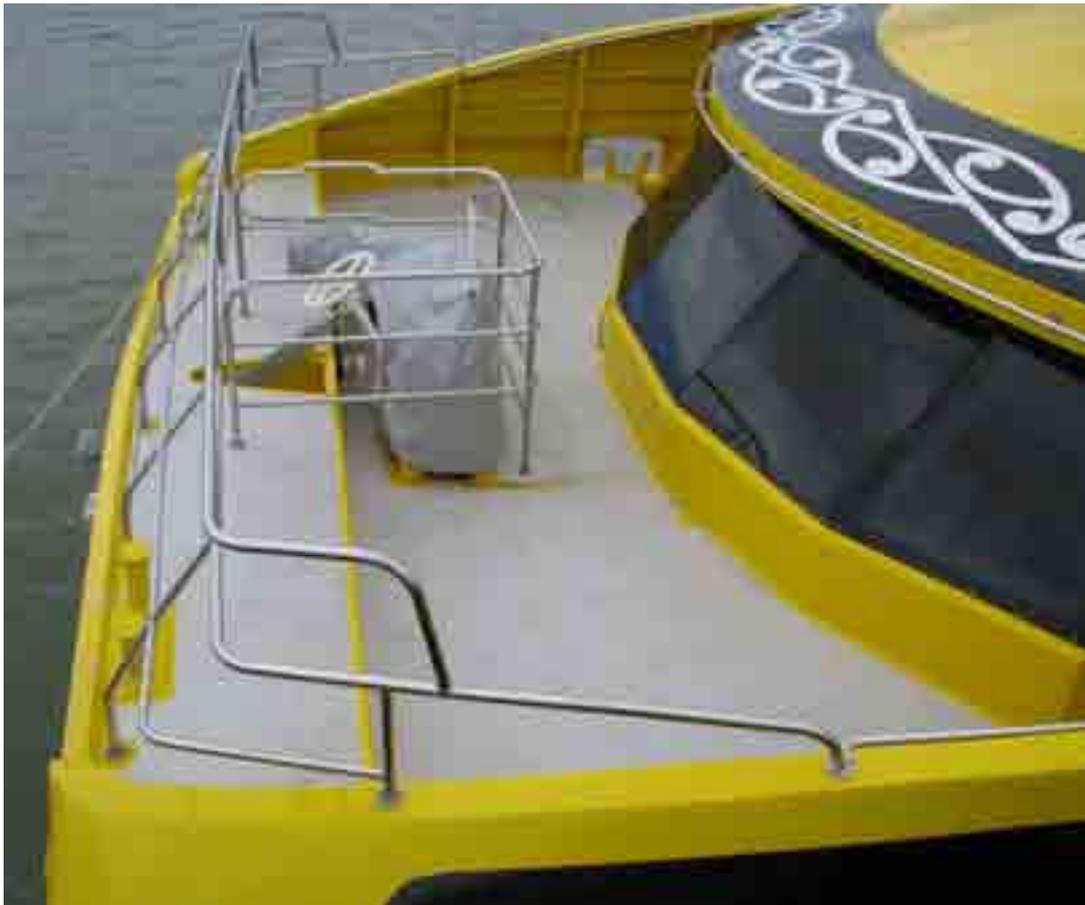
Figure 2 Bow deck of vessel

15. Inadequate communication between skipper and crew
 - skipper cannot see all of the foredeck from the helm station and has to rely on communication from the crew, which in his own admission was inadequate on the day in question; anecdotally a significant number of the passengers were suffering from motion sickness.

- passengers commented that safety briefings were vague and lacked essential detail.
17. Passenger Supervision
 - There was no close monitoring of the foredeck during the period of rough weather conditions.

- passengers located in areas not visible from the helm and were unsupervised
18. Skipper Concerns
 - had during various meetings recommended to management that crew levels be increased to 4 for over 75 passengers, but no action has been taken.

20. It is recommended that Explore NZ implements the following:
- a) Improved communication systems which enable the skipper to be fully aware of passenger whereabouts and welfare at all times. This would allow for two way communication with crew.

- iii) Effective communication to non-English speaking people.
 - c) Crew operating procedures are reviewed to include improved monitoring and supervision of passengers at all times, particularly in hazardous areas and when in adverse conditions.
