# Accident Report

Gas Explosion

*Double Trouble*

Final Report Issued 17 April 2008

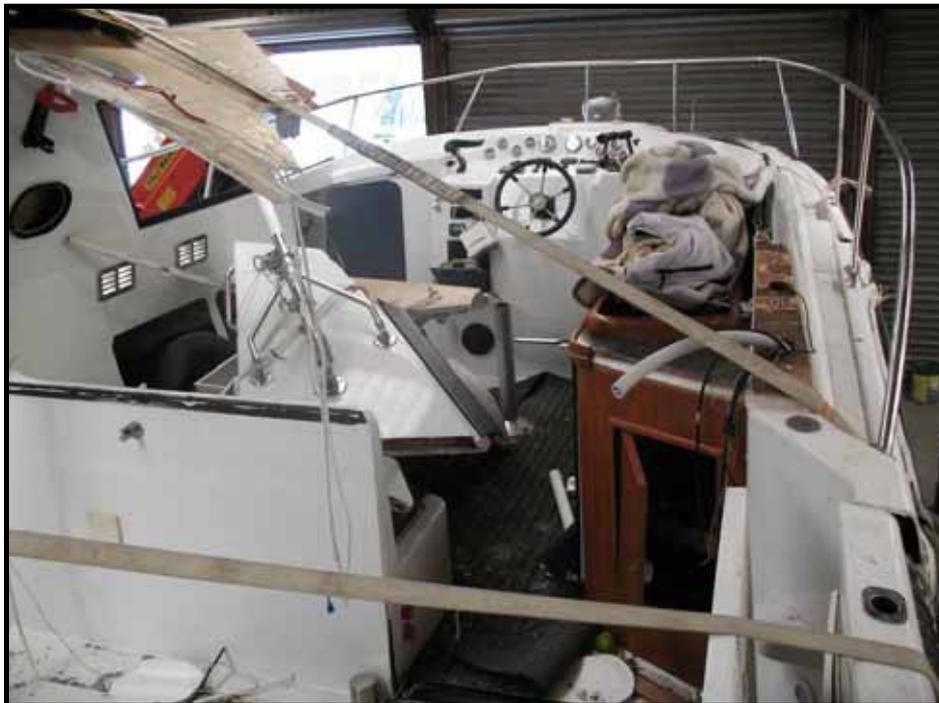
Photograph 2

- 1.1.4 The vessel was effectively destroyed in the blast with sections of the cabin blasted from the hull (*See Photograph 2*).
- 1.1.5 The Skipper and crew suffered serious burns of varying degrees. The Skipper also sustained broken ankles.
