Accident Report

Man Overboard/Fatality

East Ocean

REPORT NO.: 04 3589

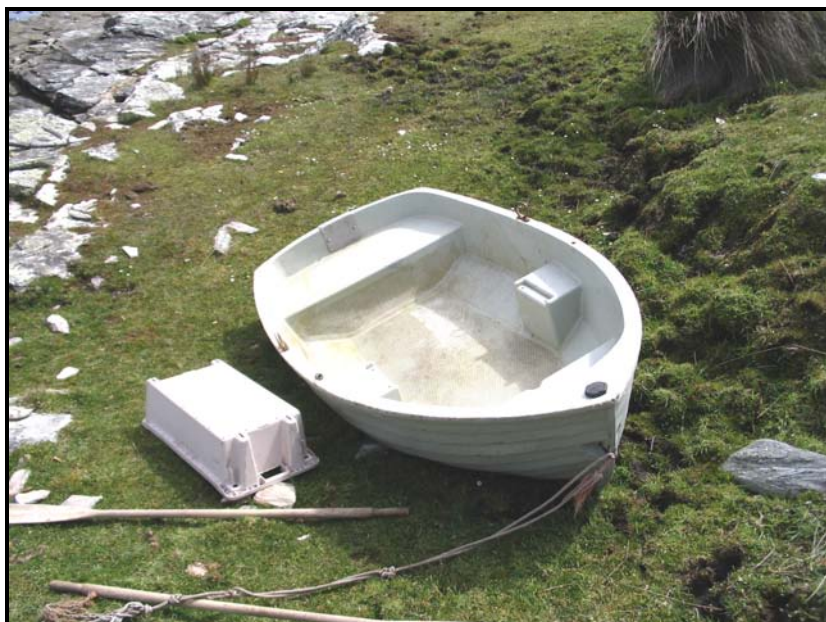
Photograph 1
Dinghy

The unnamed dinghy is owned by a local Port Hutt fisherman and is of moulded plastic construction. It has a length overall of 4.5 metres, and a maximum beam of 1.3 metres. It would have had approximately 20 centimetres of freeboard with two occupants onboard.

The dinghy was propelled by oars. It had two wooden oars, each of 1.8 metres length, which were positioned in rowlocks when rowing. The rower had to sit on an upturned fish bin as the amidships thwart was missing.

The dinghy was not equipped with any lifejackets or life saving equipment. It had a five-metre bowline attached.

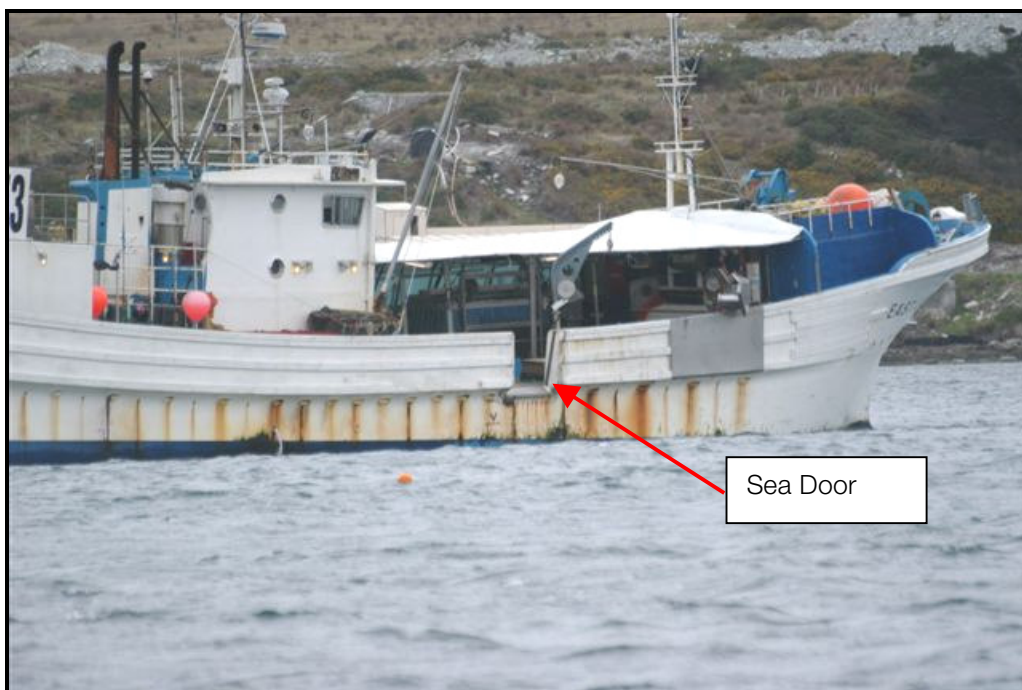
Photograph 2

When the dinghy was not quite alongside, the Engineer stood up and jumped towards the side of **East Ocean**. He missed the sea door but managed to cling on to the bulwark aft of the sea door (See *Photograph 2*). The only thing to hold on to in this position was the rubbing strake. In jumping from the dinghy, the Engineer forced the stern of the dinghy away from the side of **East Ocean**.

The sea door on the starboard side of **East Ocean** would have been approximately 1.2 metres above sea level at the time of the accident. The door is approximately 1.0 metre wide. The height of the bulwark abaft the sea door is approximately 1.0 metre (See *Photograph 2*).
