Accident Report

Man Overboard
Formosa Thirteen

12 June 2006

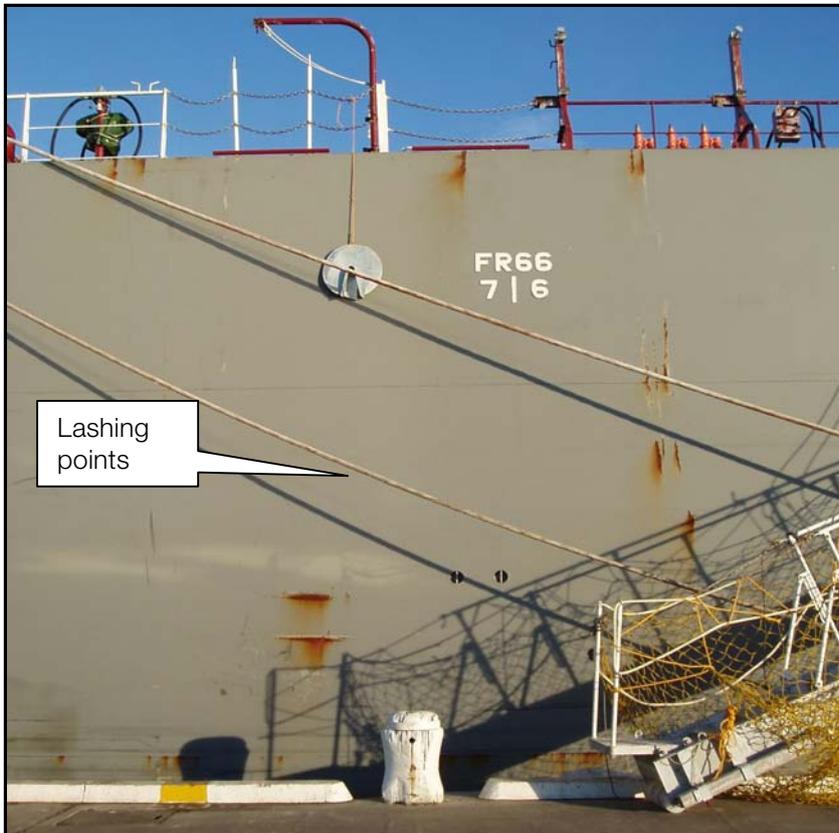
Figure 2
Gangway and lashing points

There were two ordinary seaman at the pilot ladder Mr Yanlei and Deckhand 1. Deckhand 2 had left his cabin and was on his way to assist them. Deckhand 1 said to Mr Yanlei that he thought it was too dangerous to go down the accommodation ladder to unlash the base from the ship’s hull because of the rough sea conditions (See Figure 2 – Photograph showing gangway and lashing points). However Mr Yanlei said it was ok, and he would do it.

At 1608 hours, Mr Yanlei descended the accommodation ladder so as to undo a rope lashing that was attached between the bottom of the ladder and a cleat that was recessed in the ship's hull and used to hold the ladder against the hull (See Figures 2 & 3 – Photographs). He was wearing overalls and a dark blue raincoat, over trousers steel cap safety boots, gloves and hardhat. He was not wearing a lifejacket or harness. Deckhand 1 did not watch Mr Yanlei once he had started to descend the accommodation ladder.

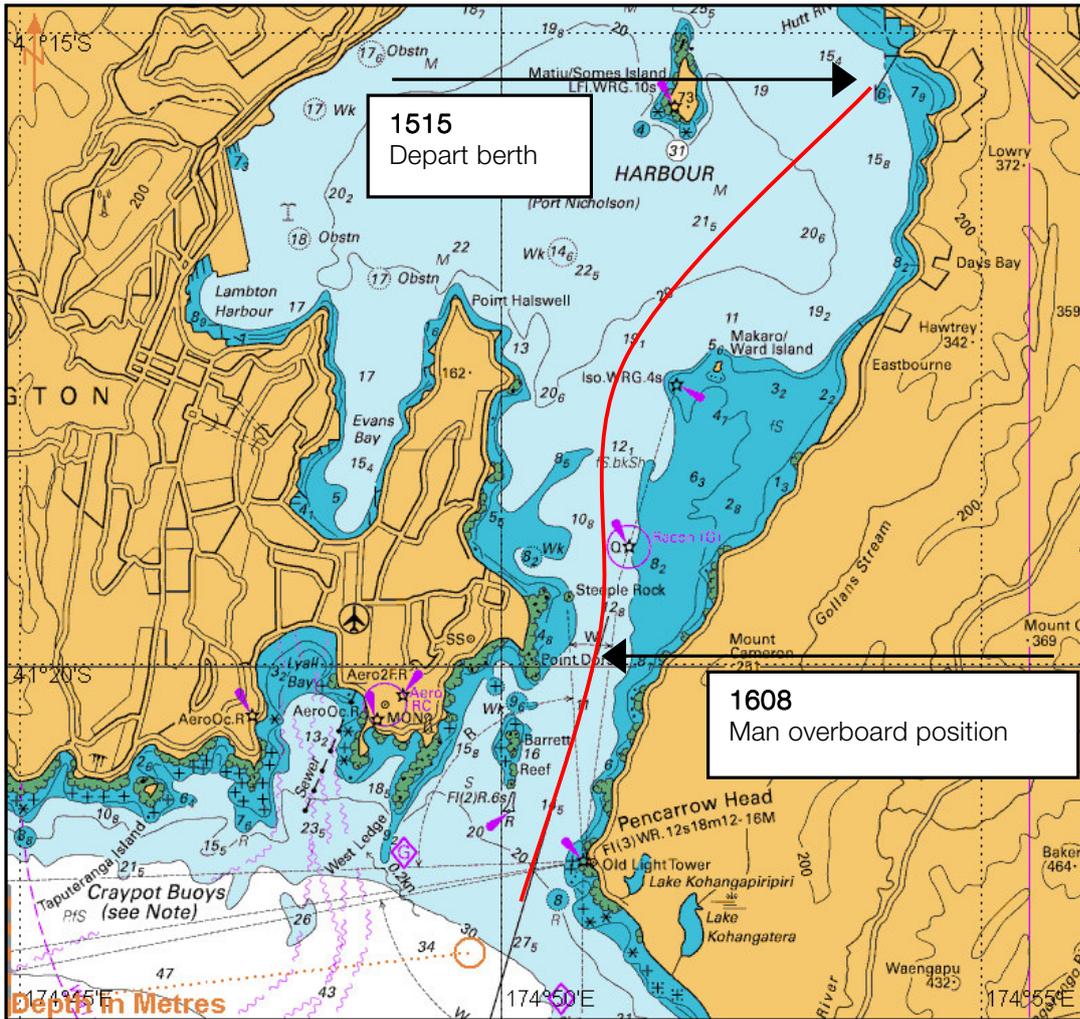
Figure 4
 Extract from LINZ Chart NZ 463 – Wellington Harbour – Showing approximate track of *Formosa Thirteen*

At 1608 hours, the vessel was abeam of Point Dorset, steering 197°(T) at a speed of about 8.9 knots (See Figure 4). The Pilot observed Deckhand 1 by the starboard gangway, shouting and gesticulating to the bridge and to the stern. The Pilot quickly realised there was a man overboard. He looked astern and saw Mr Yanlei in the water about 50-100 metres astern of the vessel. He was waving with one arm and appeared to be riding quite high in the water. At about this time the man overboard alarm was sounded.

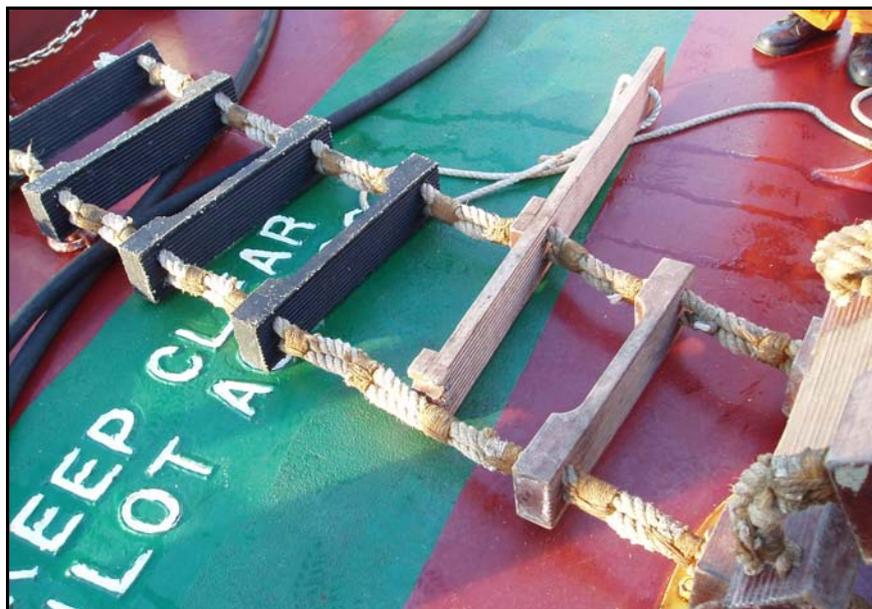
Figure 5
Broken rung from Starboard Pilot ladder

The fifth and the fourteenth rungs and spreaders of the pilot ladder were found to be broken when it was recovered. It is not known exactly when these were broken. They may have been broken by the action of the sea and waves as the vessel left Wellington.

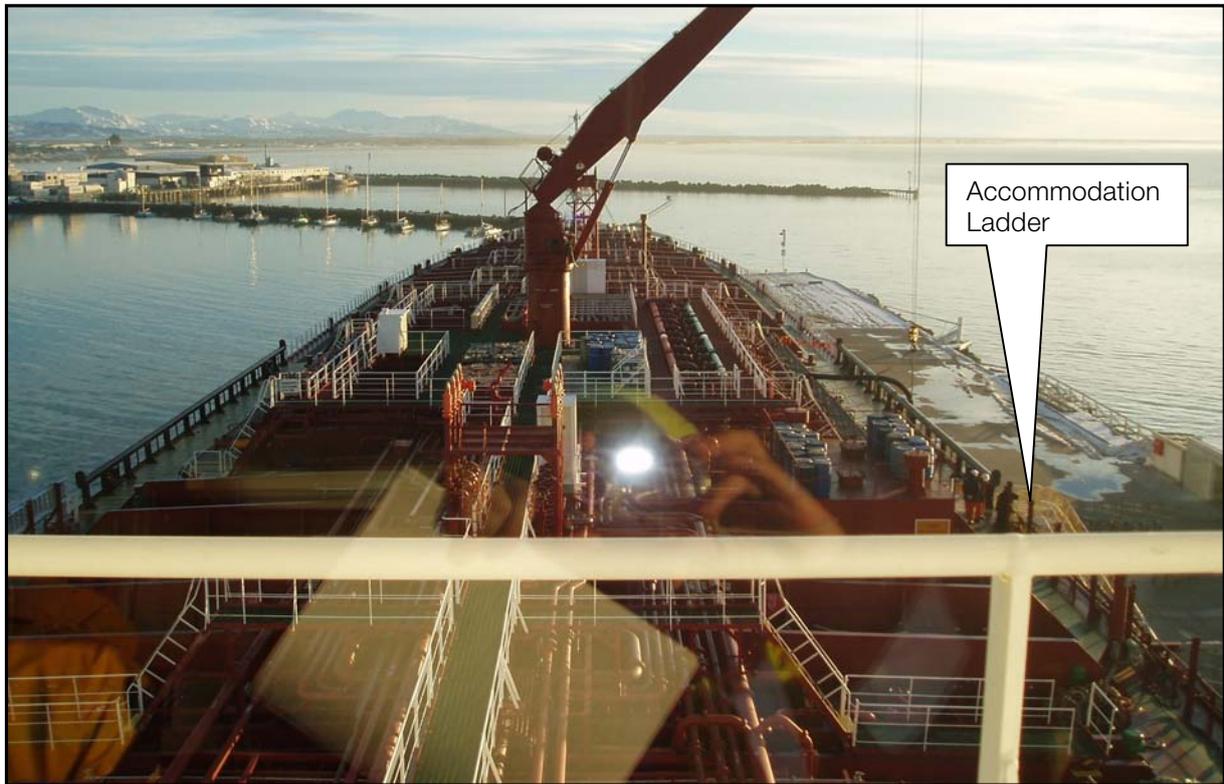
Figure 6
View from the Pilot's position on the bridge

The combination accommodation and pilot ladder was visible from the starboard bridge wing. None of the bridge team checked to see whether it was safe to raise the accommodation ladder, when the order for this was given.
