Investigation report  
*Foveaux Express* and  
*Southern Express*  
close quarters situation  
**19 January 2010**

## **Maritime New Zealand**

Published December 2010

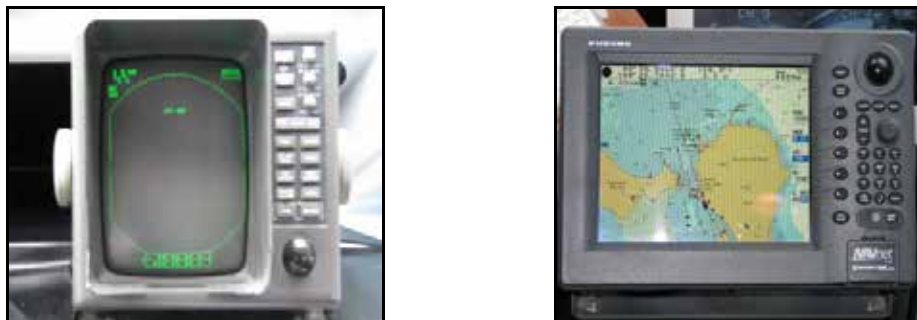
**Figure 3** Radar equipment fitted on board **Southern Express**

77. During the second transit for the morning of 19 January 2010, both masters were navigating using radar. The master of **Southern Express** was using both radar units fitted on board, one set on a range of 6 nautical miles and the other on a range of 4 nautical miles. The radar set to 4 nautical miles was the Furuno combined chart plotter, GPS and radar. This unit also repeats to the large screen fitted in the front centre of the main cabin. The unit was operating on a split screen, showing both the radar and chart plotter functions.

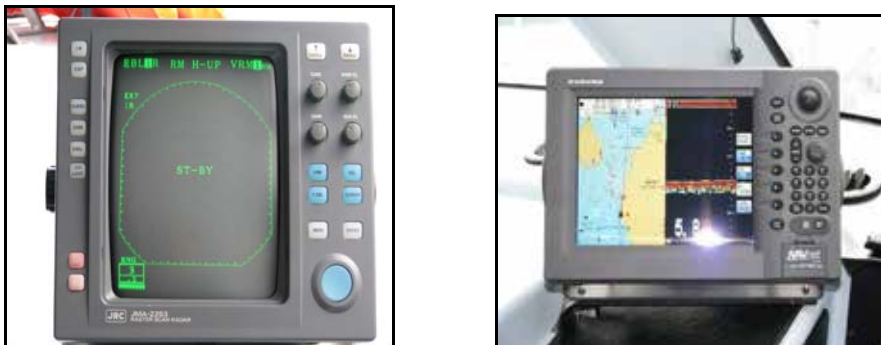
**Figure 4** Radar equipment fitted on board **Foveaux Express**

78. The master of **Foveaux Express** was using only one radar unit, the second set being used only in the chart plotter function because he believed a fault existed with its radar function. The radar sets fitted on both vessels are considered to be adequate to enable the vessels to complete a safe transit of Foveaux Strait in restricted visibility.

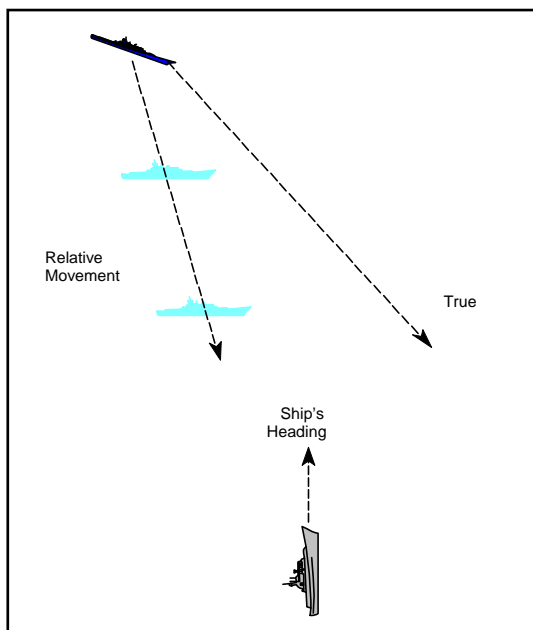
**Figure 5** Illustration showing a vessel's relative heading versus its true heading

83. In the absence of any electronic information, it appears as though both masters have effected a *cumulative turn*, as described above. Without first determining the heading of the approaching vessel by plotting its course, each master assumed that an alteration to starboard would increase the distance between the vessels at the closest point of approach. However, it is likely that one vessel would cross ahead of the other if each vessel maintained course and speed. Figure 5 shows how the relative heading, as observed by radar, can differ from a vessel's true heading.

84. As a result of each master making alterations to starboard, both vessels have effectively turned towards each other, resulting in a near-collision situation. In doing so, each master failed to take action in accordance with Rules 22.8 and 22.19 once it was recognised that a close quarters situation could result. The failure to take early and substantial action was the most immediate failure leading to the incident.

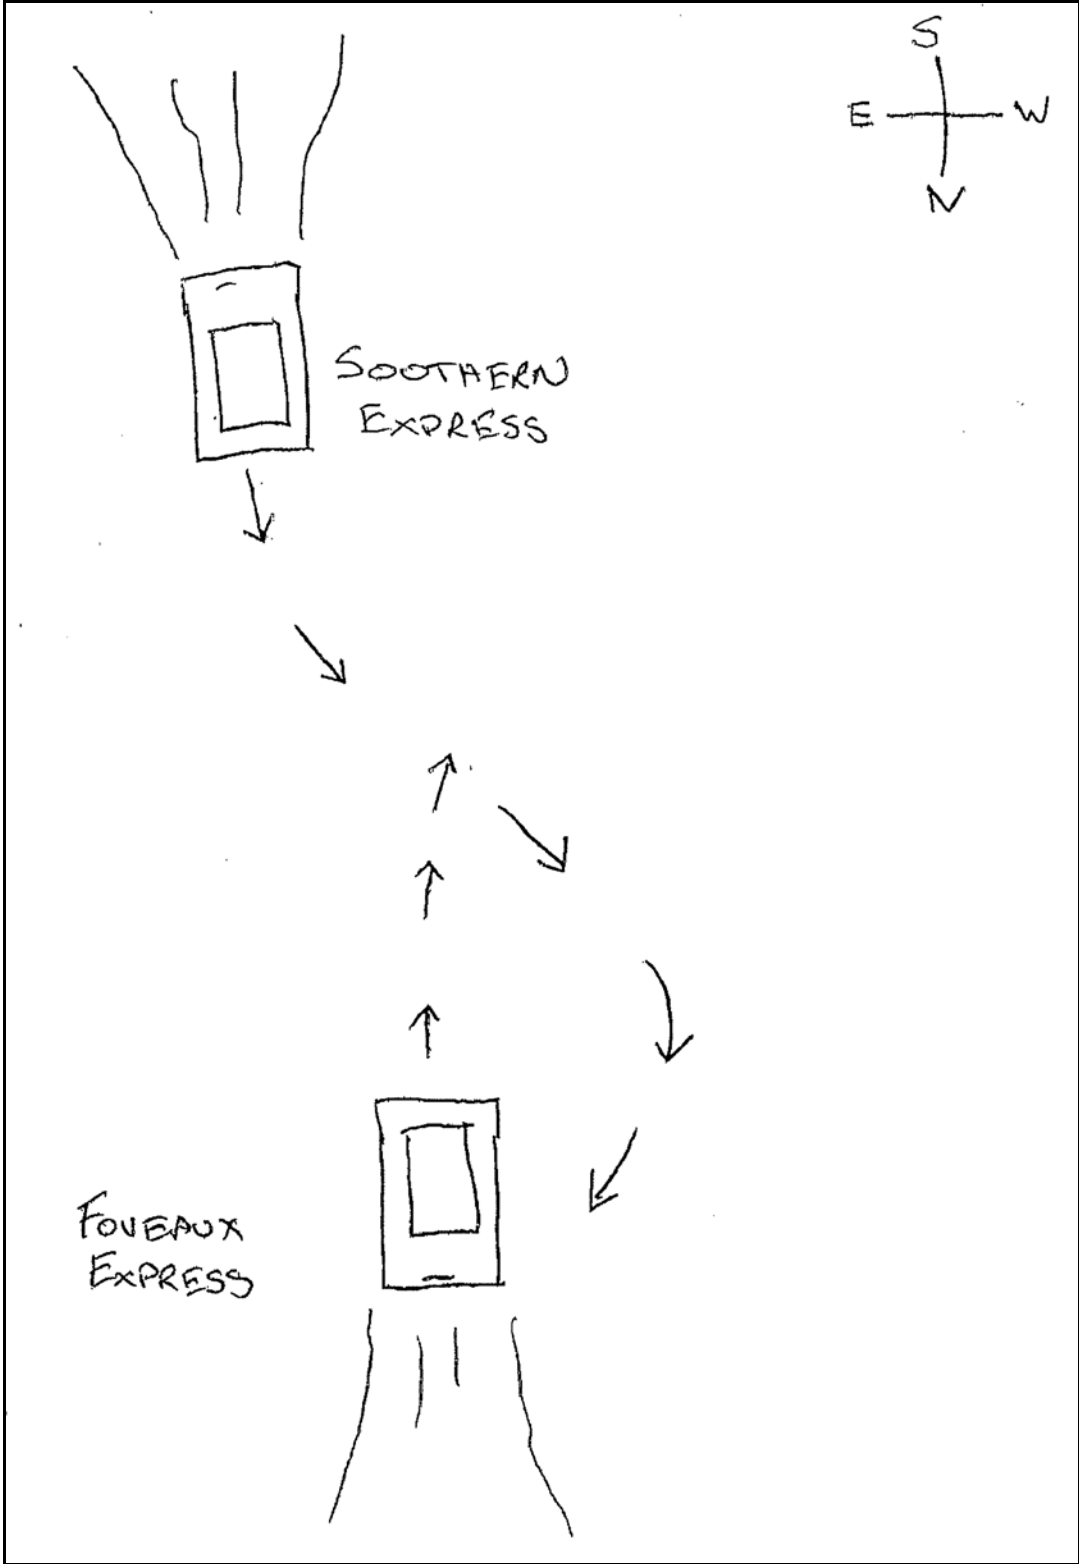
**Appendix 1: Diagram provided by master of *Foveaux Express***

24. After witnessing ***Southern Express*** pass in front of ***Foveaux Express*** by radar, the master of ***Foveaux Express*** stated that he held his course and speed because the risk of collision to starboard meant it was unsafe to make any alterations in course. Accordingly, once he had a visual sighting of ***Southern Express***, he felt the safest option was to continue on his course, believing that ***Southern Express*** would pass astern.

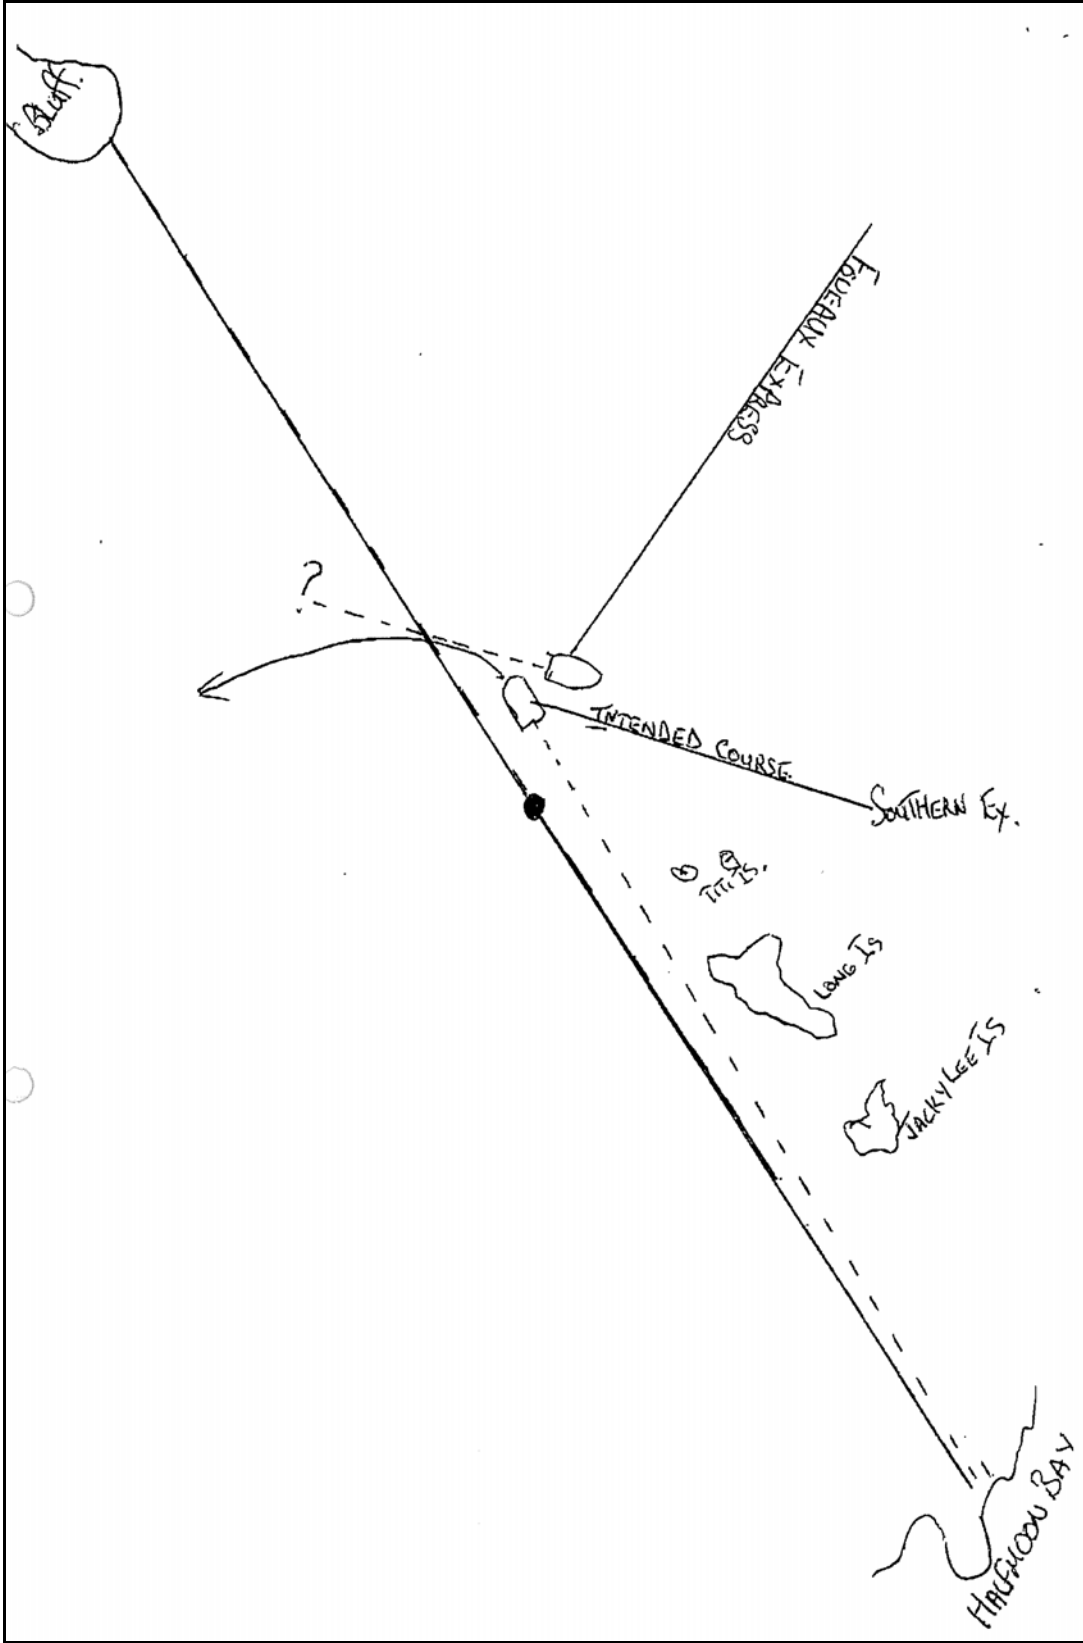
Appendix 2: Diagram provided by master of *Southern Express*

82. The north-bound vessel (**Southern Express**) made four or five small alterations to starboard, prior to making a substantial alteration to starboard a few seconds before sighting the south-bound vessel (**Foveaux Express**). The master of the south-bound vessel stated that he was moving the vessel slowly out to starboard as the vessel made its transit. As noted above, this practice is to be avoided, as prescribed in Rule 22.8. The effect of small alterations can be dangerous when observing by radar that is operating in relative motion with an unstabilised display. Burger explains this situation in *The Radar Observer's Handbook for Merchant Navy Officers* at page 273:
