Accident Report
Serious Harm to Crewmember
Genco Sugar
20 January 2006
Class C

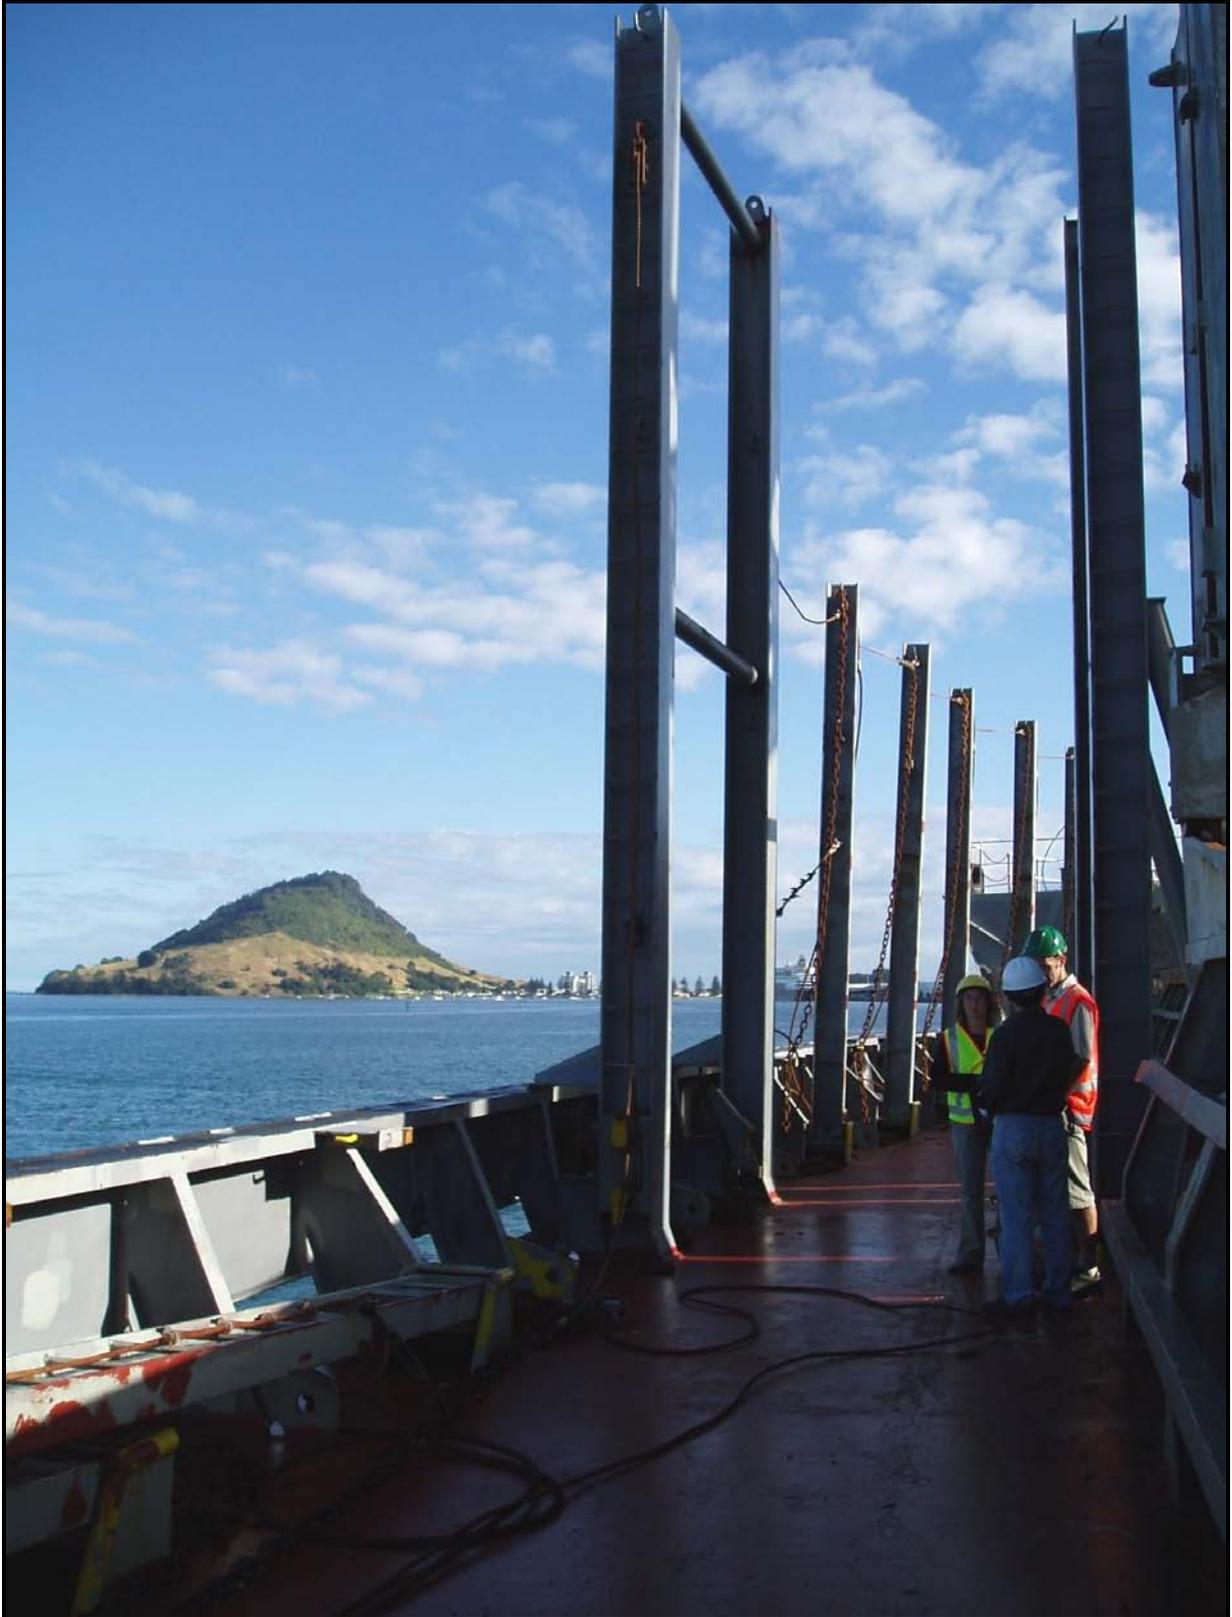
Photograph 2
Log stanchions at the port side of No. 2 hatch.

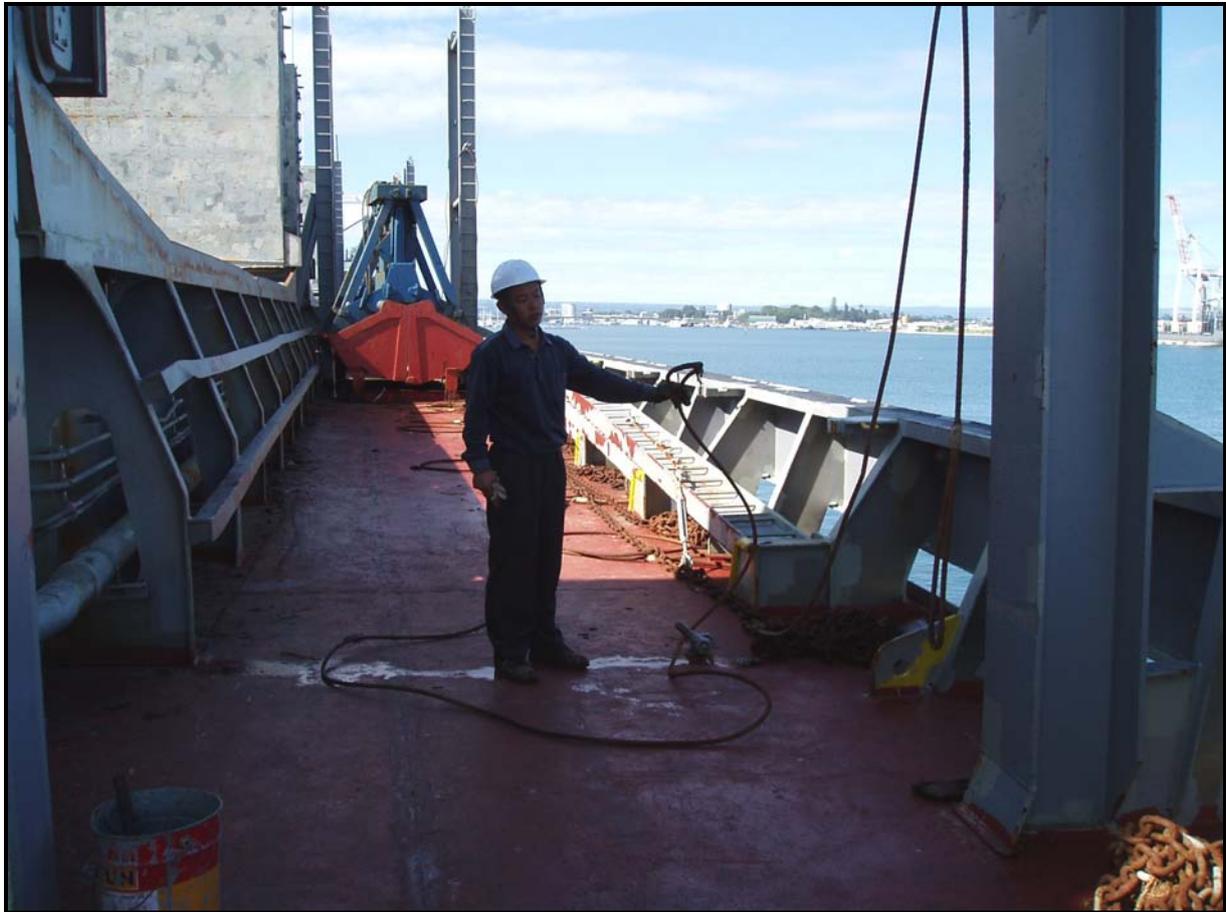
Photograph 3

Wire for rigging portable log stanchions

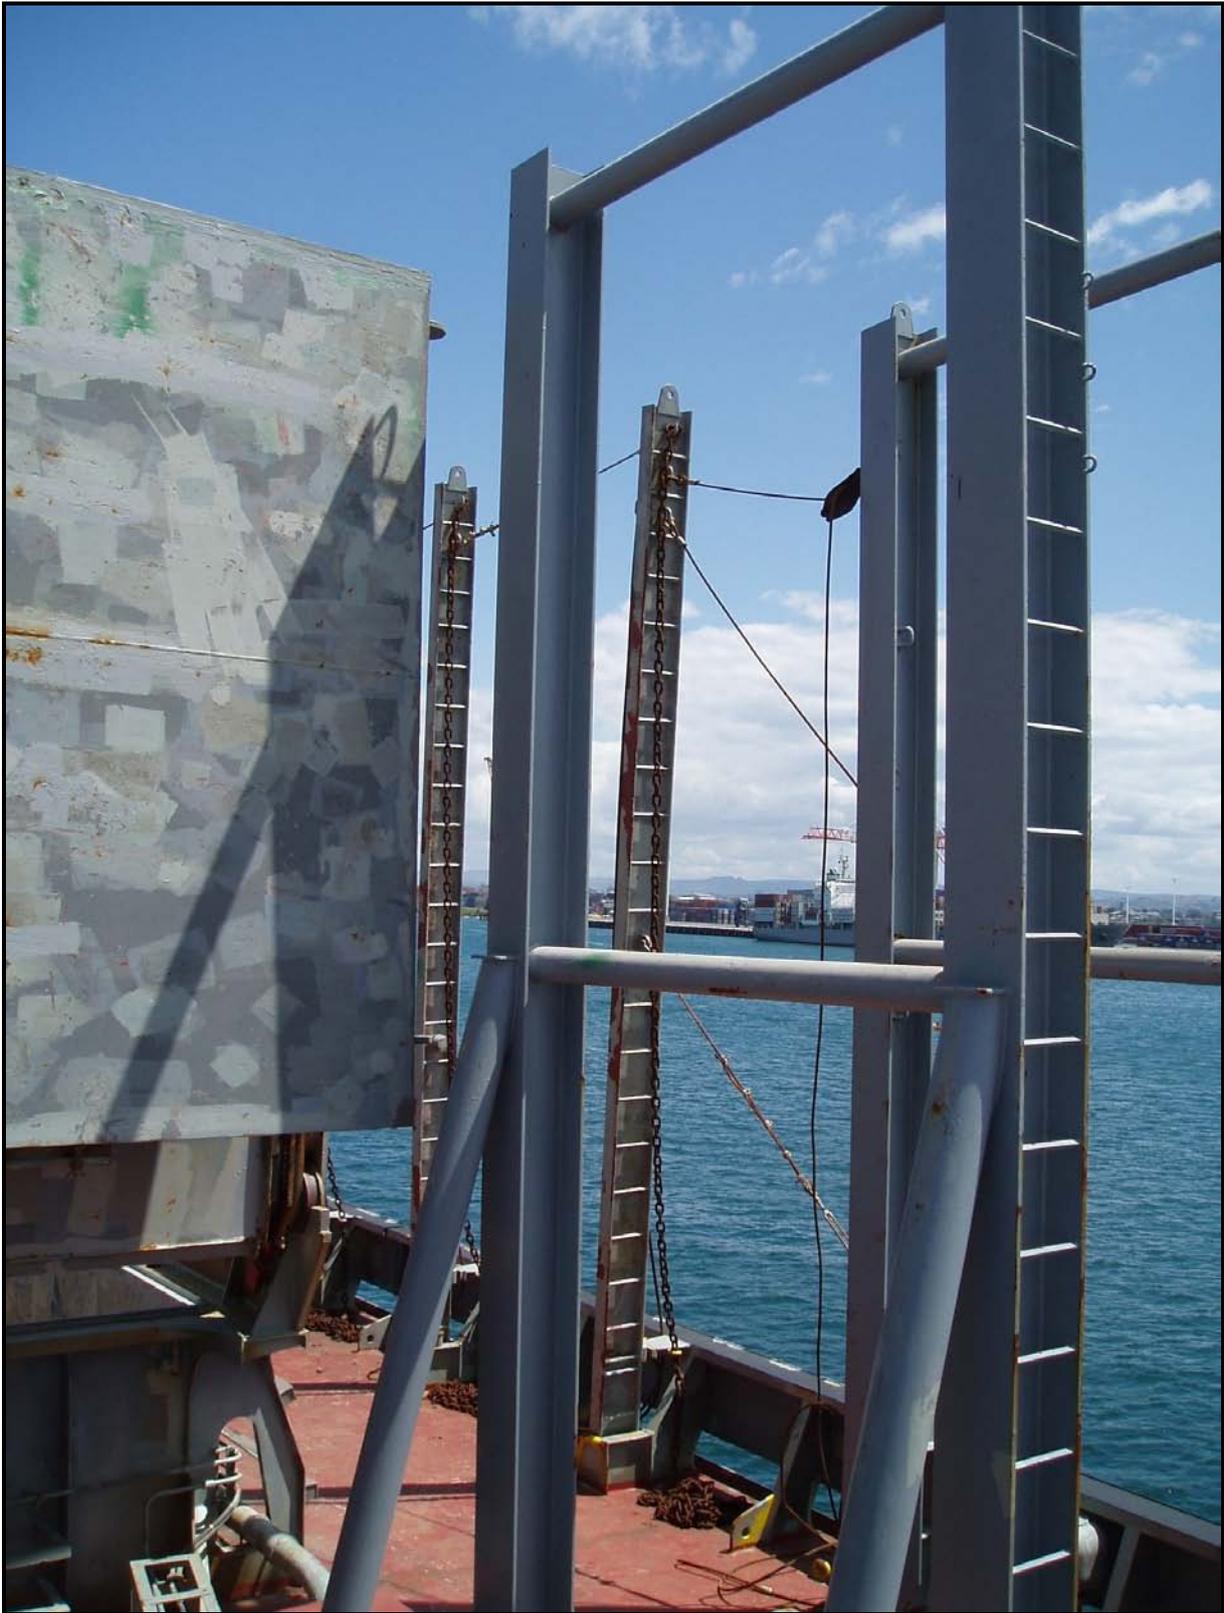
Photograph 4
Portable log stanchions at the port side of No. 2 hatch, after rigging.
