Summary Report

Contact with Wharf

General Villa

5 March 2006

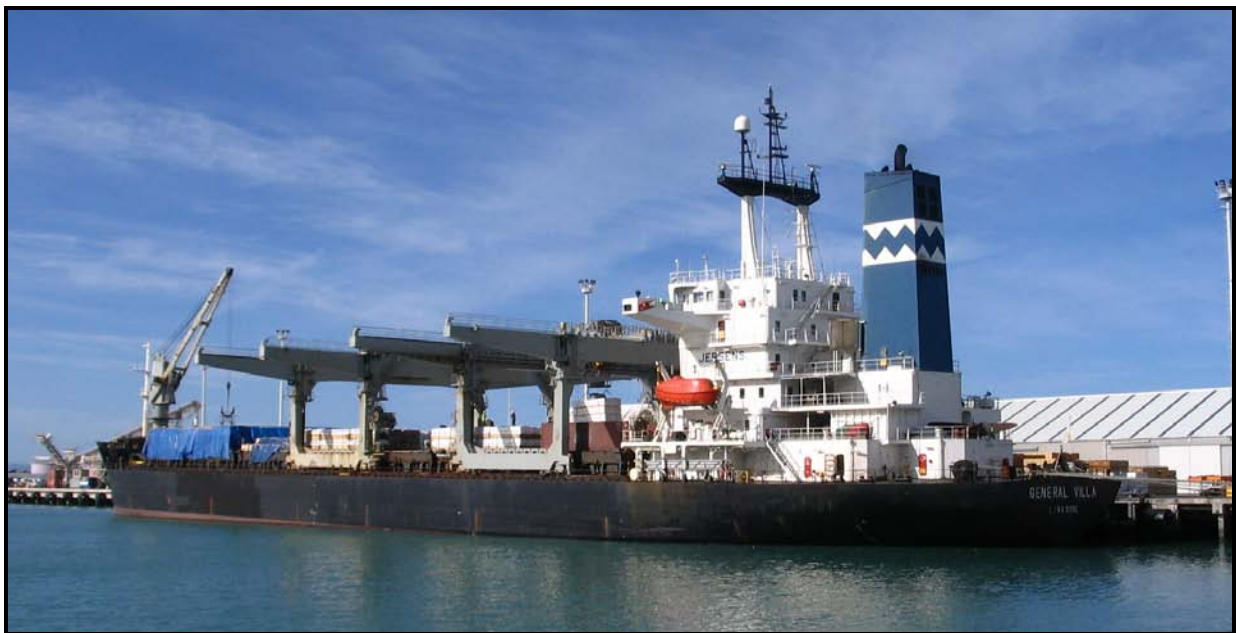
General Villa

The vessel suffered minor damage to her bulbous bow consisting of a dent measuring approximately 200mm in length, 70mm in width and a depth of 30mm. There was significant damage to three wharf pilings.
