Accident Report

Grounding

Huntress

8 November 2006

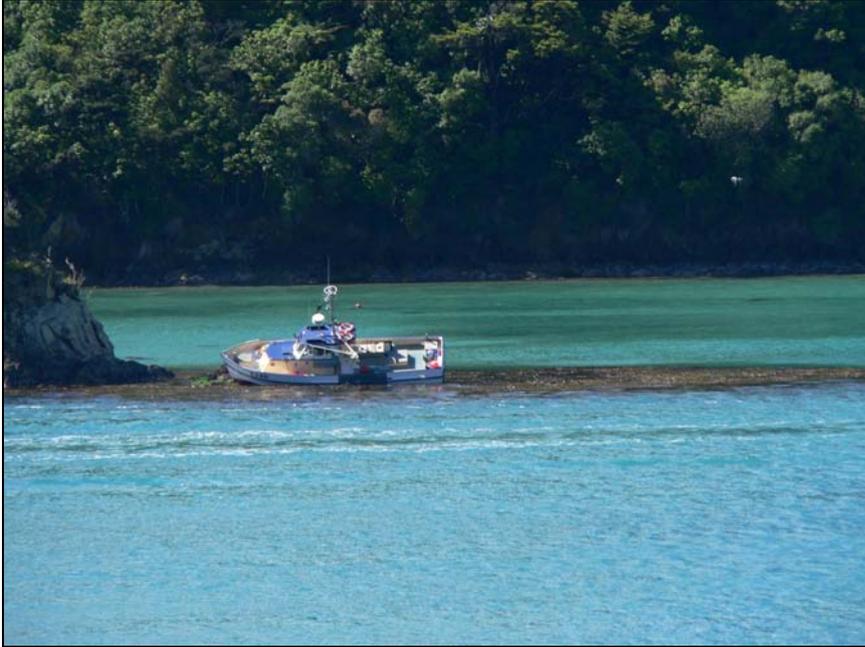
Fig 1, Huntress aground on Wiriwaka Point

While the Skipper was on deck the vessel was influenced by tide and wind resulting in the vessel being set to starboard and onto a rock shelf at Wiriwaka Point.

1. That the Skipper be censured for his failure to navigate safely in this situation. He clearly should have either: -
 - (a) Left the bin where it was.
 - (b) Tied it down properly from the start.
 - (c) Not scrubbed the bin.
 - (d) Stopped the vessel to ensure its continued safety throughout any activities on deck.
 - (e) Navigate the vessel further out into the channel to allow a greater safety margin.

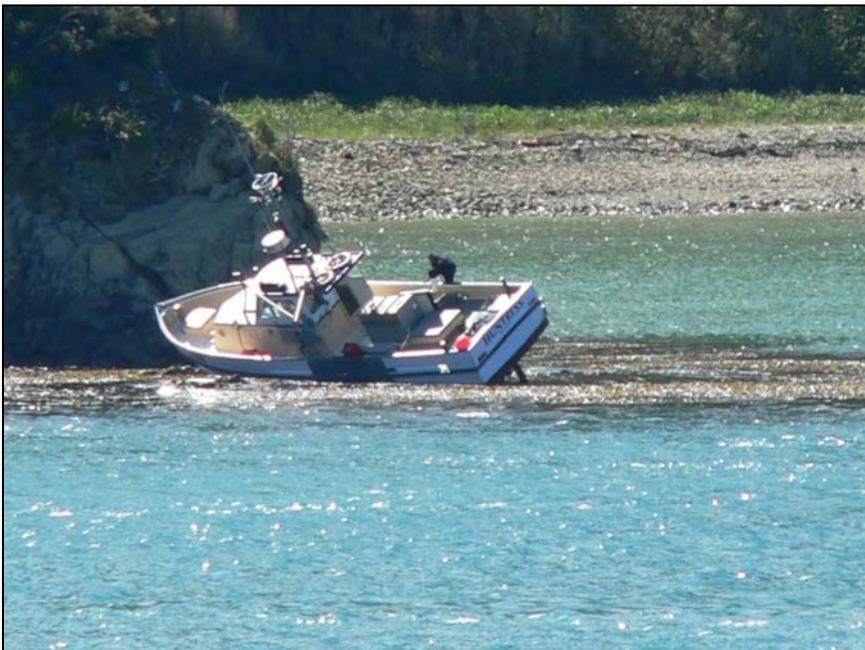
Fig 2, Huntress aground.
