Investigation report

***Ady Gil and
Shonan Maru No.2***

Collision on 6 January 2010

Maritime New Zealand

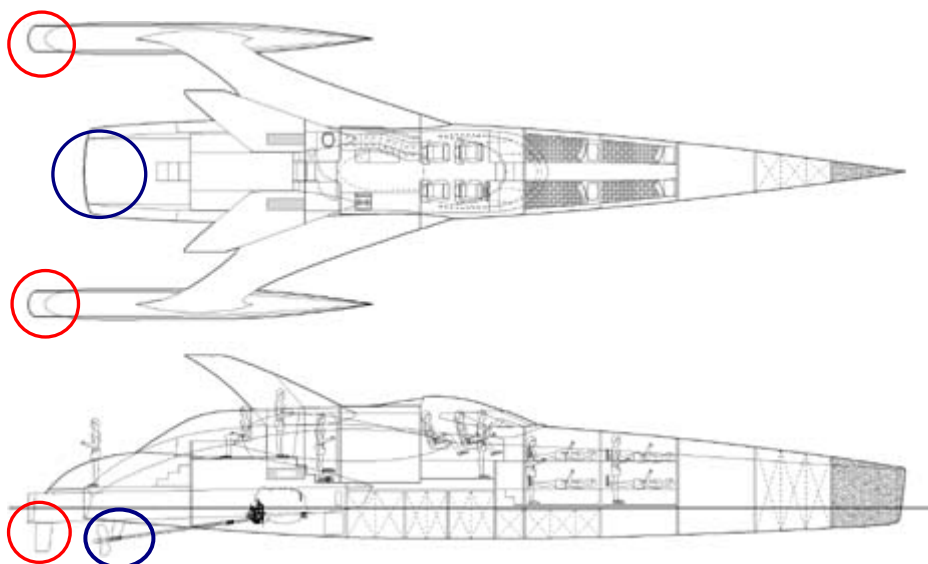
Figure 4 Diagram showing *Ady Gil*'s rudder and propeller positions
(Diagram courtesy of *Ady Gil*'s designer)

61. When moving *Ady Gil*'s throttles from neutral to ahead or neutral to astern, the respective gears had to be engaged, which was reported by the *Ady Gil* master to take between two and four seconds. Moving the throttles directly from ahead to astern without waiting for the gears to disengage and re-engage could potentially stall the engines.

62. A few days prior to the collision, the manual steering helm was found to have minor problems and the vessel was reportedly being steered under auto helm, which involves controlling the rudder with a dial control or buttons. This is a longer process than simply turning a wheel. This manner of steering is not as effective at low speeds or in conditions of moderate sea or swell.

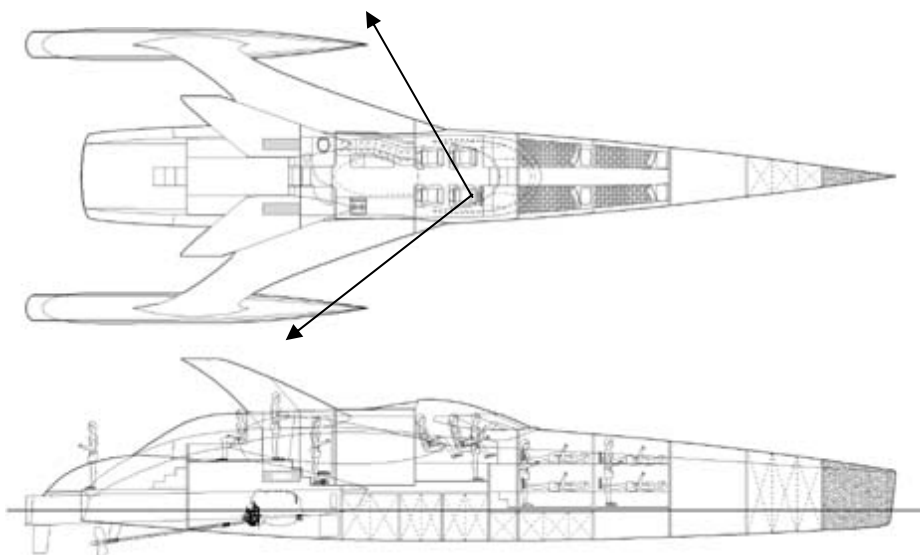
Figure 5 **Ady Gil**'s approximate area of visibility

63. **Ady Gil**'s forward windscreen was relatively small and designed to withstand the impact of waves. General visibility astern from the conning position was very limited, with only a small window providing any visibility directly astern. The master explained visibility from the helm as follows:

Visibility astern on the starboard side is, is limited in that you've kind of got to put your head over and you can look back I would say at about 45, maybe 50 degrees, maybe a little bit more, maybe 60 degrees astern on the starboard side you can look back, but from the driver's seat looking on the port side I would say you could look only 10 degrees astern of directly to port, if that makes sense, from your driver's seat. If you jump out of your seat, and you go over and you look back there.

64. Accordingly, the helmsman¹⁰ relied on verbal commands from a crewman standing at the stern when reversing or for maintaining a general lookout. Verbal commands would usually be done using handheld VHF radios, although radios were not used when engaging with the whaling fleet because of concerns they would be overheard. Alternatively, voice commands were relied on.

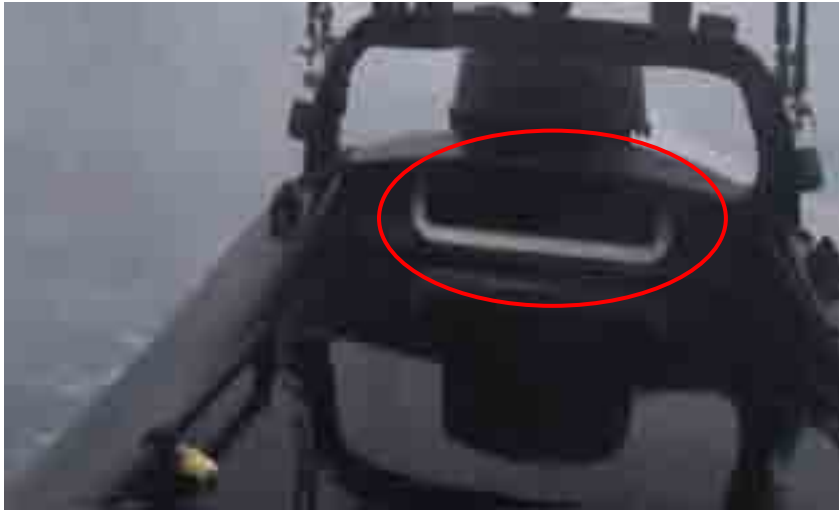
Figure 8 Small window at rear of **Ady Gil**'s cockpit
(Photograph courtesy of SSCS)

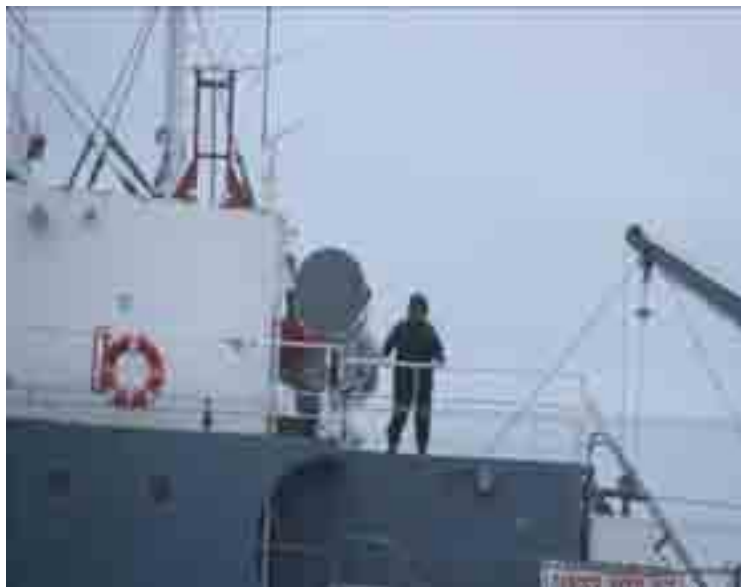
89. Following the warning, a long-range acoustic device (LRAD)¹⁵ sounded from **Shonan Maru No. 2** caught the attention of the master and crew at the stern of **Ady Gil**, but not the attention of the helmsman, who remained unaware of **Shonan Maru No. 2**'s approach.

Figure 10 **Shonan Maru No. 2**'s LRAD (the disc-shaped device at the centre of the photo)

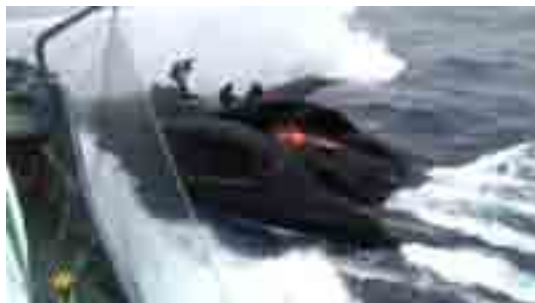
Figure 17 Propeller wash showing a further increase in **Ady Gil**'s propulsion

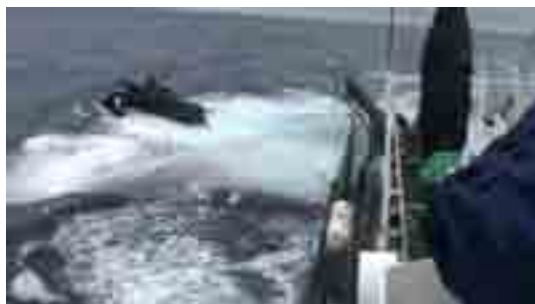
Figure 18 Propeller wash showing **Ady Gil**'s astern propulsion

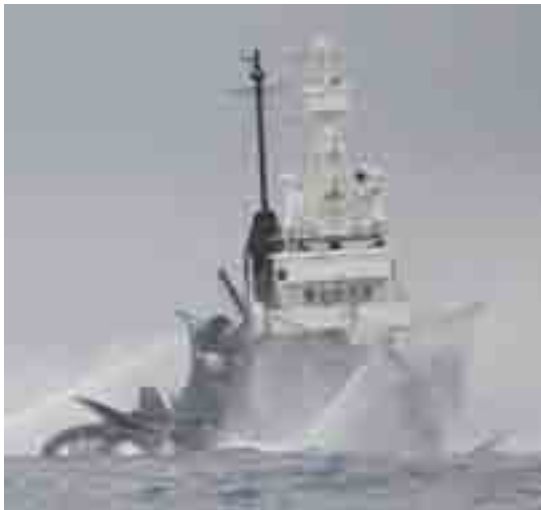
Figure 19 Collision
(Photograph courtesy of SSCS)

104. **Shonan Maru No. 2** and **Ady Gil** subsequently collided, striking **Ady Gil**'s bow and port sponson, taking approximately 3.5 metres off her bow. The moment of collision is shown in the photograph below. From the information available, it was not possible to plot accurately the final metres of each vessels track in relation to the other.

126. Similarly, there was insufficient evidence to determine whether it was *Ady Gil*'s bow or sponson that was struck first. This could not be accurately determined without recovery of the vessel for examination. Attempts were made to retrieve the bow on to *Bob Barker*. However, it was logged with water, the weight of which caused it to break apart when lifted.

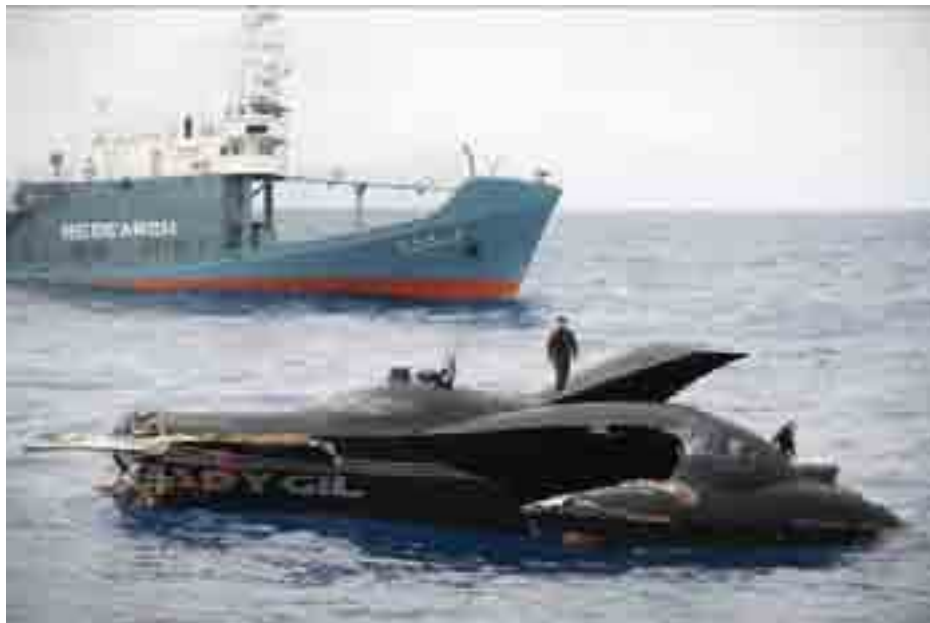
Figure 20 Damage to *Ady Gil*

127. Inquiries were subsequently made with the manufacturer of *Ady Gil*. On assessing images of the damage sustained, the manufacturer expressed the opinion that the remainder of the hull, undamaged sponson and other watertight areas would be sufficient to keep the vessel afloat.

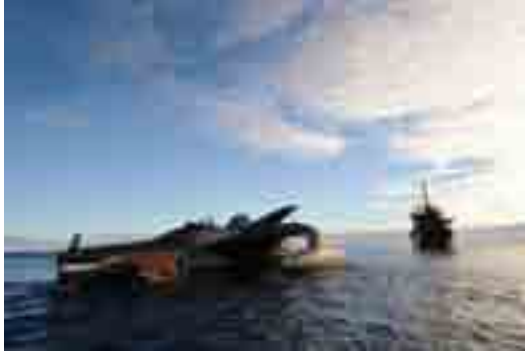
Figure 21 **Ady Gil** under tow
(Photograph courtesy of SCS)

114. Around 0230–0300 hrs AEDT on 8 January 2010, **Ady Gil** was sitting low in the water and believed by crew on **Bob Barker** to be sinking. The master of **Ady Gil** was consulted and, with the view that the vessel was not likely to remain afloat, the decision was made to cut her free. **Ady Gil** was subsequently released from her tow and cast adrift to sink.
115. On 9 January 2010, the ICR faxed MNZ advising that it had located **Ady Gil** drifting at a position of 64° 27.7'S, 143° 03.4'E. The ICR also alleged that **Ady Gil** was leaking oil. This is believed to be residual oil leaking as a result of damage sustained in the collision.

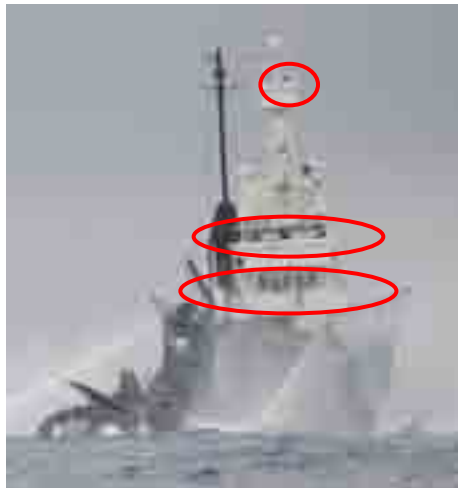
Figure 22 Eight crew maintaining a lookout on **Shonan Maru No. 2**
(Photograph courtesy of SSCS)

153. There is no evidence to suggest that the lookout from **Shonan Maru No. 2** was ineffective. Therefore, the lookout maintained by **Shonan Maru No. 2** is not considered to be a factor in the collision.

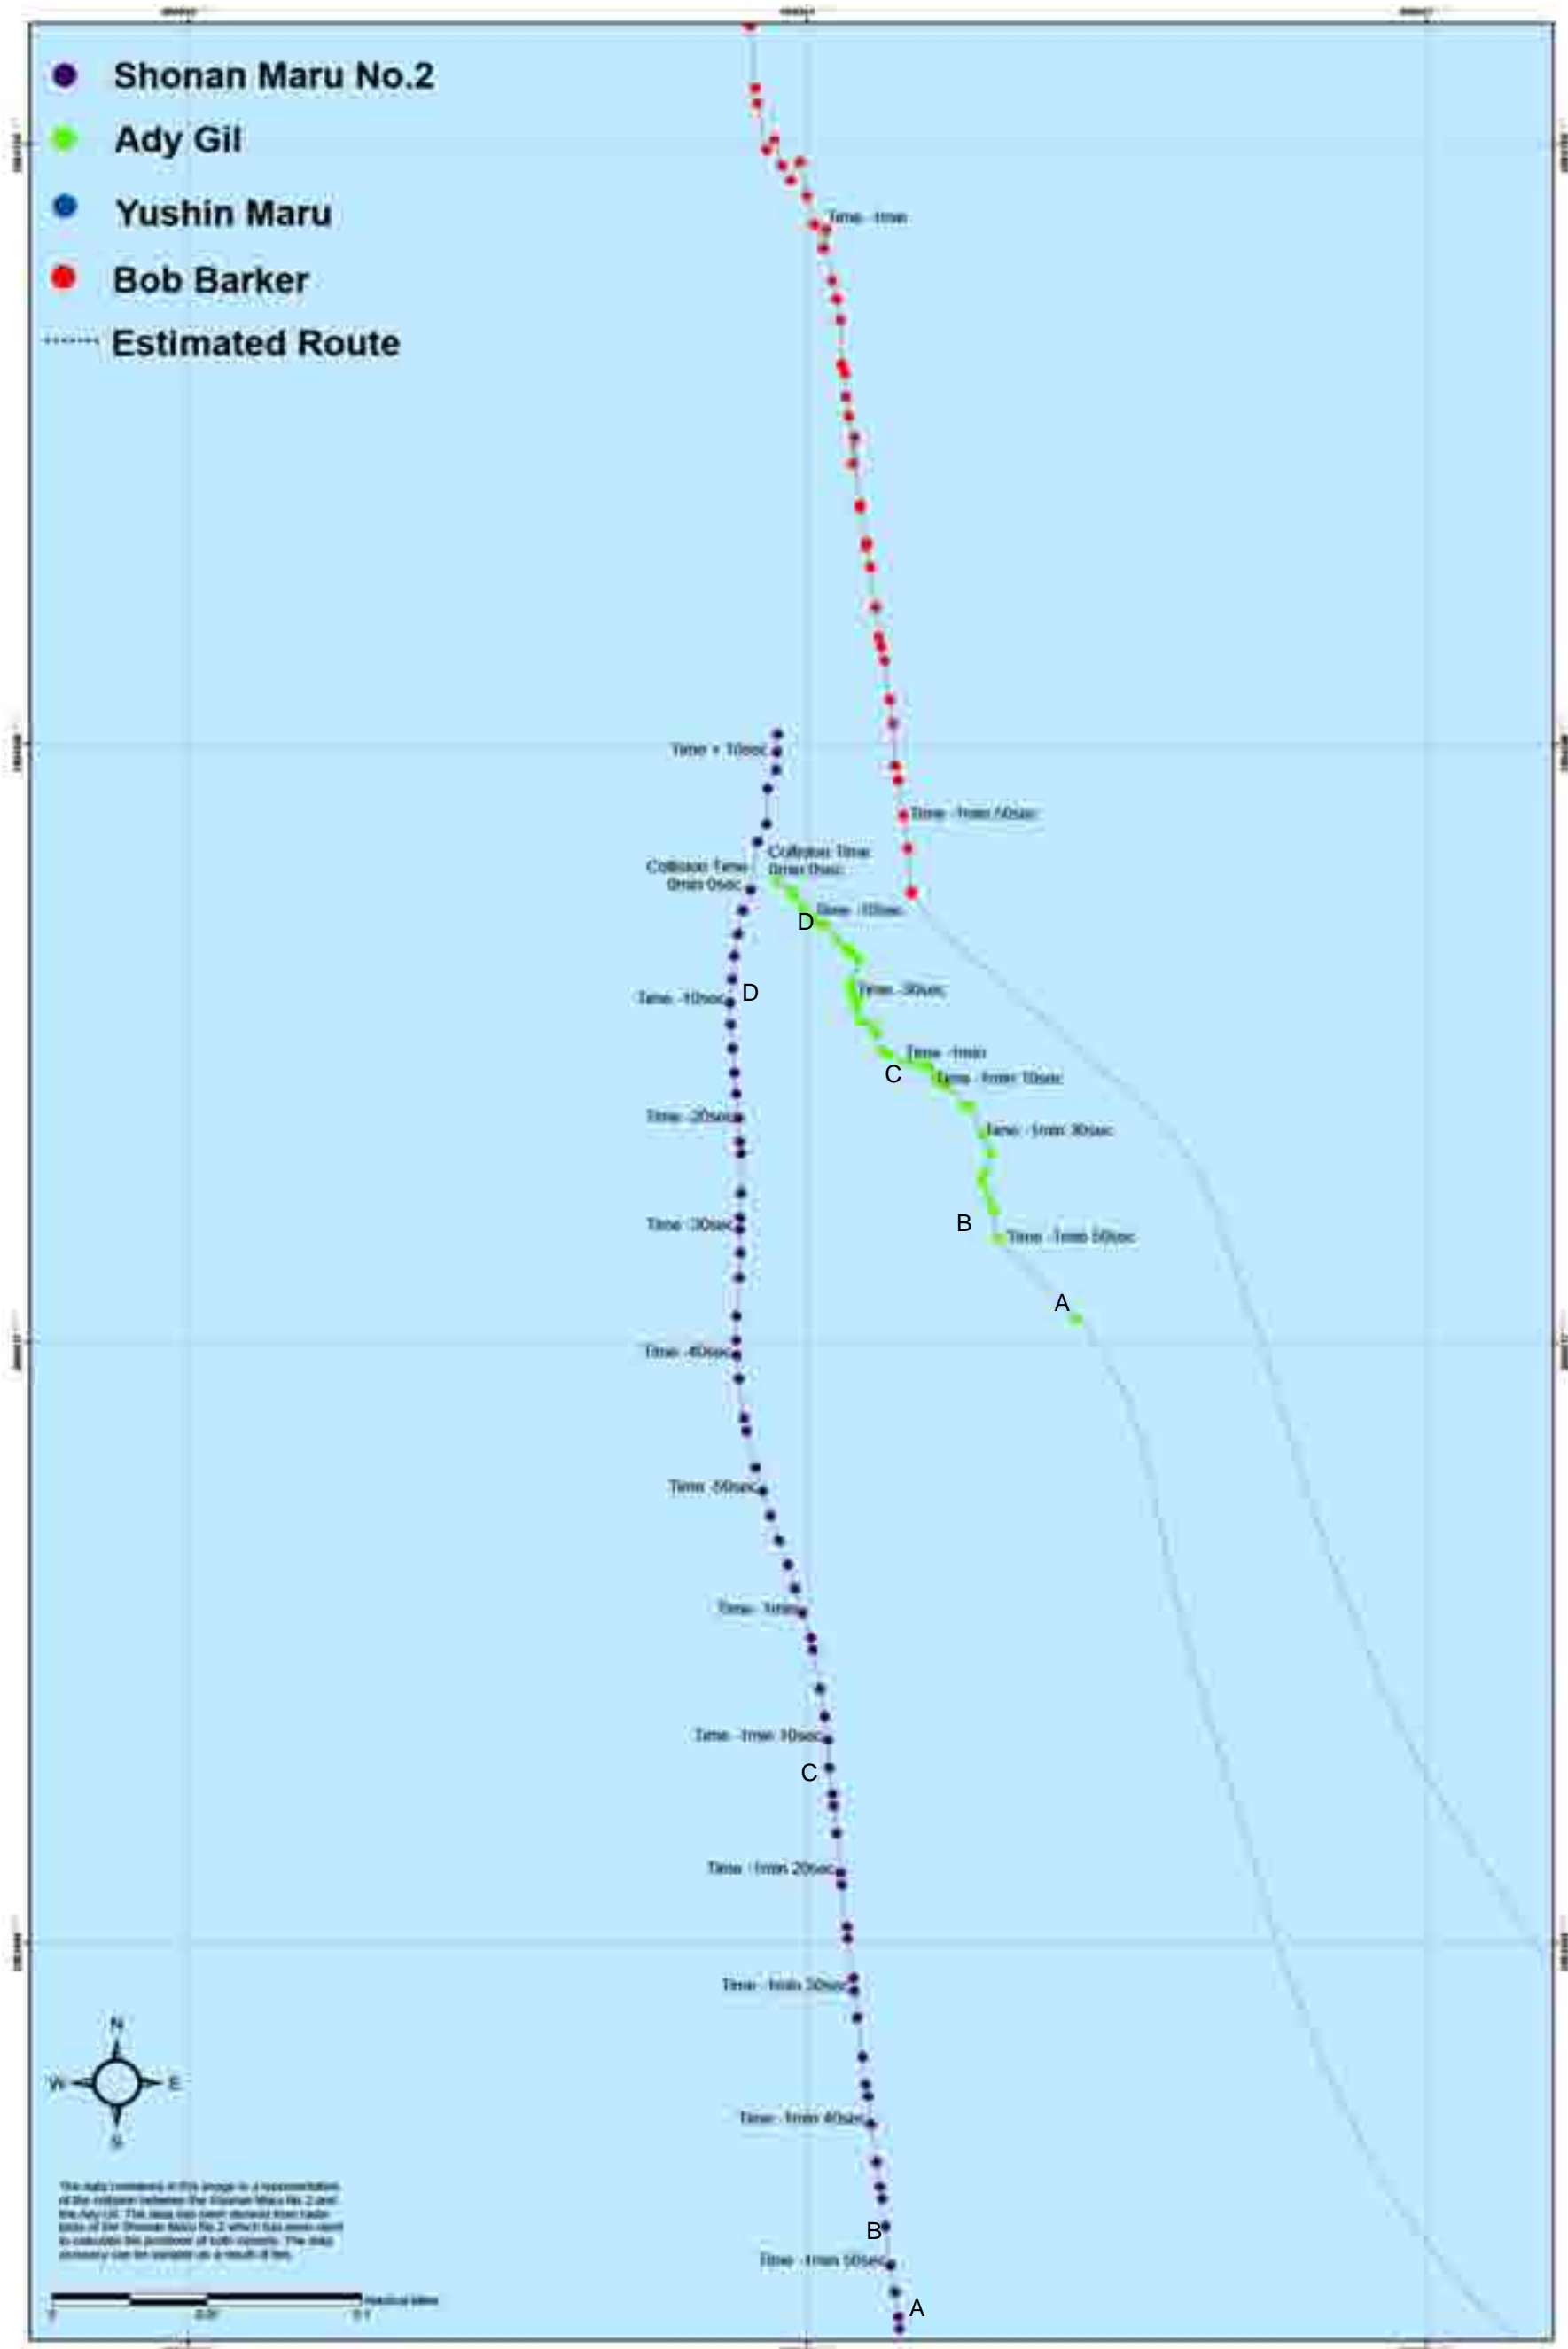
Appendix 4: Vessel tracks

93. The information available suggests that, when **Shonan Maru No. 2** was approximately 130 metres away from **Ady Gil**, **Shonan Maru No. 2** steered so as to alter her track line some 13° degrees starboard (that is, from about 350°(T) to 014°(T). This alteration of course by **Shonan Maru No. 2** rendered a close quarters situation inevitable in the absence of either a further change of course by **Shonan Maru No. 2** or a change of course by **Ady Gil**. (Refer to Appendix 4 from Point D onwards, and to Appendix 5)

132. The track of *Yushin Maru No. 3* was plotted to ascertain whether or not its presence prevented *Ady Gil* or *Shonan Maru No. 2* from complying with the international collision regulations. *Yushin Maru No. 3* was found to be well clear of *Shonan Maru No. 2*, *Ady Gil* and *Bob Barker*. The same process was applied for the *Bob Barker*. For this reason, investigators were able to rule out the possibility that *Yushin Maru No. 3* or *Bob Barker* limited the manoeuvrability of any other vessel or contributed to the collision. (Refer to Appendix 4)
