Kawarau Jet 3
Internal Injury
Lake Rotorua on 13 January
2005
Class B Non Serious Harm Accident Report

REPORT NO.: 96 349
KAWARAU JET 3 – INJURY

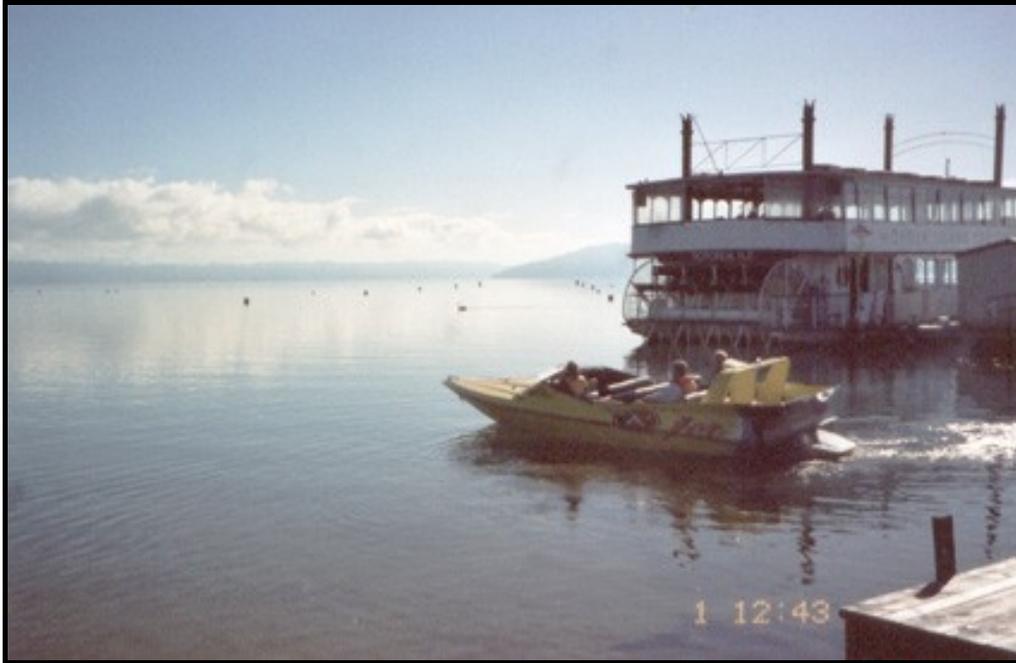
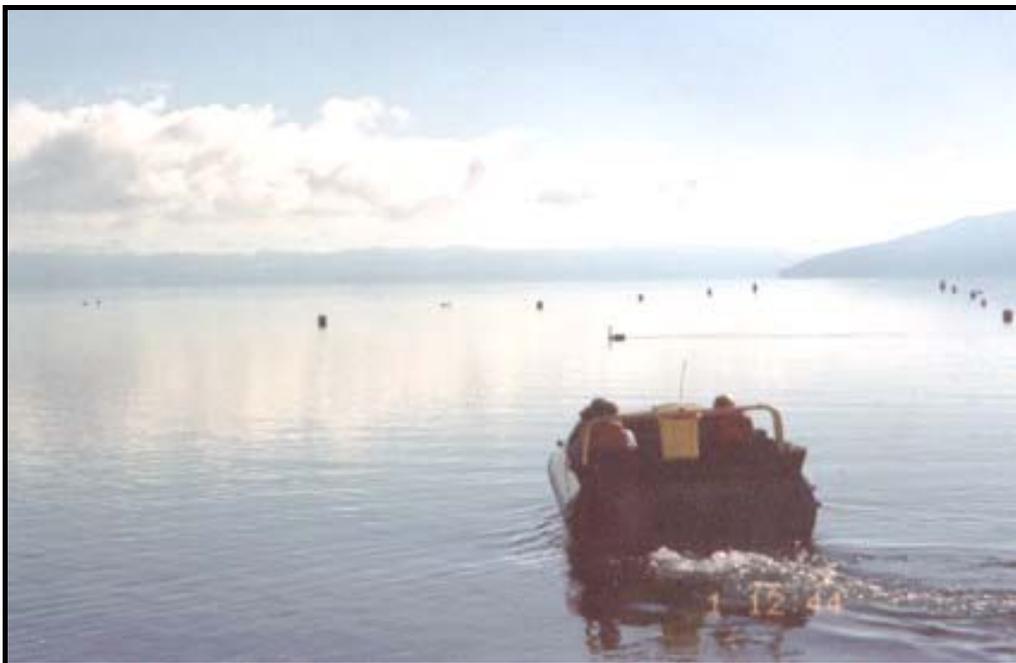
Kawarau Jet 3

- 1.5 One of the passengers said that as the spin was about to commence, she become concerned for the young children and put out her arm to hold on to a young child who was sitting on her right. This left her with only one arm to brace herself. As the boat came to a halt after the spin, the passenger was thrown against the gunwale and the passengers sitting next to her were pushed up against her. She stated that she was gasping for breath after they stopped and advised the Skipper. The Skipper told her she was probably winded.

- 3.6 During the passage, before commencing the spin, the Skipper reminded passengers to hold on to the rail in front of them with both hands and looked round to make sure they were doing so. The passenger who said she was injured had taken one hand off the rail to try to hold a small child who was sitting, unrestrained, on the seat next to her. The Skipper said she did not know that a passenger had been injured.

- 4.1 Although the sides of *Kawarau Jet 3*, abreast of passenger seating, were padded, the company was arranging to fit extra padding to provide greater protection.
- 4.2 It is recommended that the company reassess its procedures to take into account the ability of passengers to withstand the forces associated with Hamilton turns, particularly children and older passengers.
- 4.3 It is recommended that the company reviews its safety briefings to take account of all aspects relevant to the boat, the voyage and conditions and ensures that passengers are given an appropriate briefing before their boats leave the wharf.
