Accident Report
Serious Harm Injury
Kawau Kat
14 April 2007
Class A

1. SUMMARY

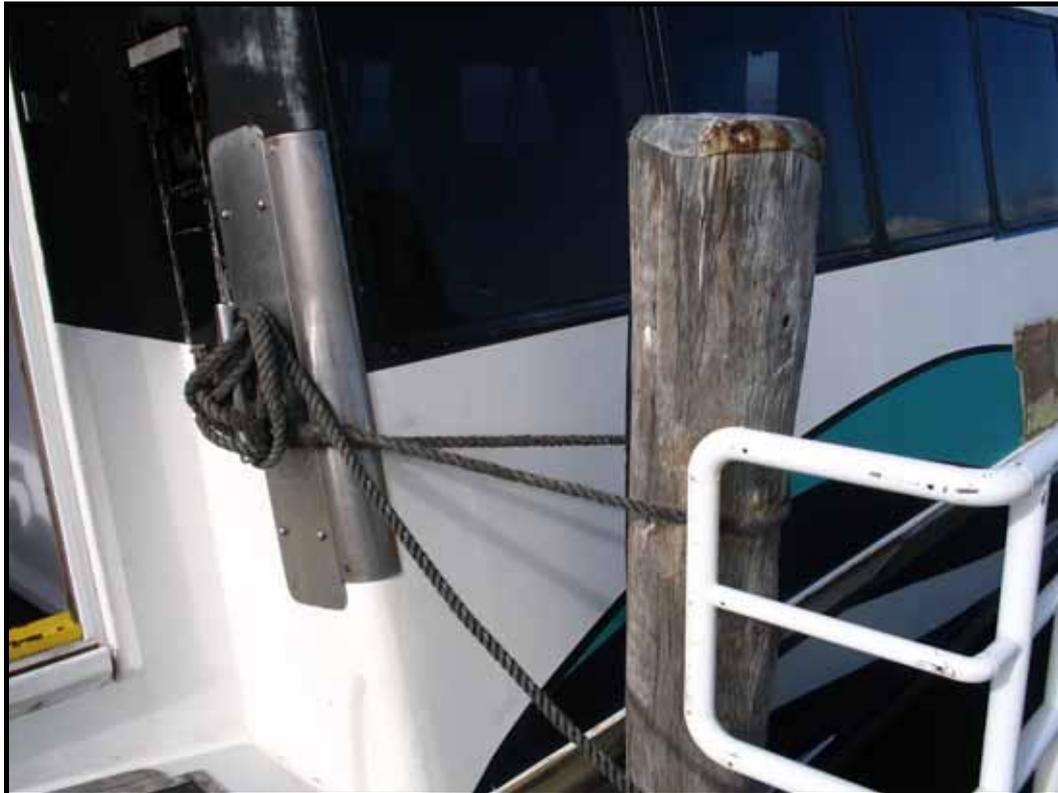
Photograph 2

3.1.2.8 On examination after the accident, minor damage, in way of an indentation in the timber construction, was found to the vessel in the vicinity of the mooring cleat. It is thought probable that this indentation was caused by the mooring cleat contacting the vessel when it recoiled after failing.

Mooring cleat on *Kawau Kat* with the same rope used in the accident.

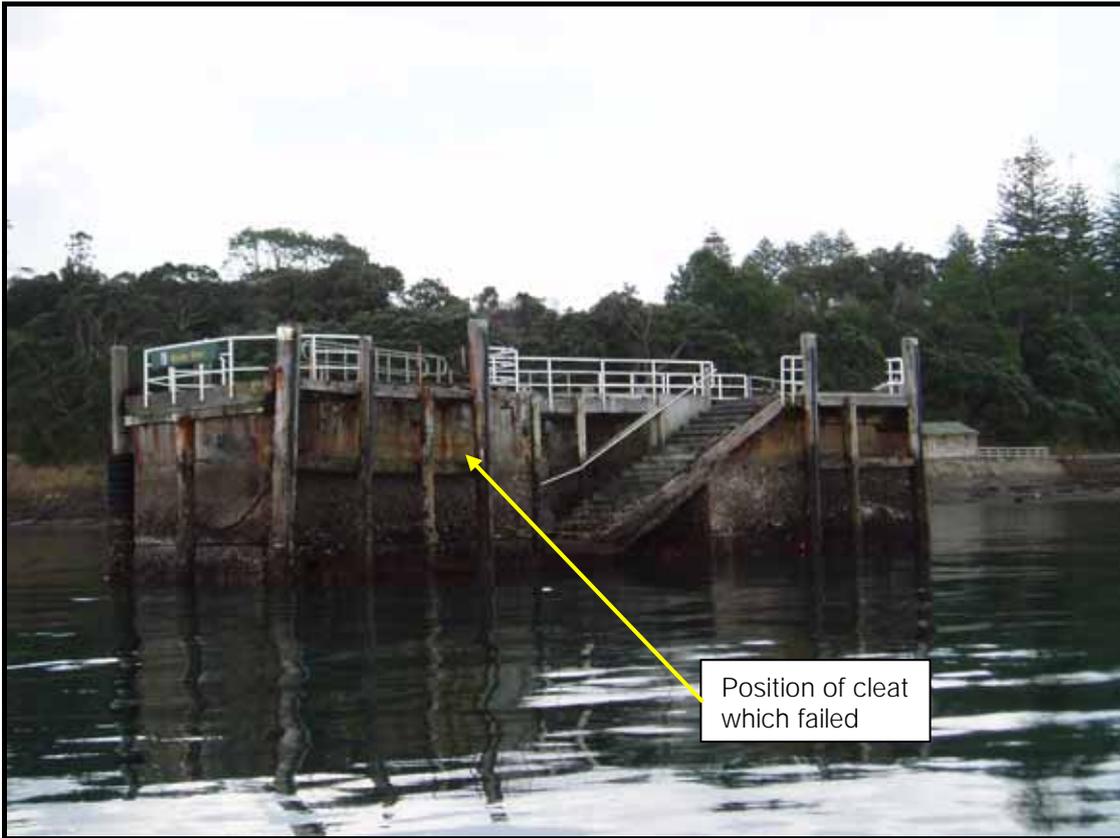
Photograph 3
Motuihe Wharf

- 2.5 The Skipper repositioned the vessel and made another approach to the wharf. This time, the vessel's port bow was close enough for the Deckhand to be able to land the eye of the spring line over the wharf's mooring cleat (*See Photograph 3*). He promptly made the spring line fast to the cleat located on the port side of ***Kawau Kat***. When turned up, the spring line was approximately 3 to 3.5 metres in length. The Skipper put the helm hard to starboard, port engine ahead and the starboard engine astern and attempted to maintain tension on the spring line in order to bring the vessel alongside.

3.1.3.4 On the wharf, there are three different types of mooring equipment. There are two large bollards, a medium sized bollard and a large cleat positioned on the wharf's deck and four smaller mooring cleats on the steps. On the lower timber waling (horizontal timber) are two medium sized bollards and the cleat that failed.

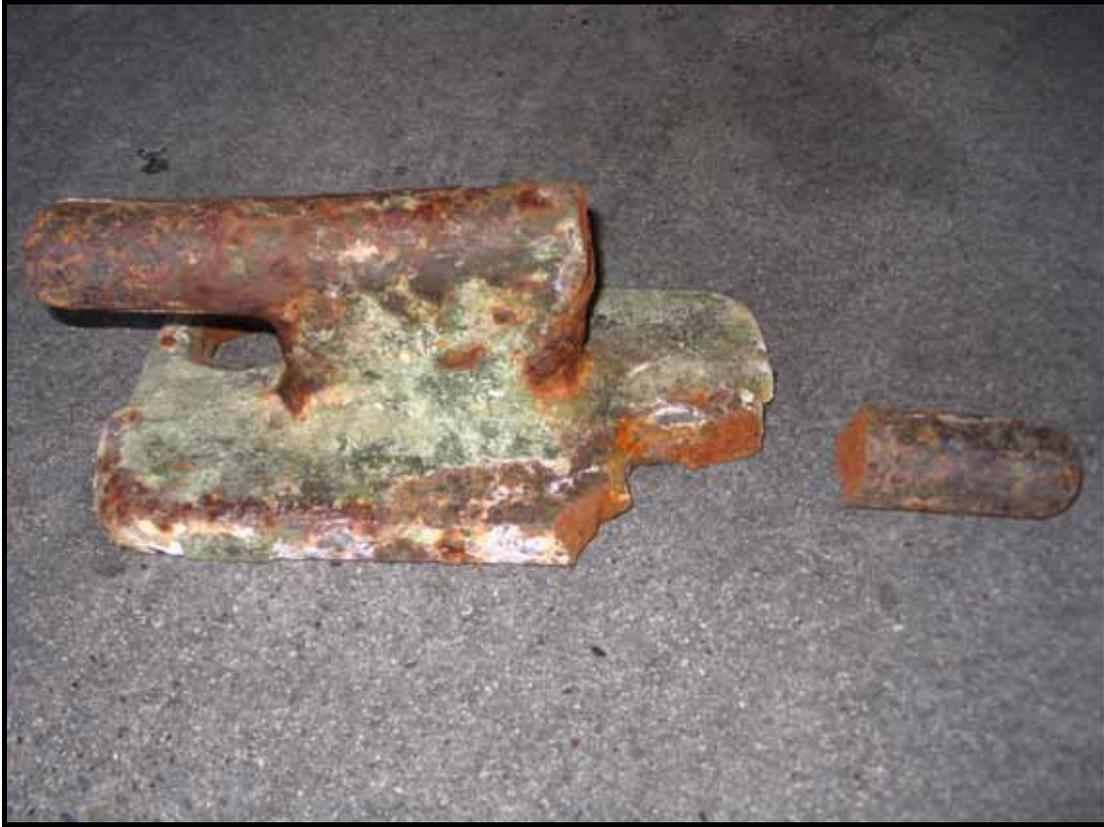
Photo 4
Mooring Cleat and Detached 'Horn'

- 3.1.4.9 When examined after the accident, it was found that one side of the cleats 'horn' had been broken off and the seaward corner of the base had broken off across the bolt hole. The underside of the cleat's base showed evidence of pitting where it had been in contact with the treated timber to which it was affixed. It is likely that there has been a cathodic reaction between the cast iron cleat and the copper present in the treated timber.

- 3.1.4.10 The rear bolthole was found to be oversize (approximately 30mm, compared to the normal 22mm for a 20mm bolt). This is probably due to corrosion caused by a cathodic reaction from the cast iron being in contact with the treated timber or the bolt, which was constructed of a dissimilar metal. Another possibility is that the bolt hole was oversize for the 20mm bolt when the cleat was first fitted and that the gap was obscured by the washer below the nut.

- 3.1.4.11 The cleat was covered with surface rust. This surface rust was no worse that could reasonably be expected given its position on the wharf.

- 5.1 It is recommended that the Department of Conservation replace the remaining cleats of the same type on Motuihe wharf as a matter of urgency. *In commenting on the draft report DOC stated that they had engaged their consulting engineers to carry out an unscheduled inspection of the cleats and bollards with a view to the removal and replacement of suspect items. DOC are also further discussing with their consulting engineers a new design and fabrication of a mooring point/cleat/bollard fixing method that will withstand the rigours of use and corrosion.*

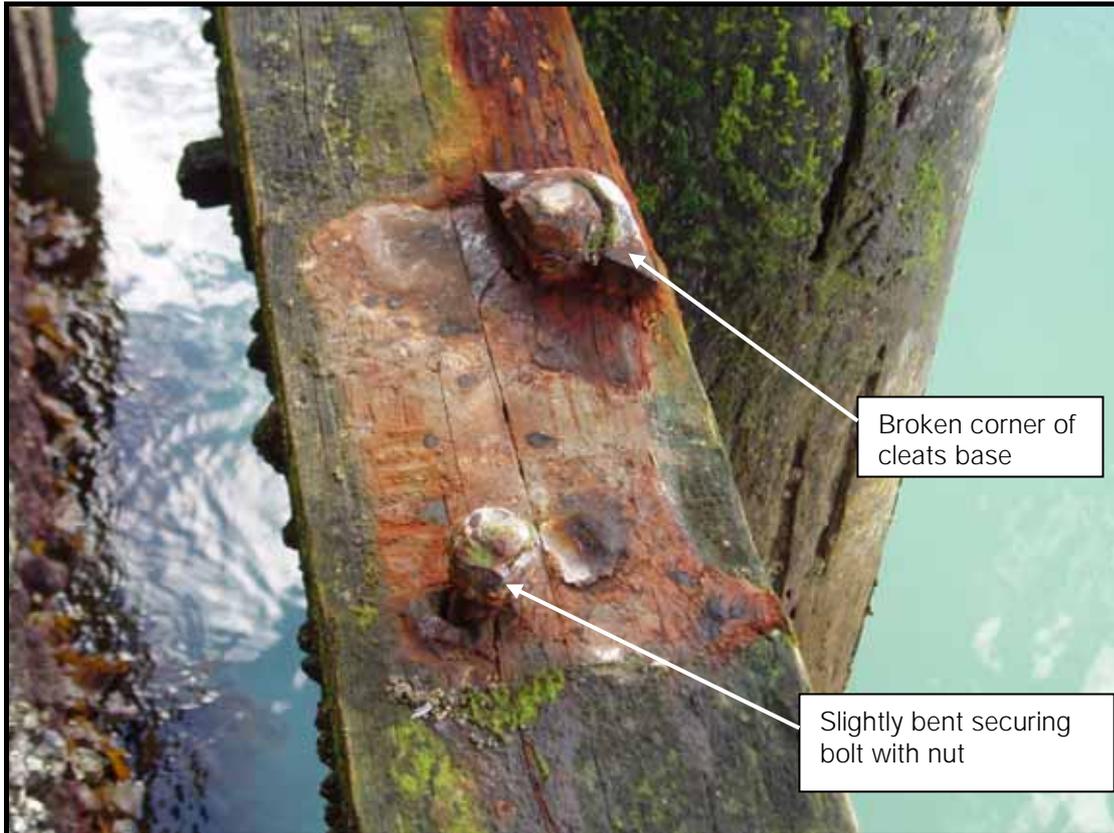
Photograph 5
Cleat's Position Prior to Failure

- 3.1.4.12 The corrosion around the bolt hole probably allowed the cleat to be pulled over the bolt's nut and in doing so breaking the washer. The lifting of the rear of the cleat placed stresses on the casting causing the seaward corner, which was still effectively attached by its bolt, to fracture. This corner section of the base remained in position on the wharf.
- 3.1.4.13 The cast nature of the cleat's construction means that prior to the moment of failure; the cleat would not have given any indication of its impending fracture.

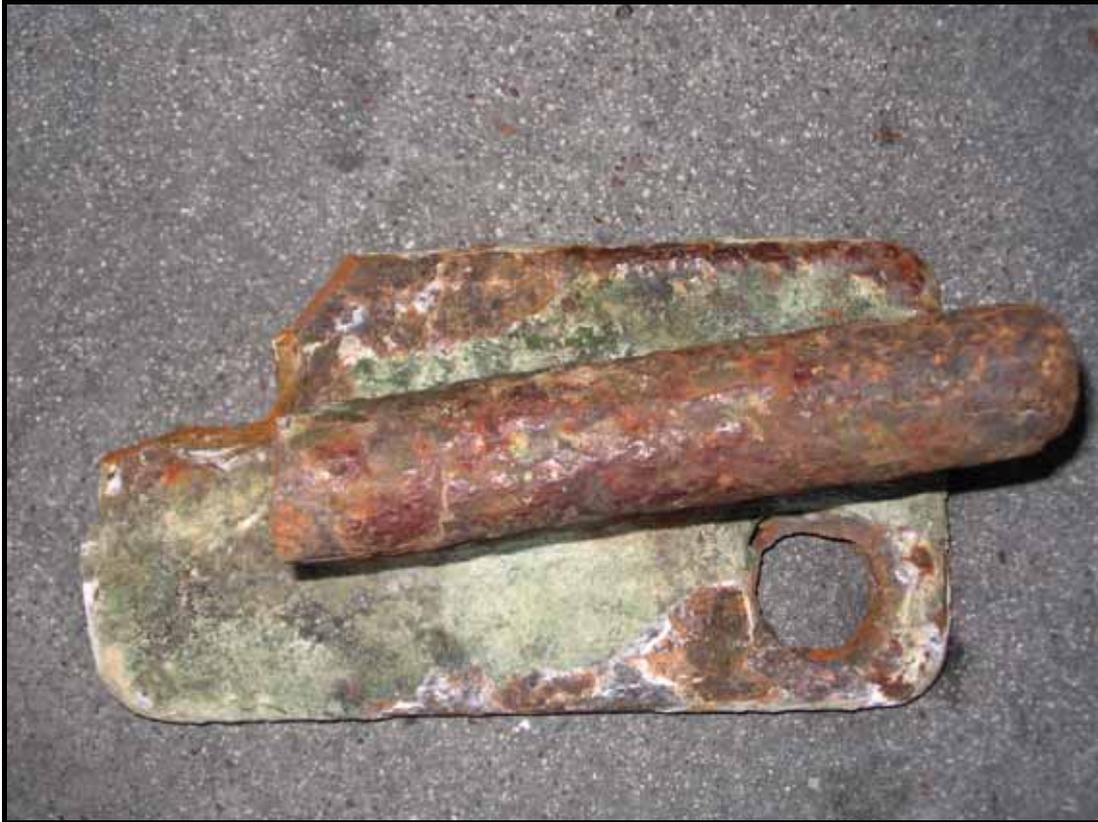
Photograph 6
Mooring Cleat Showing Corrosion Around Bolt Hole

- 4.1 The mooring cleat was able to be pulled off its bolts due to corrosion. This subsequently caused the cast iron to fracture.
- 4.2 The possible causes for this corrosion are the cathodic reaction between two dissimilar metals in seawater, either between the cast iron and the copper present in the treated timber to which the mooring cleat was affixed, or between the mild steel bolt and the cast iron. *In commenting on the draft report the Department of Conservation (DOC) stated it would bring Conclusions 4.1 and 4.2 to the notice of their consulting engineers and that they would be replacing all cast brackets with mild steel as per their consulting engineers inspection report.*
