Class B Accident Report

# **Lady Kawhia**

# **Mechanical Failure**

## **REPORT No: 04 3604**

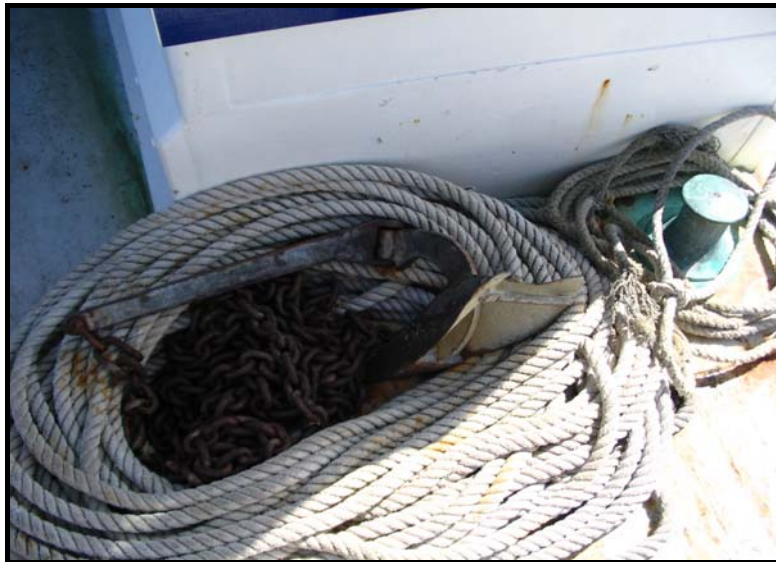
**Main Anchor**

When the anchors were recovered, it was found that they were fouled on a large commercial fishing net and in its associated traces. The anchors would not hold because of this.
