Class A Accident Report

# Lucky No.5

# Capsize/Fatality

At Raglan on 16 January 2005

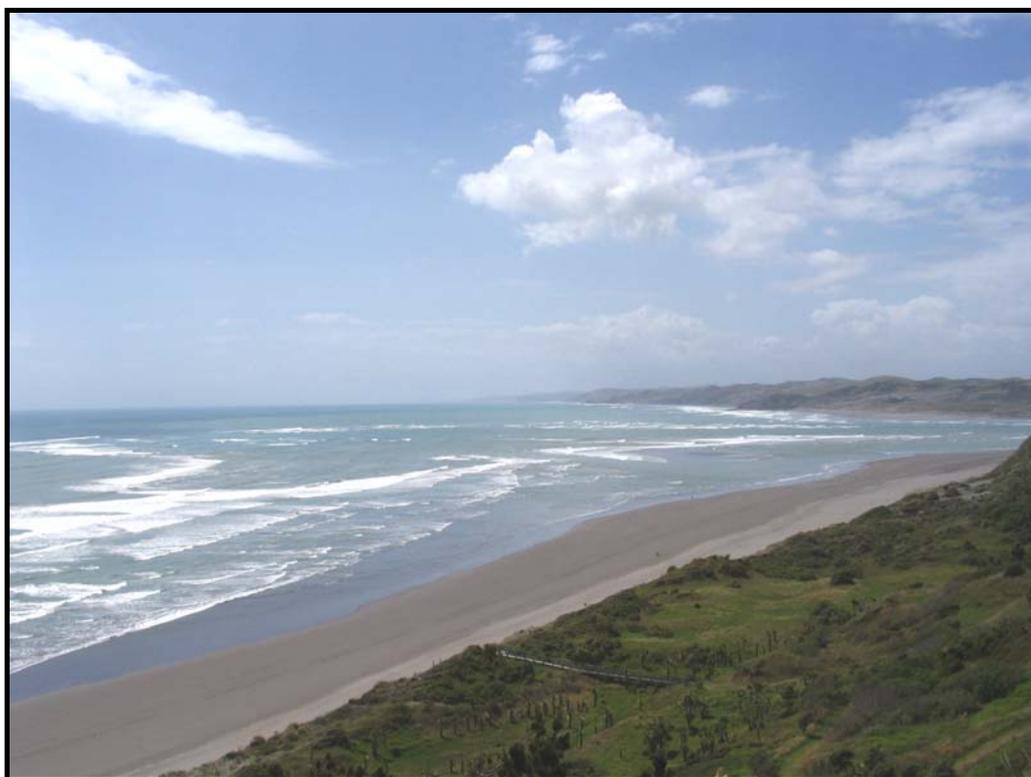
PHOTO 1 - RAGLAN BAR

At the time of the accident, the actual wind was approximately 8-10 knots from the west. The waves on the bar were approximately 1.0 to 1.5 metres in height. The seas in the harbour and beyond the bar were calm. The Skipper of *Lucky No.5* claims that the waves were 2-4 metres in height.

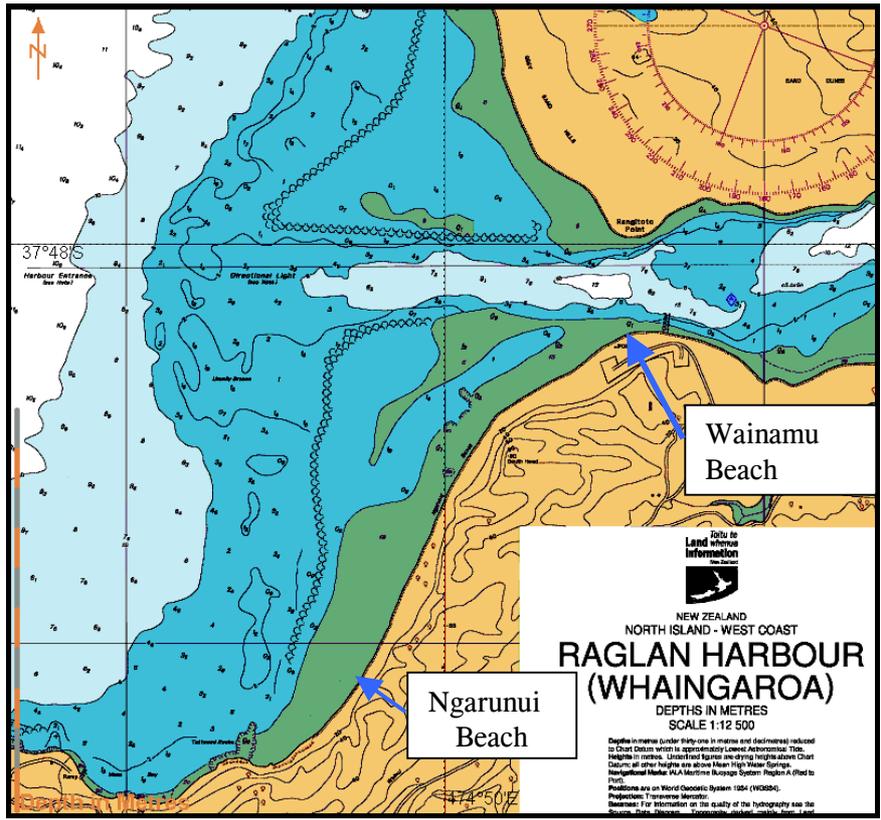
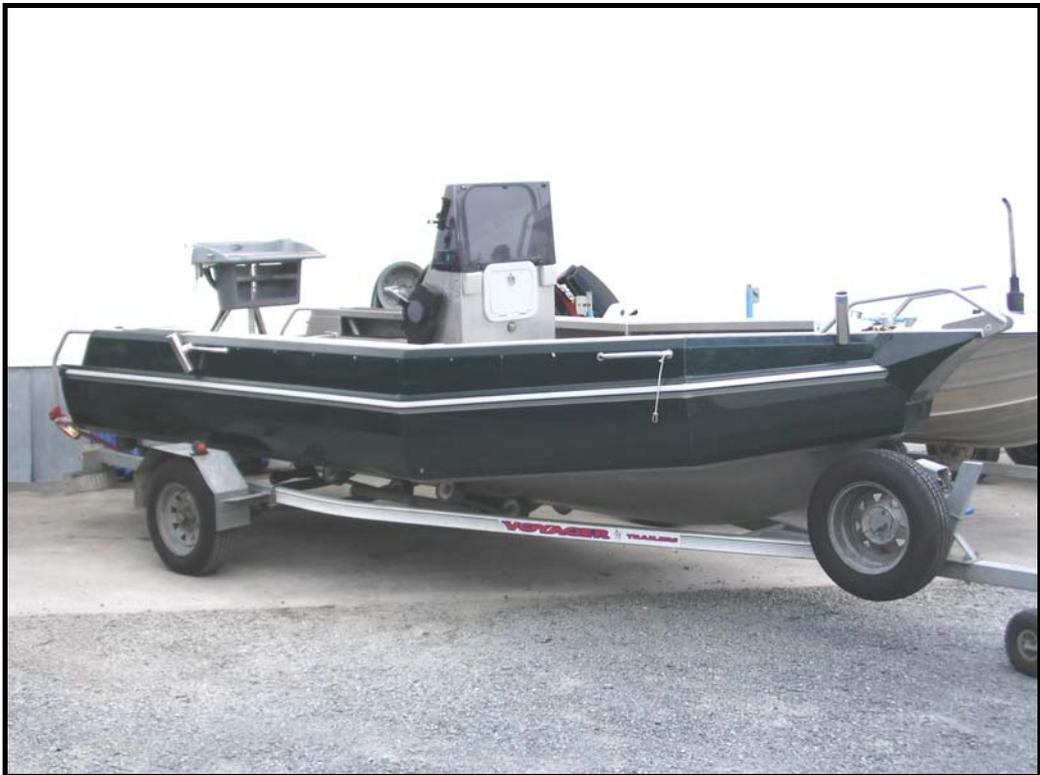
**PHOTO 2 - UNNAMED STABICRAFT (WITHOUT AWNING)**

The Honda outboard on the Stabicraft had not received its first service.

The Honda Warranty Service Interval for such an engine calls for a one-month or 20 hour initial service check. It then moves to every 200 hours or every 12 months, whichever happens first.

When the Investigator examined the vessels after the accident, the engine gauge on the Stabicraft showed 31.3 hours.

The Stabicraft is fitted with a manufacturer's plate recommending a maximum engine size of 75 horsepower. The engine fitted to the Stabicraft was 90 horsepower.

- The reason for the failure of the unnamed Stabircraft's engine is not known. There is a possibility that as the bow lifted out of the water on hitting a large wave, the engine was submerged. It is unknown if the fact that the engine appears to be overdue its first service contributed to its failure, although this is considered unlikely.
