Incident Report
Close Quarters
MOL Wellington & Chips
7 September 2005
Class C

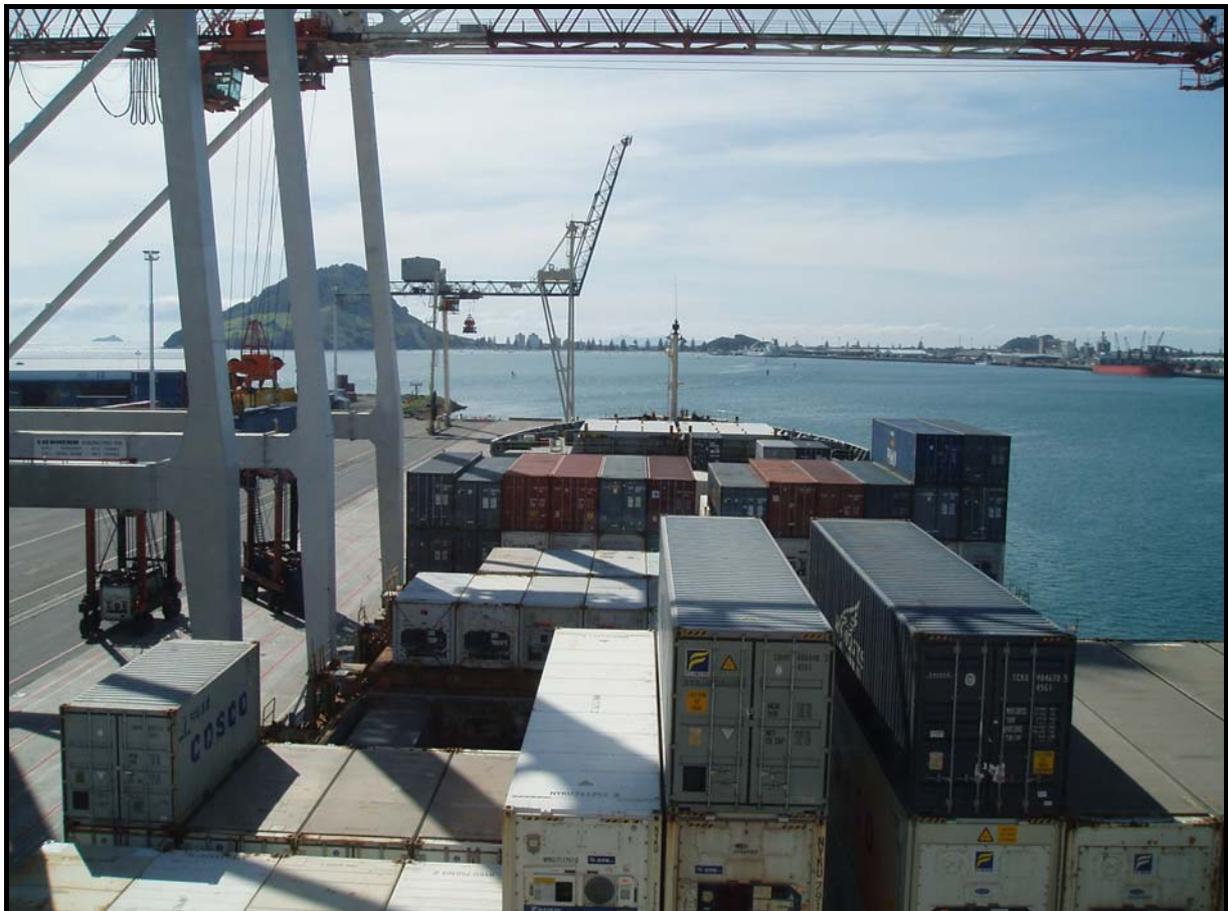
Photograph 2

The Able Seaman was steering until the Second officer changed the steering mode to autopilot, after which he stood by the helm to monitor the course and to keep a lookout. Both Second Officer and Able Seaman stated that they did not see any small boats near their ship. From the bridge of **MOL Wellington** there was clear visibility on both sides and of the sea beyond about 300 m ahead of the ship (See *Photograph 2*).

View from the wheelhouse of **MOL Wellington**

1. The Master of *MOL Wellington* instruct his watchkeepers both verbally and in his written standing instructions to be vigilant in keeping a lookout for small vessels by all available means, including radar and VHF, when navigating around the New Zealand coast.
2. The Skipper of *Chips* takes into account the risk to his vessel from ships when planning to trawl in the port approach area. Information about times of arrival and departure of ships are available from the port company.

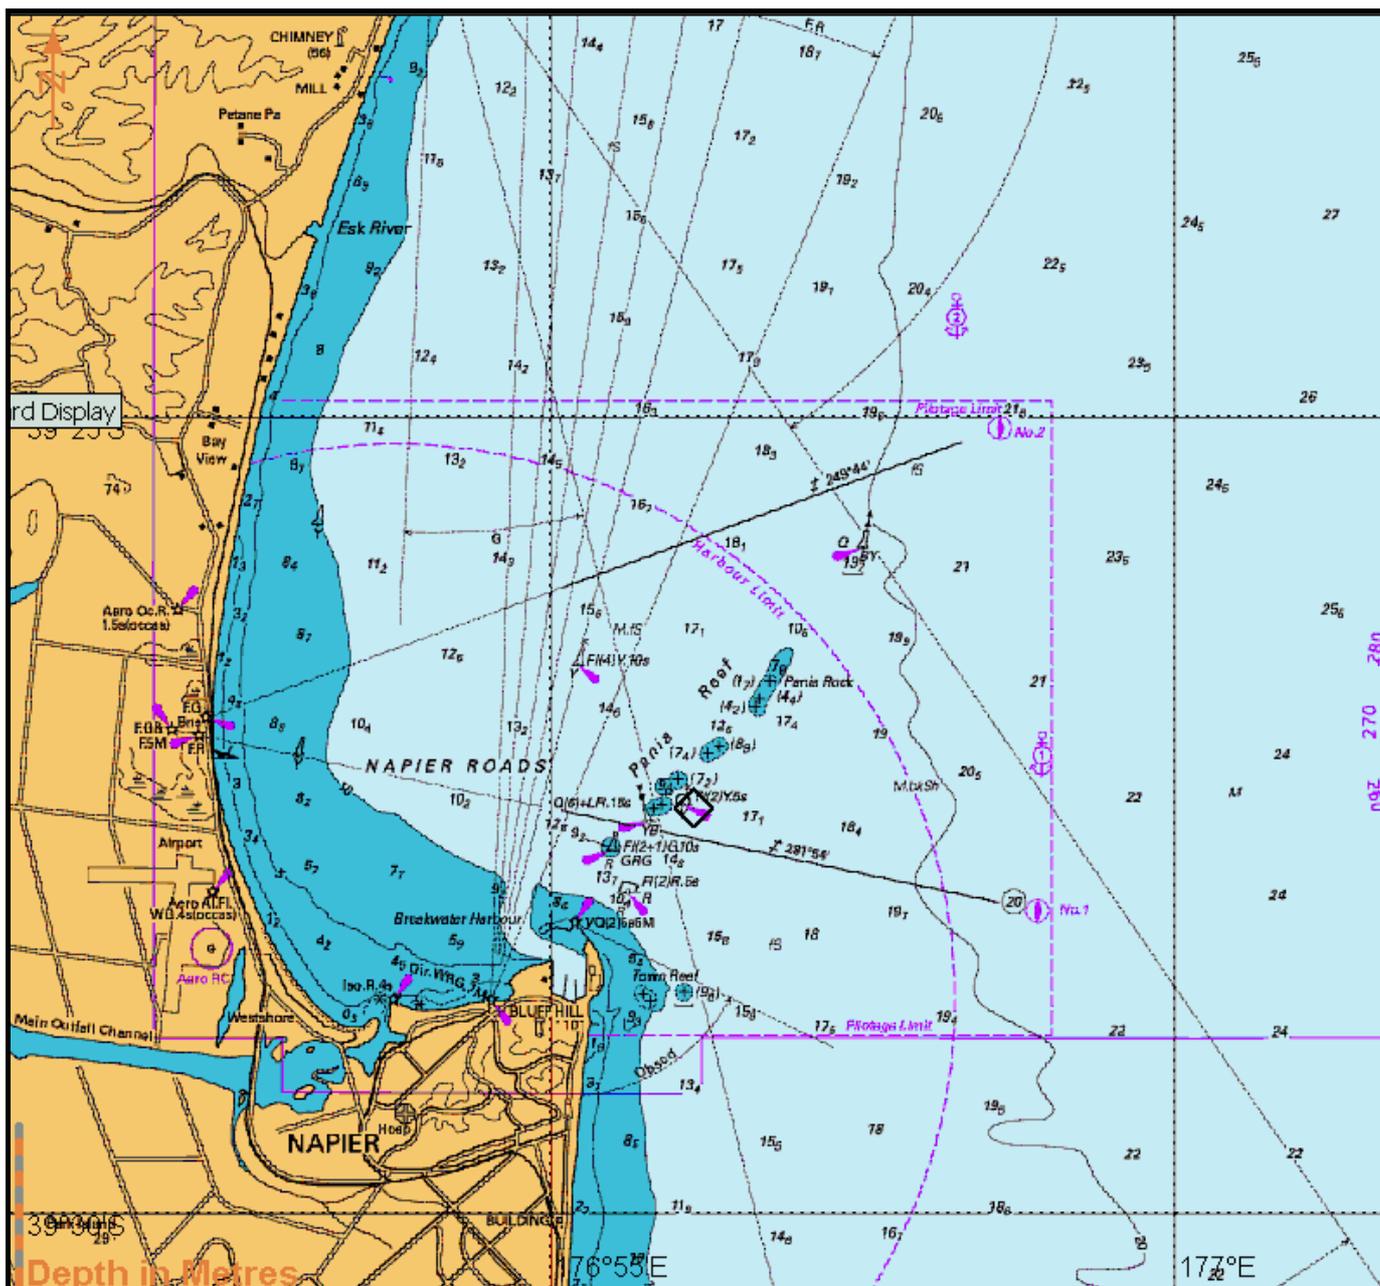
Figure 1
Chart Extract – Approaches to Napier

At 1500 hours, *MOL Wellington* was in a position with the north cardinal buoy (39° 25'.8 S 176° 57'.6 E) bearing 072°(T), distant 1.3 miles (See *Figure 1 – Chart Extract*). The engine order full away was given and the vessel's speed began to increase from 12 knots to 19 knots, a process that would take about an hour.

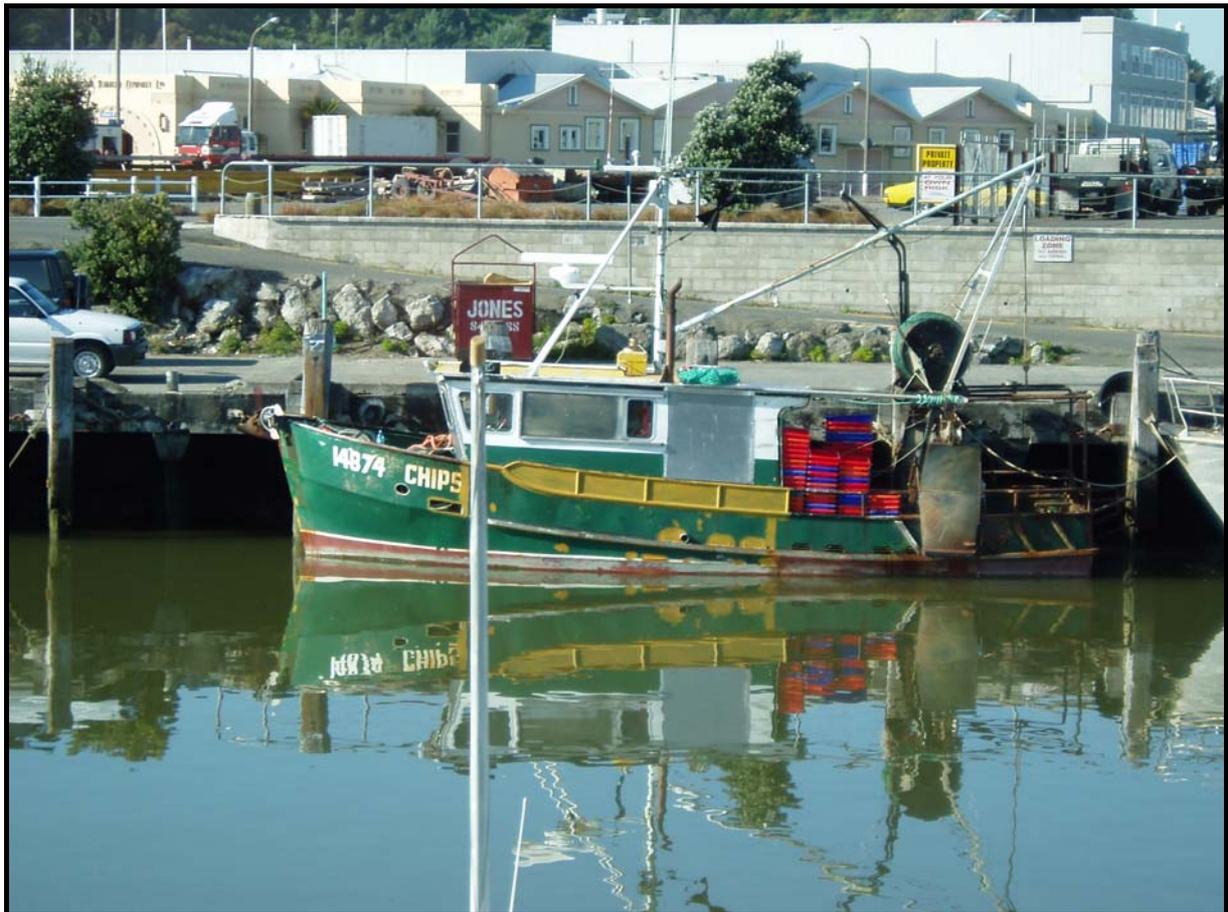
Photograph 3
FV *Chips*

The Skipper of *Chips* said that *MOL Wellington* crossed ahead, within 50m of his vessel.
