Accident Report  
Close Quarters  
*Manutere & Ocean Monarch*  
12 March 2006  
Class C

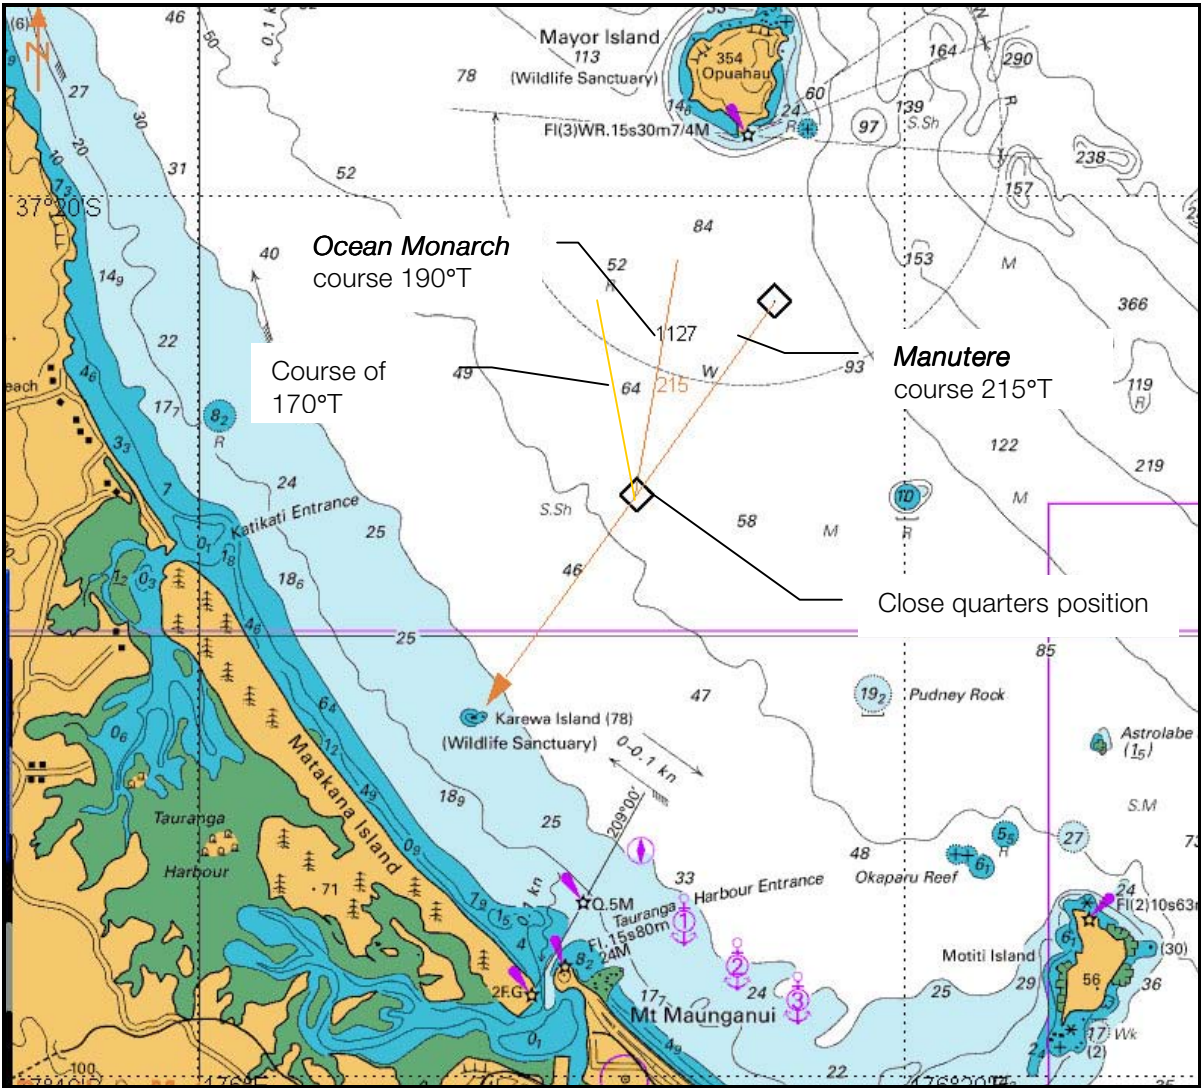
Figure 1  
Chart NZ 541

The accounts of the close quarters incident presented by the Skippers of the two vessels do not agree. **Manutere's** evidence shows that **Ocean Monarch** was overtaking while **Ocean Monarch's** Skipper and one of his passengers maintain that the vessels were crossing. However, the following information indicates that **Ocean Monarch** was overtaking **Manutere**:

- **Ocean Monarch** was going to Tauranga harbour entrance, heading 190°(T)
- **Manutere** was going from Pinnacles to Karewa Island, heading 215°(T)
- **Ocean Monarch** was approaching **Manutere** from a direction of about 65° abaft its starboard beam.

It is possible that the Skipper of *Ocean Monarch* made an incorrect estimation of the direction in which *Manutere* was heading.
