Accident Report

Gas Inhalation

Marlborough River Queen

9 June 2007

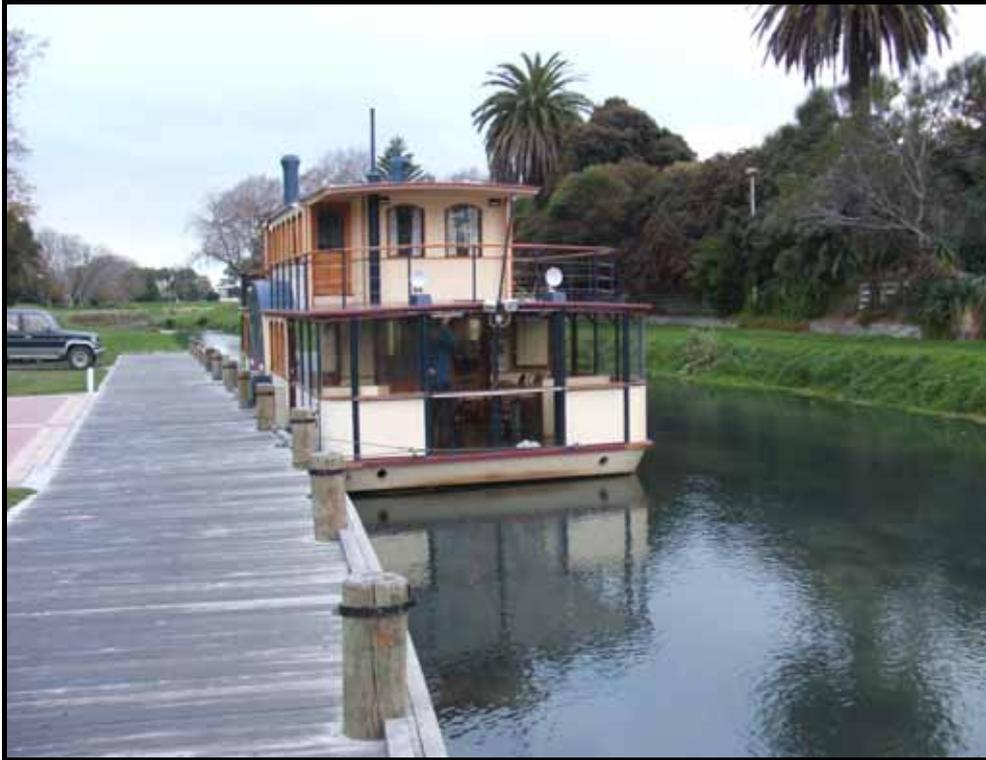
Both outboard engines are mounted on a false transom and are completely enclosed with a non structural wall on three sides. The aft wall has a pipe passing through it for passive venting only.

Figure 2
Vessel alongside berth, note two passive vent holes in the stern.

1. On 11 June 2007 the Owners were issued with a Prohibition Notice requiring the operation to cease until the following were complied with.
 - Install powered extraction fans in each of the engine housing units
 - Install fresh air ducts to vent the aft deck area.
 - Install a gas detector in the galley/bar area.
 - Seal the under seat access hatches to the fuel tank storage area.
2. The above was complied with on 14 June 2007.
3. It is recommended that a guidance notice to be sent out to all Safe Ship Management Companies and Maritime New Zealand Safety Inspectors to highlight the need to check this issue in any other vessels of a similar configuration (*See Appendix 1 – Guidance Notice*). *This recommendation is in progress.*

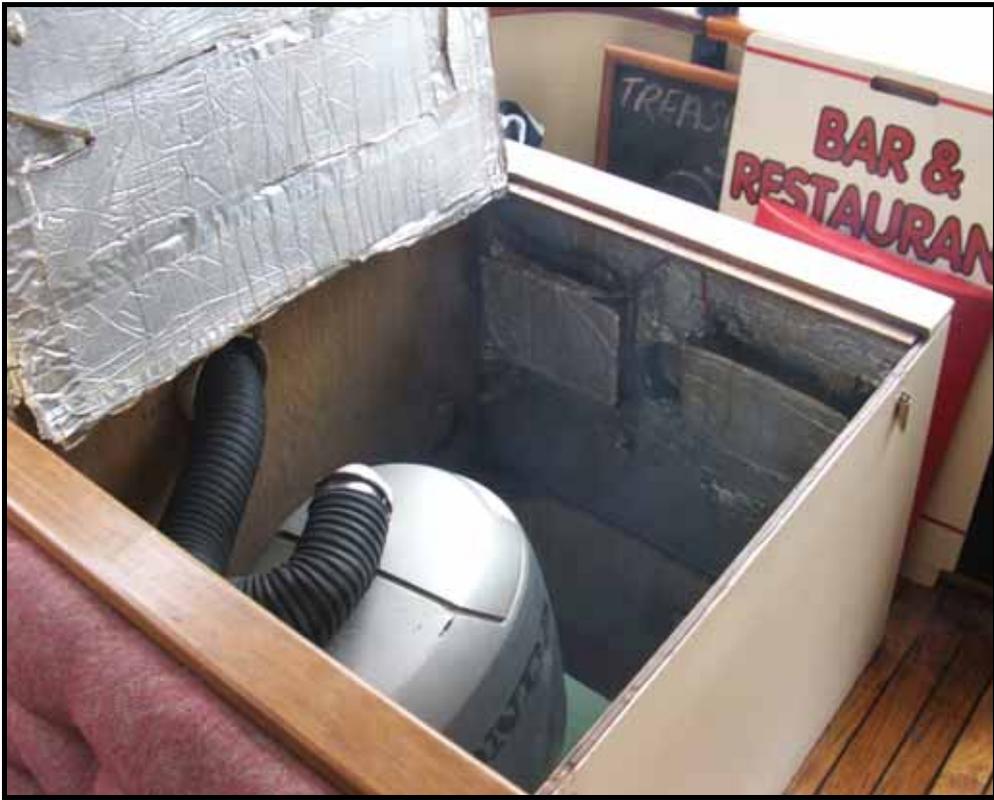
Both engines have external fresh air ducting but did not have any means of forced extraction of the exhaust gases to the outside atmosphere.

Figure 3
Starboard engine configuration.

The vessel was tested using a calibrated gas detector. It was found that the two outboard engines were feeding exhaust gases into the passenger space at low speeds.
