# Accident Report

Loss of Control of Vessel

*Milford Sovereign*

REPORT NO's.: 05 3872 & 05 3899

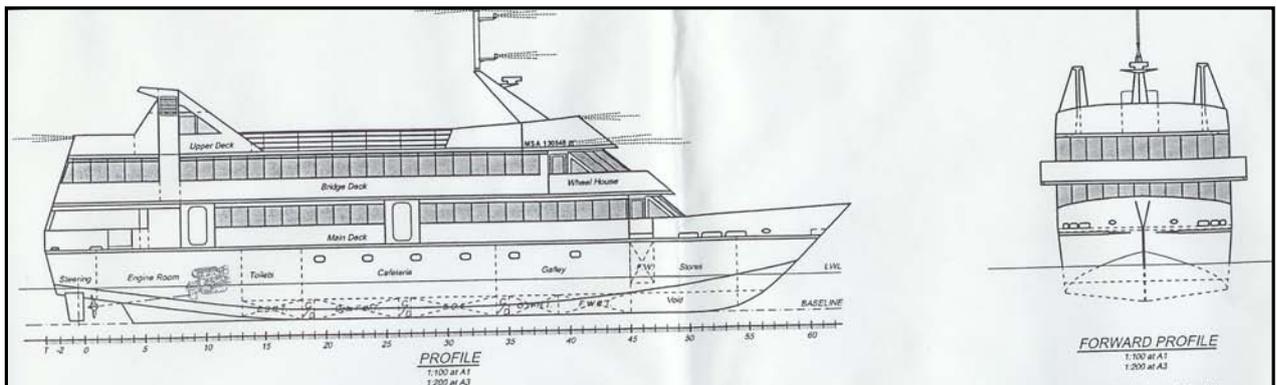
Unlike **Milford Sovereign**, **Milford Monarch** was built with a 100mm keel bar.

**Figure 1**  
Profile plan of **Milford Sovereign**

*It is our recommendation that a vertical fin bar be fixed to the flat keel bar on Milford Sovereign. This bar to be the same depth as the structural keel bar on Milford Monarch but being non structural should be of a minimum thickness and attached with sufficient welding for its purpose as a "spoiler" to break up the lateral flow of water under the hull. This will achieve as near as practicable, low speed handling characteristics similar to those of Milford Monarch.*

The vessel has been fitted with a keel bar and inclining tests have been carried out.

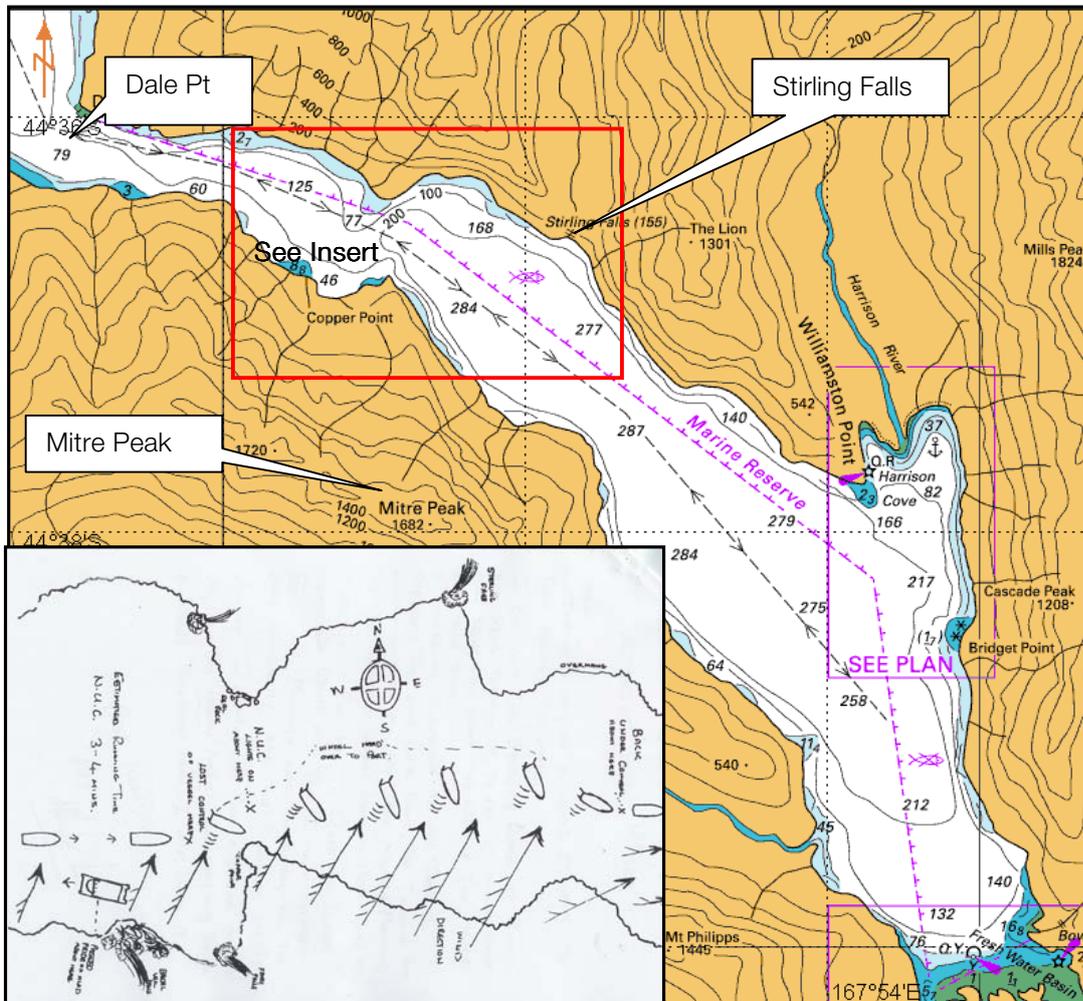
As the wind was “gusty” the Skipper found that the strongest winds were bouncing off the southern side of the Sound (Peak) and blowing across to Stirling Falls (See Figure 2). Because of this the Skipper favoured the southern side of the fiord as he headed back to Freshwater Basin.

**Figure 2**  
Milford Sound – Chart extract from Land Information New Zealand (LINZ) Chart 7622  
Insert – Diagram drawn by the Skipper of **Milford Sovereign** at the time of the incident.  
*The diagram does not necessarily accurately reflect the actual times and distances as portrayed above.*

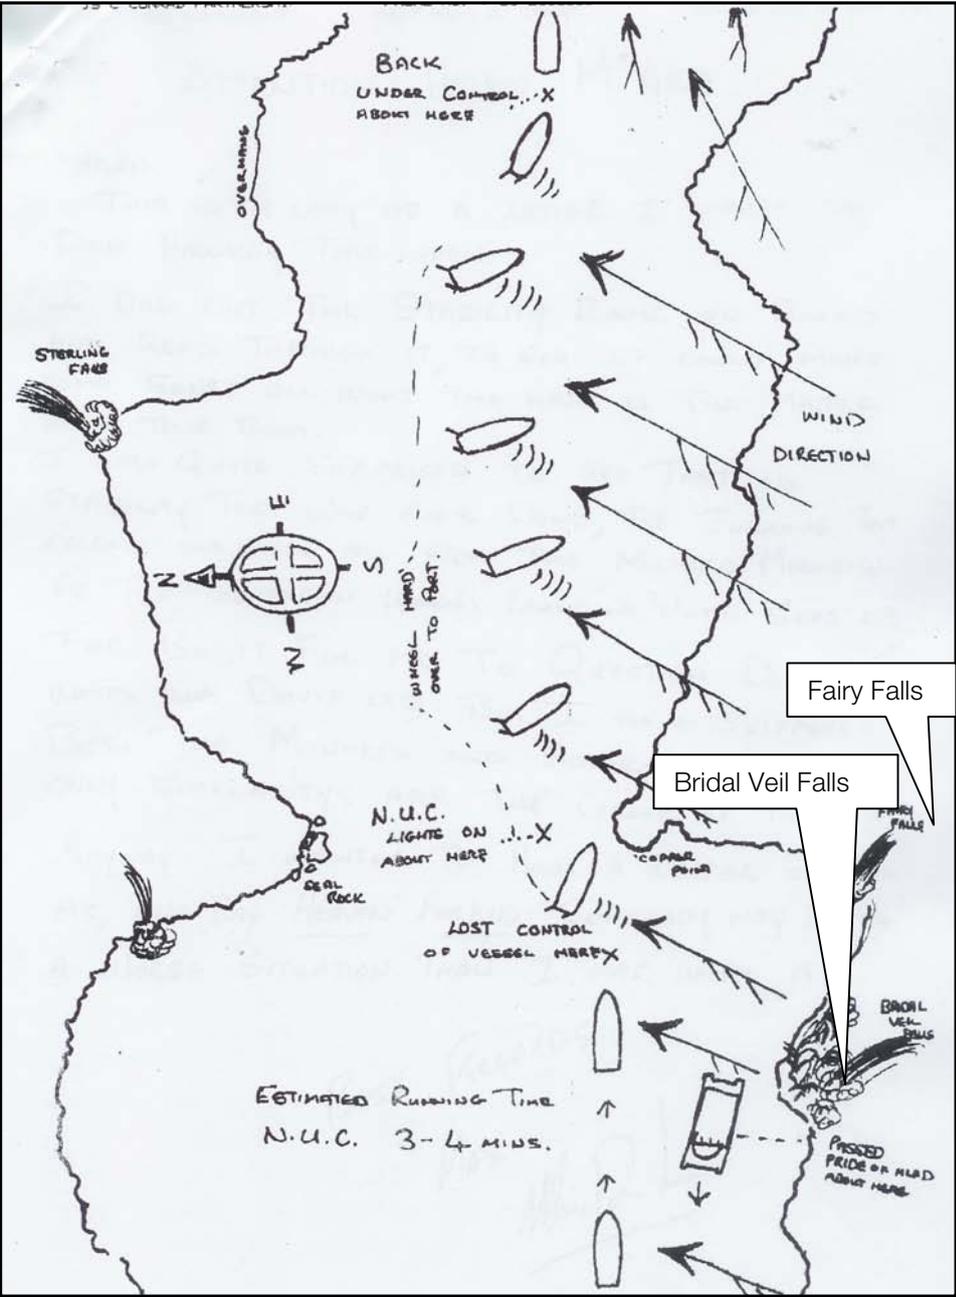
As the vessel passed abeam Fairy Falls *Milford Sovereign* was struck on the starboard quarter by a large gust of wind measuring 65 knots on the vessel's anemometer. The vessel heeled over approximately 18-20 degrees to port. When this happened the Skipper found that he had no control over the vessel. The Skipper had the helm hard over to port and the propulsion at full ahead equating to a speed of about 11½ knots. Notwithstanding this action, the vessel did not respond and continued to drive down the Sound under the influence of the wind (See Figure 3).

**Figure 3**  
Diagram of the incident drawn by the Skipper of *Milford Sovereign* at the time of the incident.

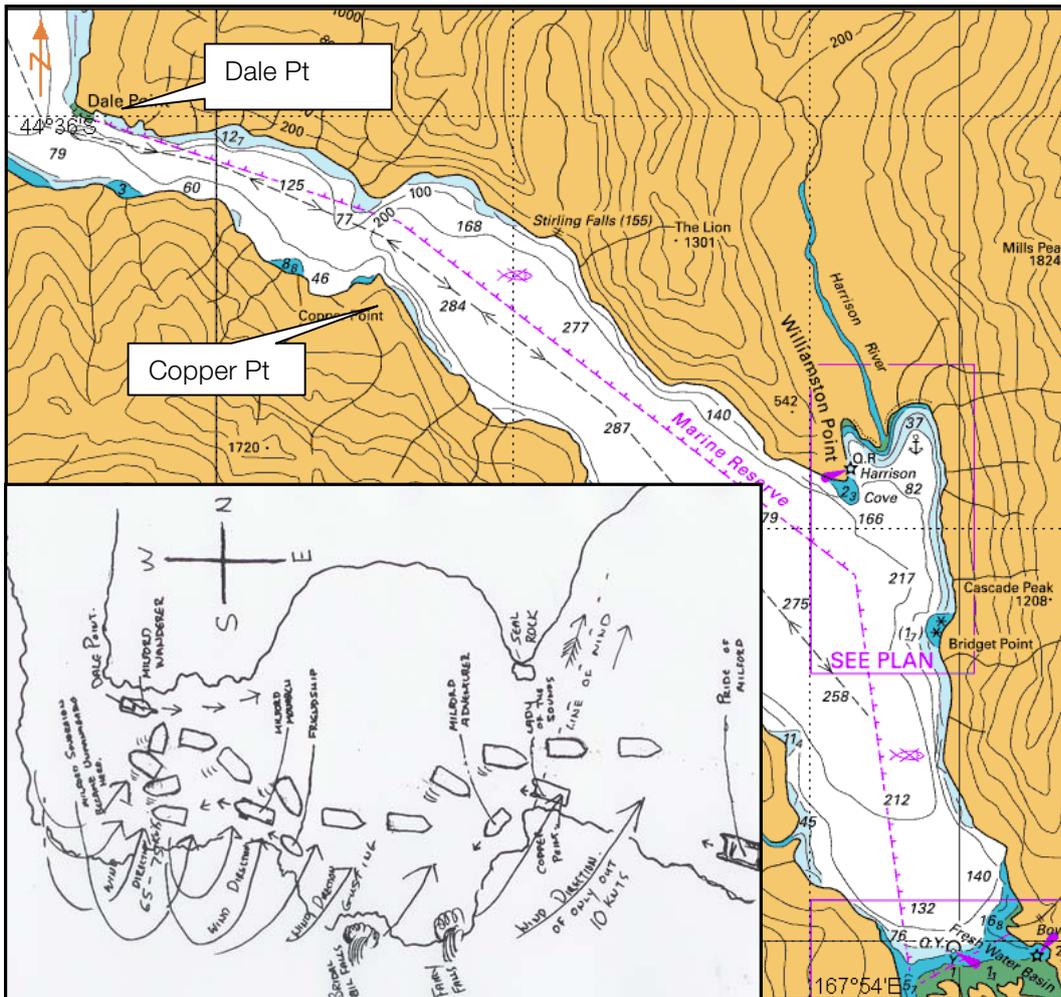
At 1300 hours, **Milford Sovereign** departed for the afternoon cruise. When they reached Cooper Point the wind increased to 45-55 knots from the north. As the vessel proceeded past Copper Point towards the heads at Dale Point, they were struck by a gust of 70 knots on the forward port side. The vessel heeled over to starboard and the bow swung to starboard, allowing the wind to strike the port side of the vessel (See *Insert on Figure 4*).

**Figure 4**  
 Milford Sound – Chart extract from Land Information New Zealand (LINZ) Chart 7622  
 Insert – Diagram drawn by the Skipper of *Milford Sovereign* at the time of the incident.  
 The diagram does not necessarily accurately reflect the actual times and distances as portrayed above.

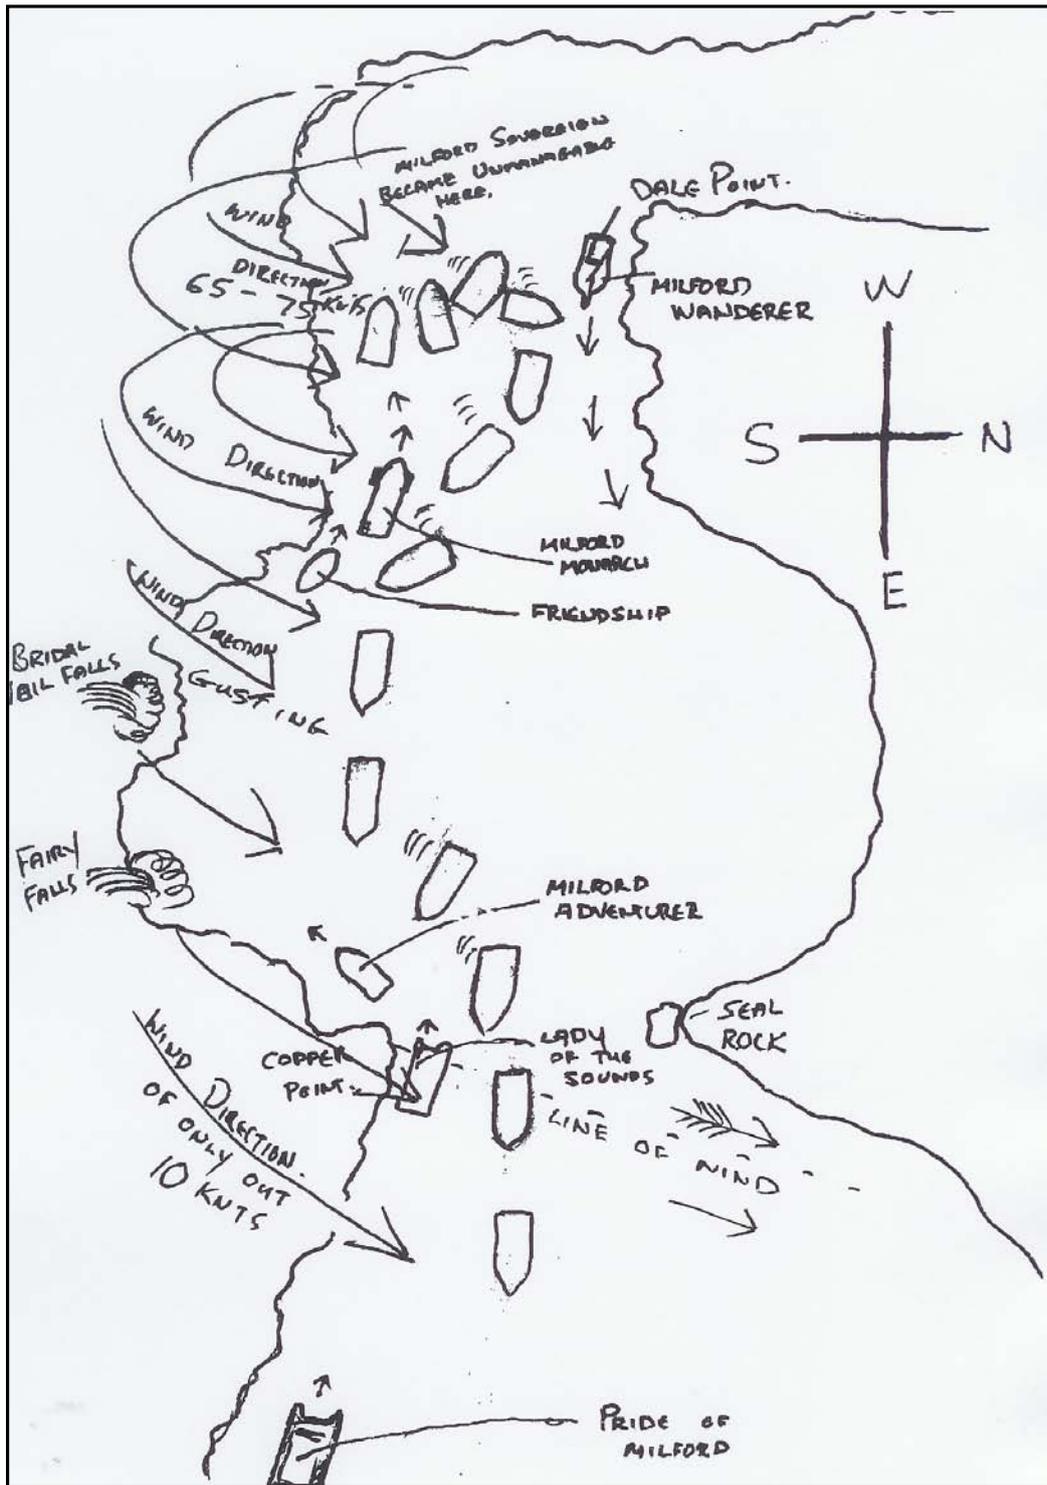
At the above time, **Milford Wanderer** was entering the Sound from seaward and was directly opposite **Milford Sovereign** on the northern side of the fiord (See *Figures 4 & 5*). The Skipper of **Milford Sovereign** was concerned that his vessel would be blown into the path of the **Milford Wanderer**, but was able to regain control of the vessel before this occurred. The Skipper then headed down the Sound towards Freshwater Basin.

Figure 5  
 Diagram drawn by the Skipper of *Milford Sovereign* at the time of the incident.  
 The diagram does not necessarily accurately reflect the actual times and distances as portrayed above.
