Class B Accident Report

NZL41

Injury to Passenger

Auckland 27 November 2004

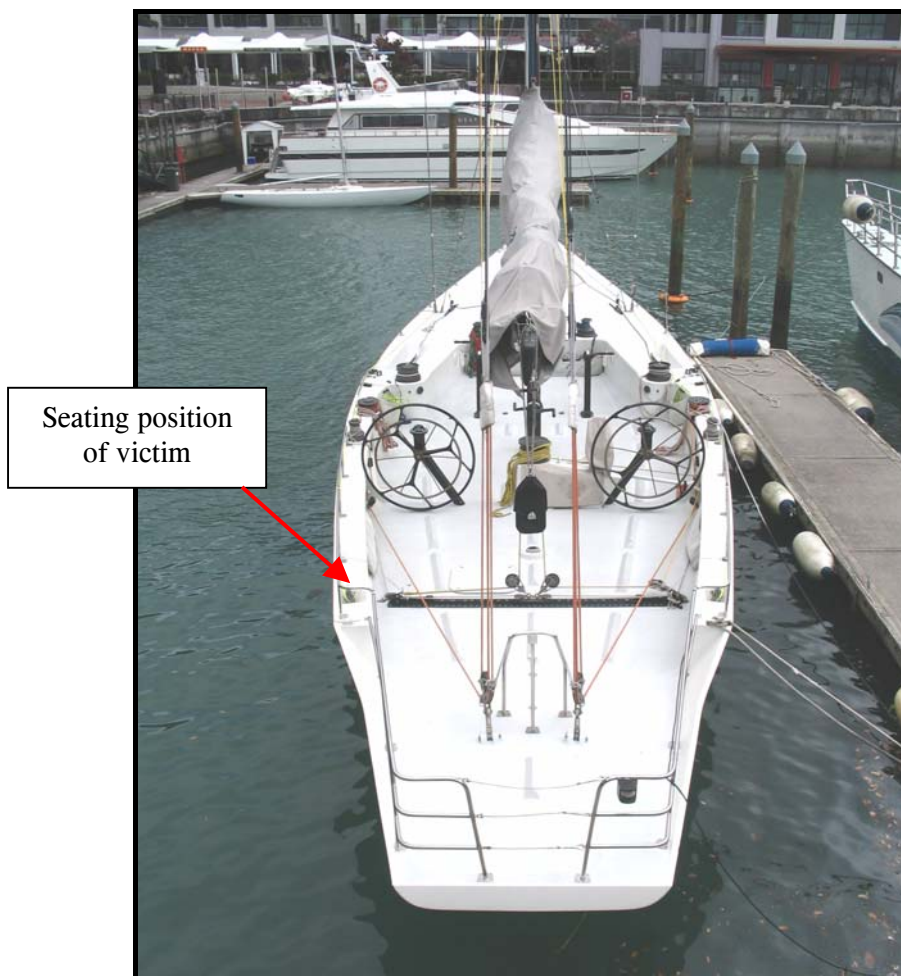
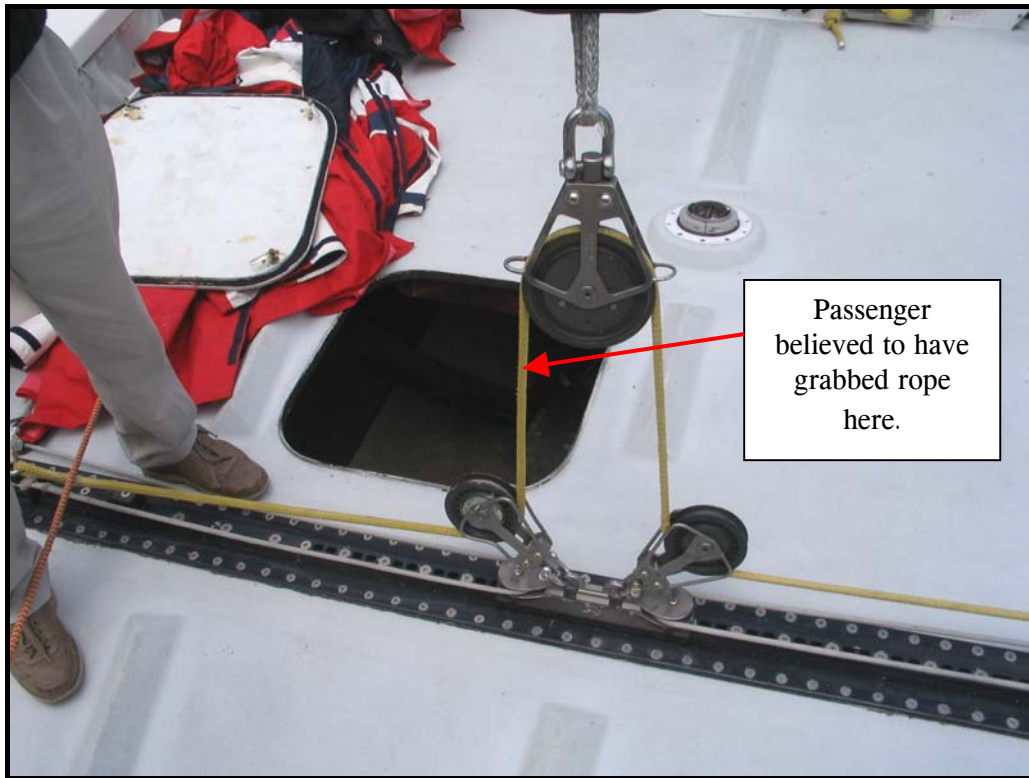
The vessel eventually turned around and commenced tacking back towards the harbour bridge. At approximately 1530 hours, whilst on a port tack approximately 300 metres south of Stanley Point, the vessel tacked to starboard. The victims' husband stumbled over a deck stiffener and fell. The victim, who was sitting on the port side of the vessel, attempted to move across to the starboard side but had nothing substantial to hold on to. In moving, she held onto the mainsheet line. At that moment, the mainsheet moved along the traveller. The passenger's right hand entered the mainsheet block thumb first. This resulted in the right thumb being amputated and other injuries to her right hand.

The passenger instinctively grabbed hold of the mainsheet to steady herself whilst moving from the port side to the starboard side of the vessel during a tack. At that instant, the mainsheet moved along the traveller causing the mainsheet, which the passenger was holding, to run through the block. The passenger suffered major injuries to her hand as a result.

At the time of the accident, the mainsheet block was uncovered, with nothing to prevent a person's hand being caught in it.

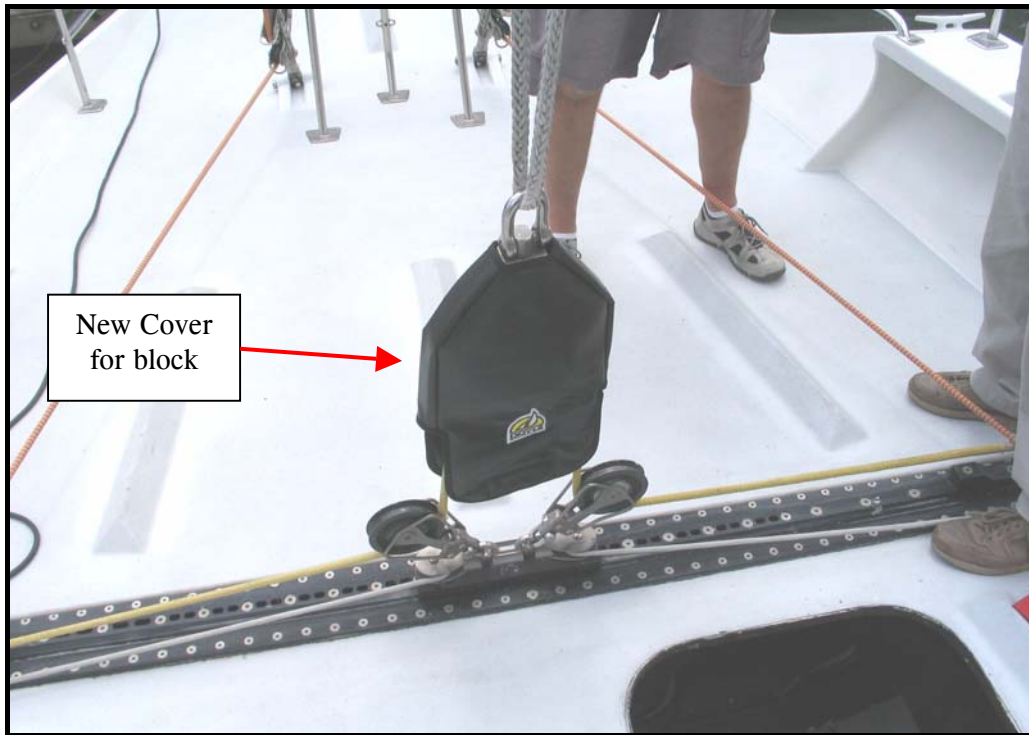
Since the accident, the owners of *NZL41* have fitted a cover over the mainsheet block (see photo below). This cover enables the block to function fully but also provides a degree of protection to passengers.

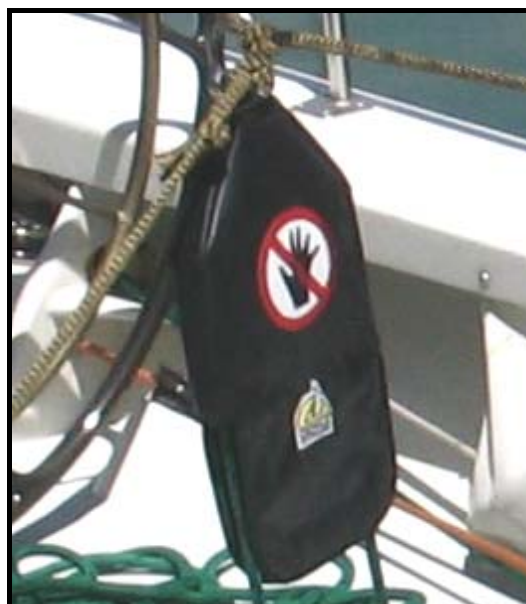
The cover has since also had an unambiguous sign added to it as below.
