Accident Report

Pacific Way

26 November 2005

Pacific Way – Injury

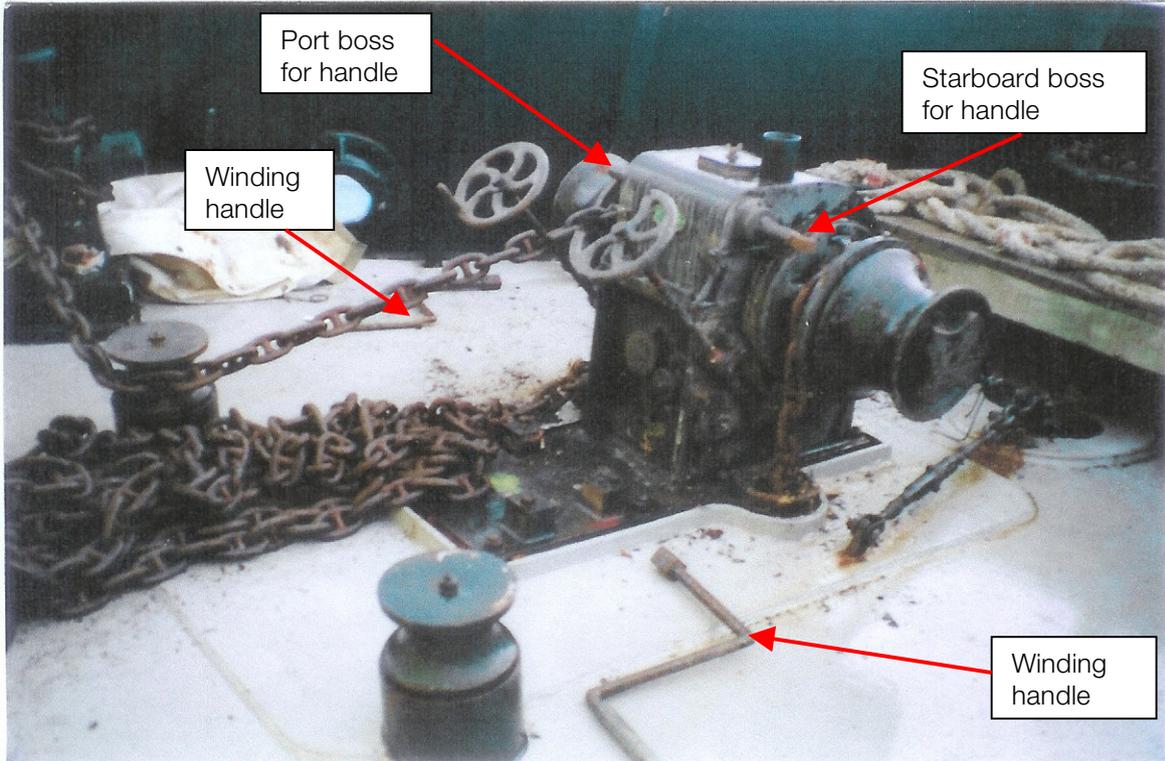
After one shackle had been heaved on deck, **Pacific Way** lifted on a two metre swell wave bringing considerable weight onto the cable. This caused the anchor to suddenly run out and the winding handles to counter-rotate. The starboard handle stuck a crewmember on the left wrist.

Photograph 2
Windlass viewed from Starboard Quarter

The windlass was manually driven by means of winding handles. There was no ratchet in place to prevent the cable running out when weight came on.

1. It is recommended that the owners of ***Pacific Way*** install an alternative (mechanical, hydraulic or electrical) means of operating the windlass as soon as possible. Also, as the anchoring equipment is used infrequently, it is recommended that a planned maintenance regime be implemented for the windlass.
2. It is recommended that the owners of ***Pacific Way*** immediately ensure that crew training records be kept up to date and all relevant paperwork onboard ***Pacific Way*** is brought up to the required standard.
3. It is recommended that the owners of ***Pacific Way*** immediately issue written procedures to the Masters of their vessels reaffirming the need to inform Maritime New Zealand directly of any accident, incident or mishap involving serious harm, as soon as practicable.
