Summary Report

Serious Harm Injury

Patea Explorer

21 September 2006

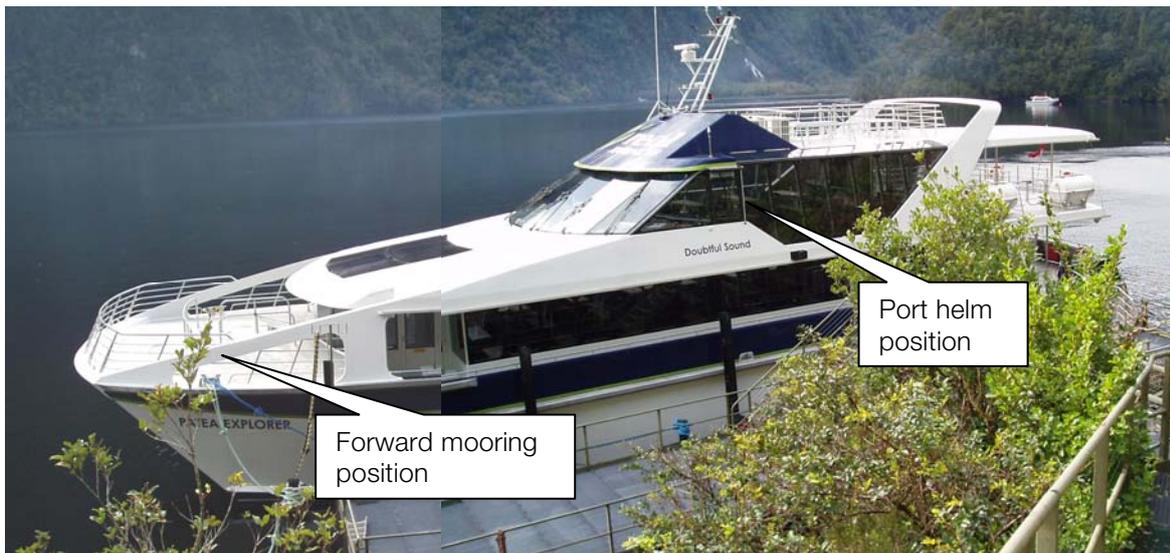
Photograph 1
Patea Explorer

At about 0845, the school children and their teachers boarded the vessel. At 0900, the crew made preparations to leave the wharf. The Skipper was on the bridge at the port helm position (See *Photograph 1*) whilst Crew 1 and Crew 2 were at the stern, readying the lines.

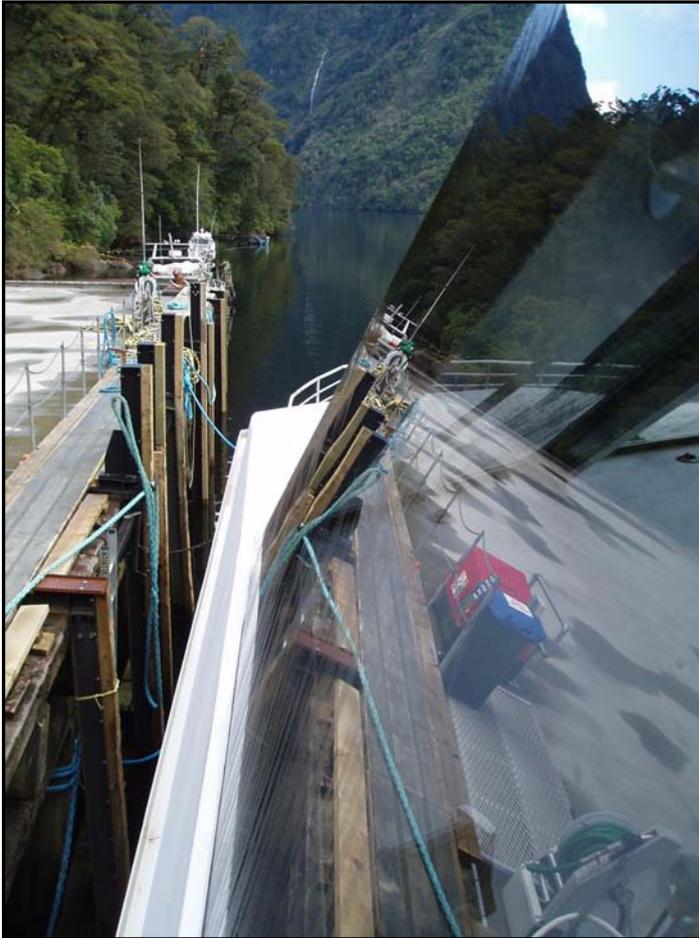
Photograph 2

The Skipper could see that Crew 1 was at the bow (See *Photograph 1*) and ready to let go the forward lines but he could not see all that was happening in this area due to his position at the port helm station on the bridge (See *Photograph 2*). As such, he could not see the bits where the forward lines were attached to the vessel or what Crew 1 was doing with them.

View from port helm position on the bridge (leaning out the window)

The Skipper has limited vision of the port waist and bow mooring area from both the port and starboard helm positions on the bridge.

1. Employ a second fulltime crewmember on *Patea Explorer*.
2. Establish radio communications between the bridge and bow.
3. Ensure Skippers have positive control of the vessel and crew at all times while mooring and unmooring.

- Patea Explorer now carries a second full-time crew person during the summer season and a qualified second crew at all times during the winter.
- Radio communications between the bridge and the bow have been established in the form of hand held radios.
- Positive control has been established through tightened procedures, visual and radio communications.

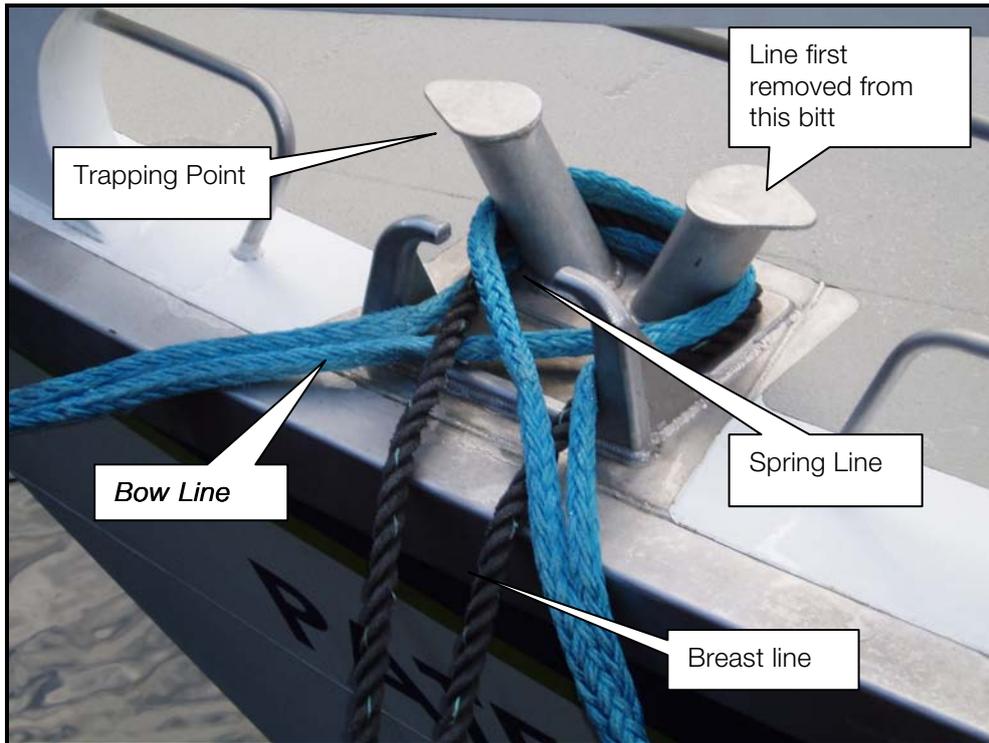
Photograph 3
Mooring lines and bollards

The eyes of three mooring lines at the bow namely, the bow line, forward breast line and forward spring line were secured over the set of bitts located on the port side of the bow section (See *Photograph 3*).

The eye of the forward spring line, which overlaid the eyes of the bow and breast lines, was the first to be removed by Crew 1. Using her left hand, she removed the eye of the spring line from the after bitt first. When she was about to remove the eye from the forward bitt, there was a gust of wind and the line tightened suddenly. Crew 1 did not have time to drop the line or move her hand before she found her left fingers trapped between the forward bitt and the forward spring.

Real Journeys are currently reassessing the mooring arrangements of *Patea Explorer*. They have approached Incat Crowther in Australia, the builders of the vessel, to prepare drawings for the modification of the mooring bits at the stern and the fitment of a single Samson post at the bow on the outside of the coaming about a metre above the deck to allow easier and safer mooring/unmooring.

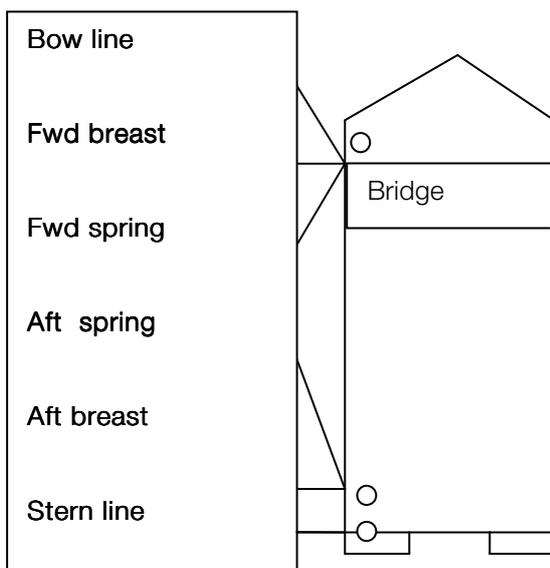
Diagram 1 – Mooring Arrangement

The shore end of the mooring lines, all of which have a fixed length, are left permanently secured to bollards on the wharf. The eye of each mooring line, is placed over bitts on the vessel, as shown in *Photograph 3*. When the mooring lines have been let go, they are looped over retaining hooks attached to the wharf (See *Photograph 4*).
