Accident Report

Physalie

Grounding Between Whites Bay
& Robinhood Bay
on 13 June 2004

REPORT NO.: 04 3492

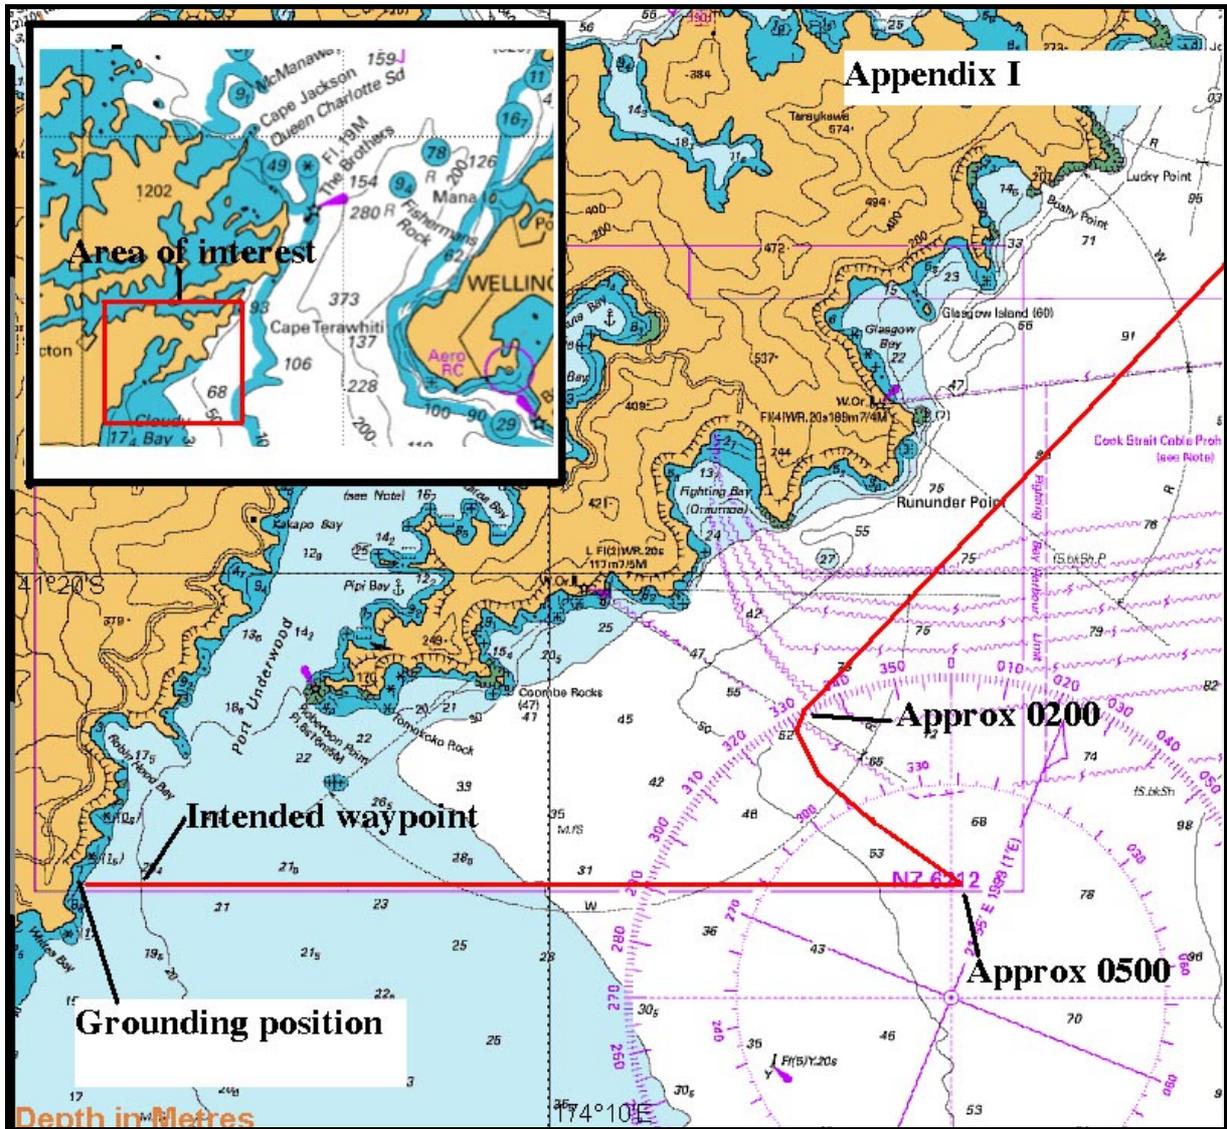
- 1.6 At 2400 hours, he took over the watch and continued the steam down to the Cloudy Bay area.
- 1.7 At about 0200 hours on 14 June, the Skipper stopped the vessel approximately 3 nautical miles (nm) south of Rununder Point (*See Appendix I – Excerpt of chart*). The Skipper then lay down on the couch in the wheelhouse while the vessel drifted in a broadly east-southeast direction. He got up and checked the vessel's position and looked for traffic, approximately 3 to 4 times, until 0500 hours.

- 1.8 At 0500 hours, when the vessel was approximately 7 nm off the coast, the Skipper headed due west at a speed of about 5 to 6 knots. The vessel got to within 1 nm of the intended waypoint, where the Skipper intended to shoot the net at daybreak. He then reduced the main engine revolutions to idle, which gave a speed of about 3 knots (*See Appendix I – Waypoint position*).

- 1.9 The Skipper sat down in the navigation chair and fell asleep. The vessel grounded at about 0600 hours (*See Appendix I – Grounding position*). Both crew were woken by the force of the impact and went straight to the wheelhouse. At this time the Skipper was reversing the vessel off the ground and sent the crew to check for damage.
