Final Draft Accident Report

Poseidon

Grounding

North of the Manukau Bar on 15 April
2004

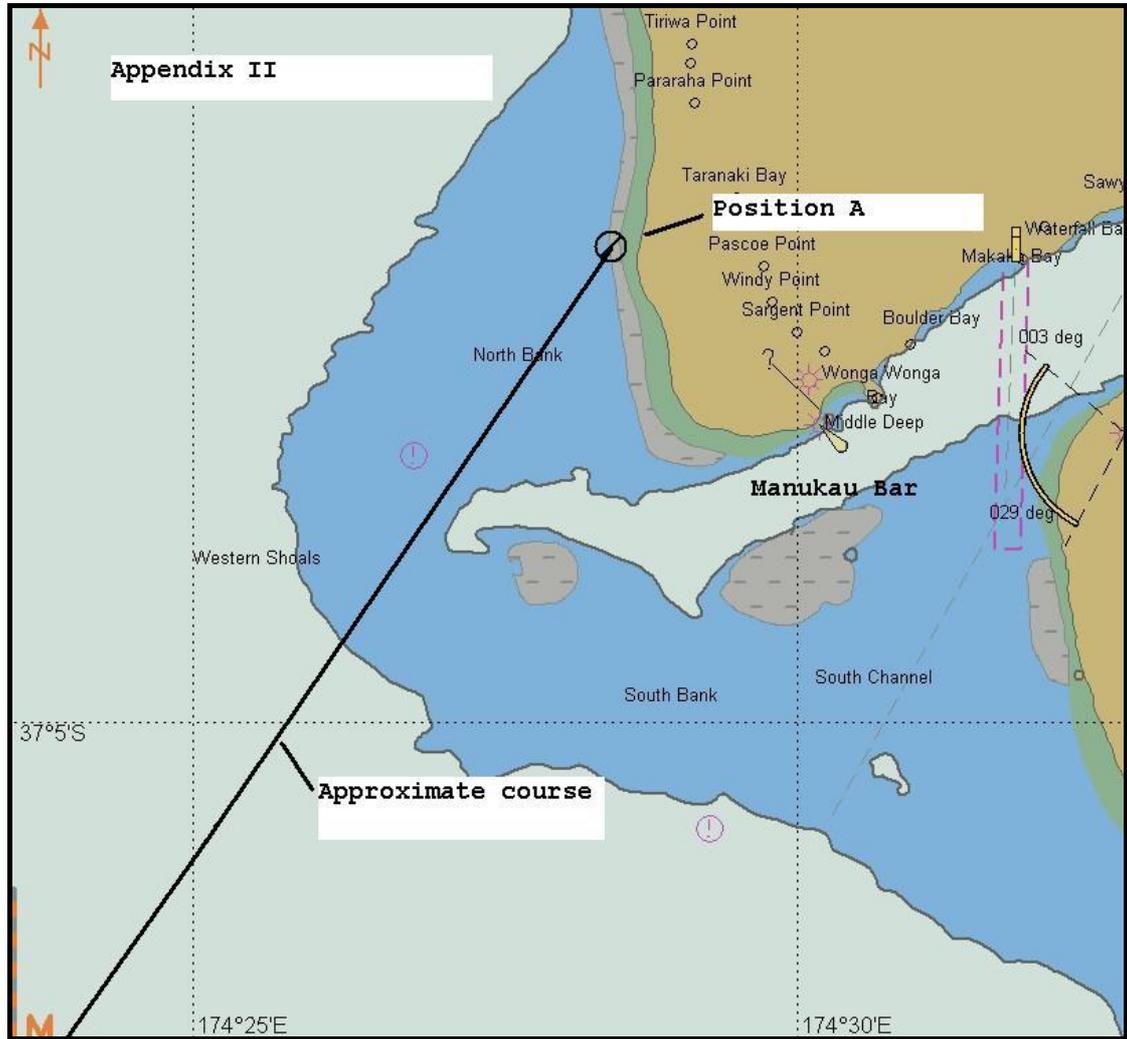
APPENDIX II

- 1.18** Crewman 'A' fell asleep while still on watch, at or about 0215 hours.
- 1.19** At approximately 0340 hours, the vessel grounded in position 37° 01.831' S 174° 28.448' E. This was approximately 1.7 nm north of the Manukau Bar. (*See Appendix II - Position A*)

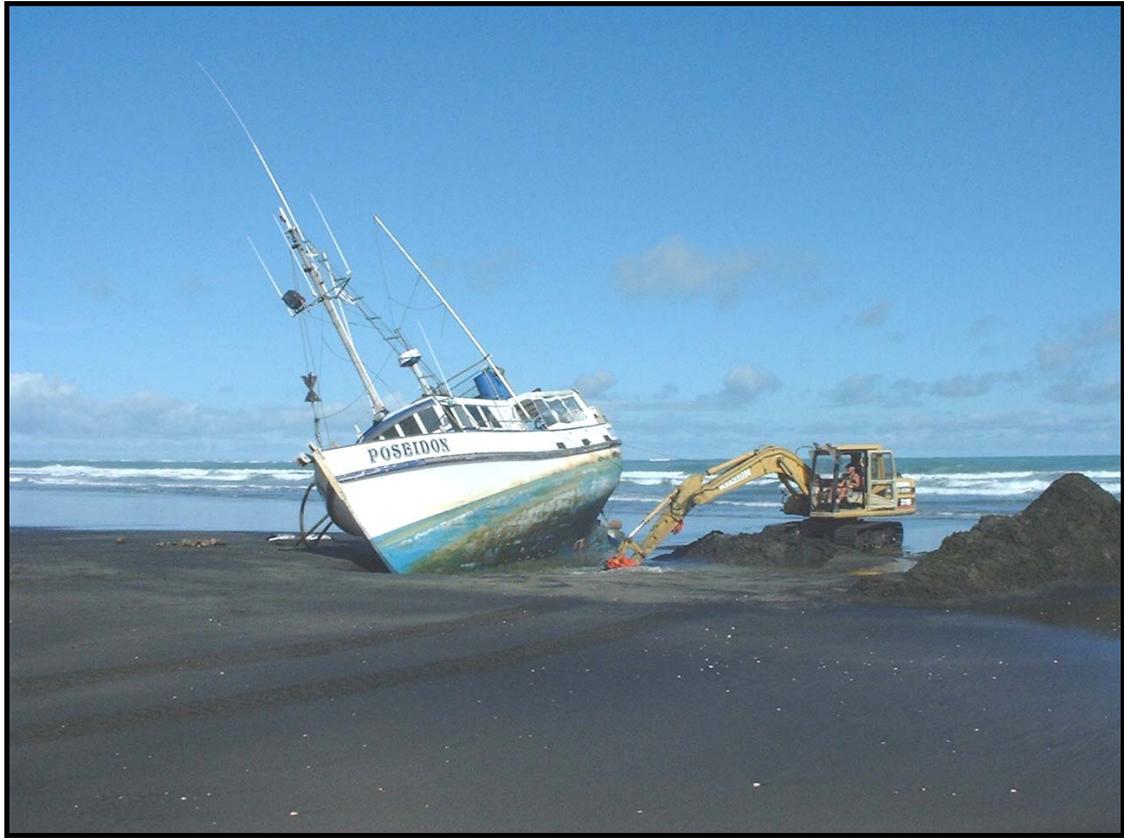
APPENDIX III

- 1.28** On Friday 16 April arrangements were made for the salvage of the vessel. This was completed at high water later that evening. (*See Appendix III - Photograph of vessel aground*). The vessel was towed into Onehunga for initial repairs then on to Nelson for permanent repair to be completed.
