Summary Report  
Grounding  
*Rex*  
4 June 2006

REPORT NO.: 06 4100

VESSEL NAME: *REX*

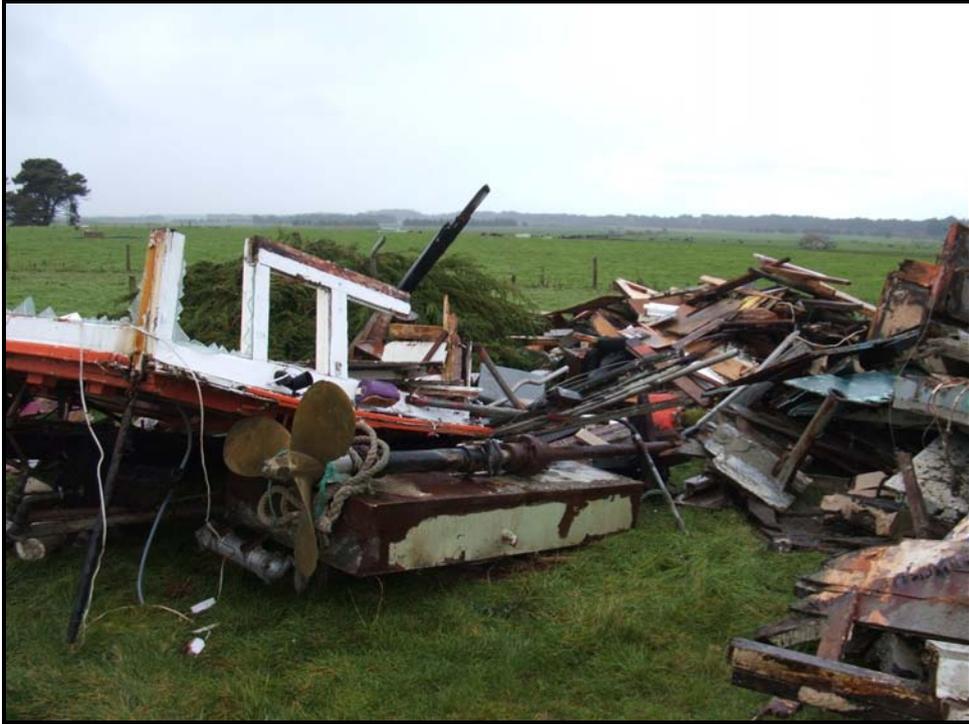
Attempts to tow the vessel off the beach were unsuccessful and **Rex** remained hard aground. The Skipper and his friend left the vessel at about 0430 hours after all hope was lost. The vessel started breaking up in the 1 to 2 metre swell shortly afterwards. Over the next 24 hours the vessel was reduced to 'matchwood' and was a constructive total loss.

**Photograph 2**  
*Rex* after the accident.
