Accident Report

Rita

Foundering at Cape Jackson,
Marlborough Sounds on
15 February 2004

REPORT NO.: 04 1074

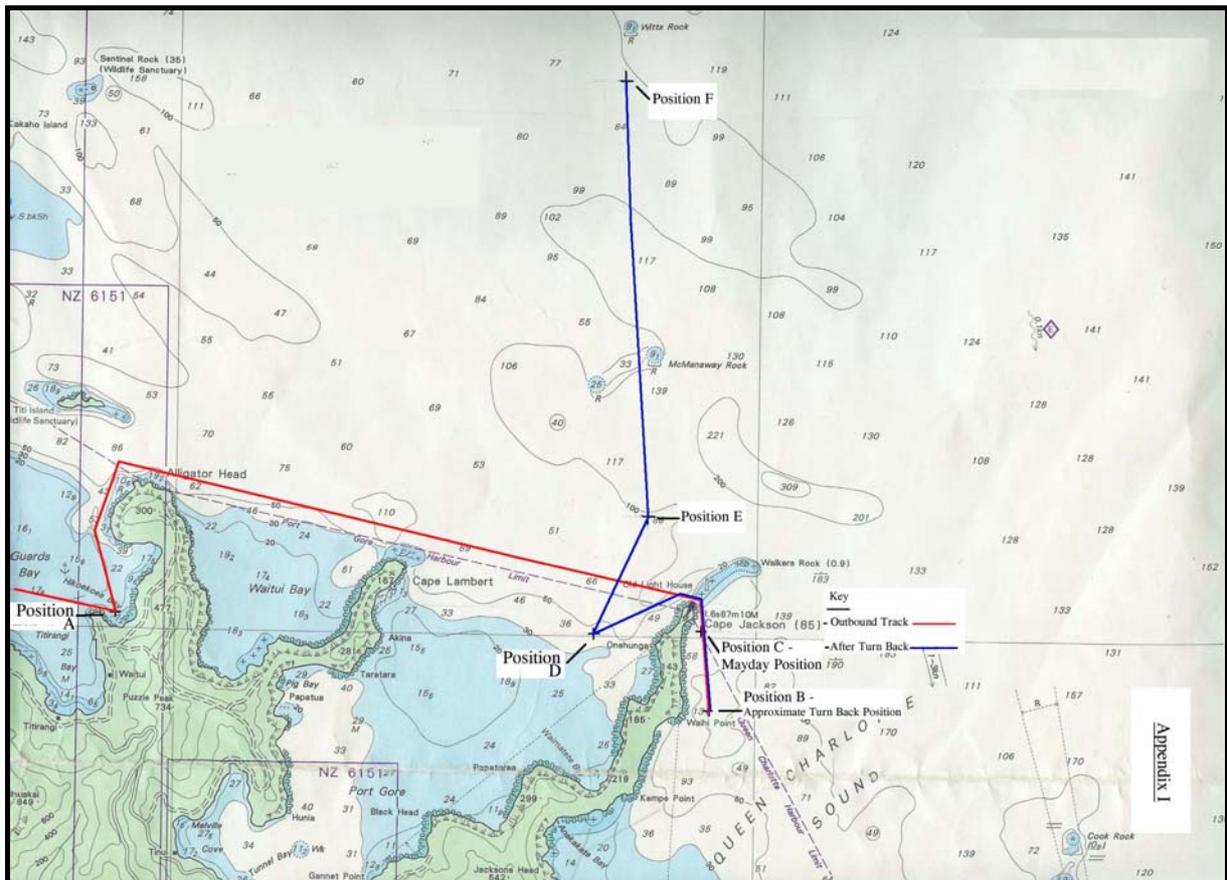
Appendix I – Chart

- 1.2 Passage was made out of Pelorus Sound through Allen Strait and into Guards Bay. The weather was deteriorating during the latter part of this passage and it was decided to seek shelter in Hikoekoea Bay (See Appendix I - Approximate course of vessel).

- 1.3 At 1100 hours, they attempted to anchor in Hikoekoea Bay but the southerly winds were too strong and the vessel dragged its anchor. Upon retrieval of the anchor they relocated to a nearby mooring in the same bay and made fast to it (See Appendix I - Position A).

- 1.7 After the **Rita** had travelled about 1.5 nautical miles (nm) and had Waihi Point abeam to starboard, they encountered 3 metre southerly swells with approximately 50 knots (kts) of southerly wind. During this time, the Master was unable to keep the vessel from being blown off-shore due to a combination of an intermittent failure of the hydraulic steering and strong winds. It was decided by all that they should turn around and double Cape Jackson and head into the relatively calmer waters of Port Gore (See Appendix I - Position B - Approximate turn back position).

- 1.9 The main engine continued to run roughly and was still stopping completely for short periods of time. At 2025 hours, the Master put out a Mayday call on VHF channel 16 giving their approximate position as 40° 59'S 174° 19'E and requesting immediate assistance (See Appendix I - Position C - Mayday position).

- 1.13 At 2212 hours, **Rita** informed **Kent** that they were having trouble with the hydraulic steering and were manoeuvring with difficulty. **Kent** had **Rita** on radar and was still making best speed towards them (See Appendix I - Position D).

- 1.14 At 2228 hours, **Kent** was in a position where **Rita** was 50 metres to starboard and ahead. **Kent** put both main engines full astern to stop in the water. **Kent** was unable to manoeuvre closer to **Rita** so asked if they could come over to her. **Rita** started to move towards **Kent** from the starboard side and as she went past the bow, she lost main engine revolutions again and made heavy contact with the bulbous bow of **Kent**. She then scrapped down the port side of **Kent** until she became entangled in part of the stern vehicle ramp on the port quarter. **Rita** was severely damaged by the heavy motion of **Kent** in the large swell that was running (See Appendix I - Position E).

- 1.20 At 0045 hours on 16 February 2004, the survivors in the liferaft were taken onboard a rescue boat and transferred to **Amaltal Columbia** (See Appendix I - Position F).

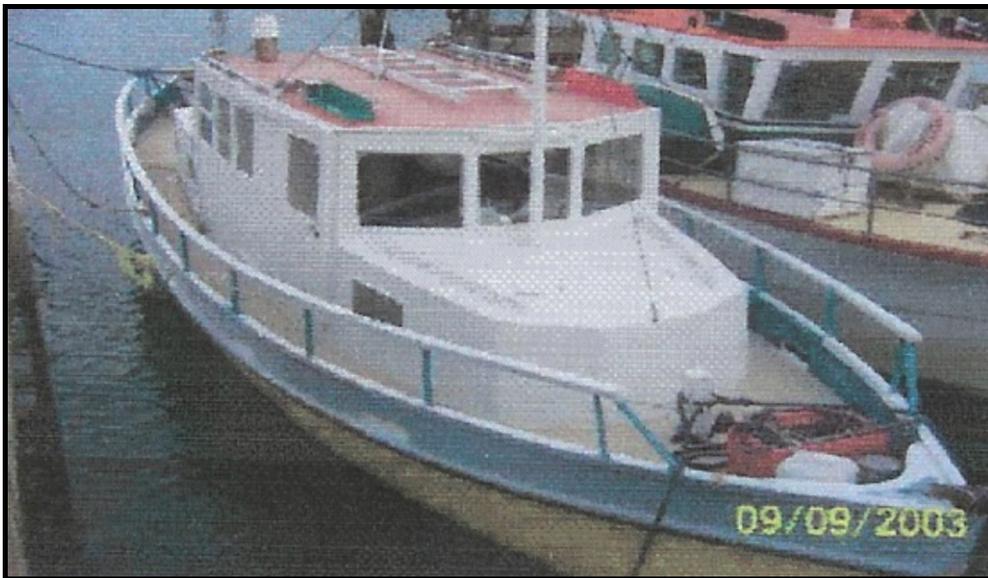
Appendix II – Photo

- 2.1 **Rita** was designed and built by Miller and Tonnage and was of kauri carvel planked construction, launched in 1902. Her dimensions were 12.1 metres in length, a beam of 3.5 metres and a draft of 1 metre. She was powered by a 65 kW 371 GM diesel main engine that had run about 500 hours since being rebuilt. The vessel had two galvanised mild steel fuel tanks with a combined capacity of 360 litres, (See Appendix II - File photo of vessel).
