# Accident Report

Grounding

*Sanga Na Langa*

REPORT NO.: 06 4041

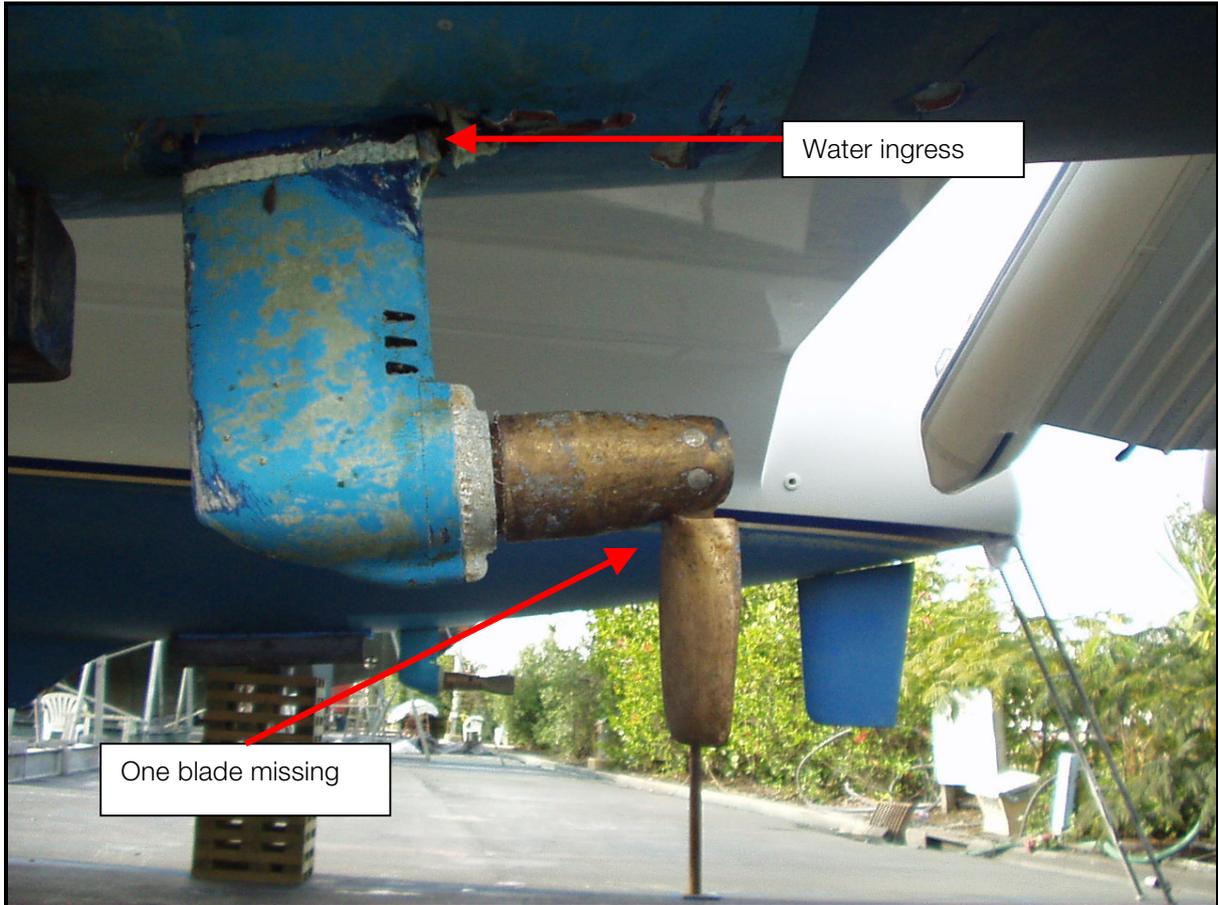
Photograph 1

Fortunately the pumps were able to control ingress and the vessel was beached in Man O War Bay on Waiheke Island using the port motor. Low tide revealed extensive port hull damage and a missing port propeller blade.

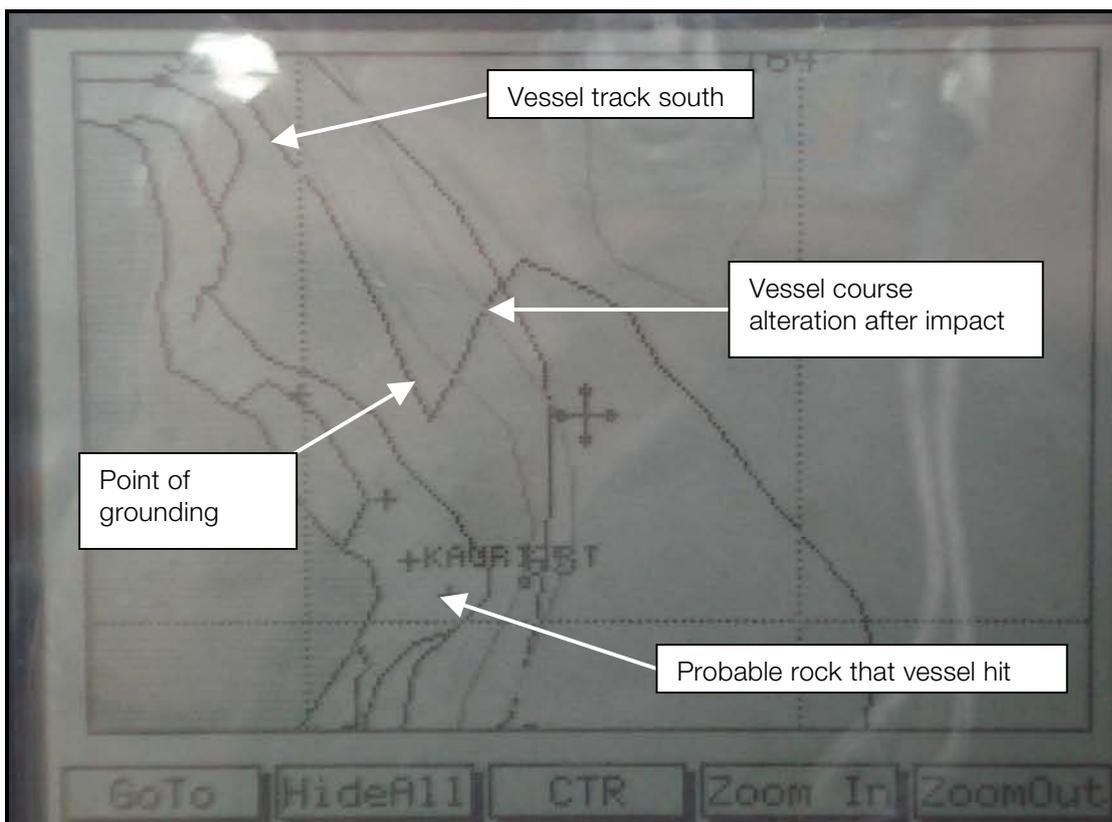
GPS data can often give incorrect data for a variety of reasons. The manufacturers agent checked the model and determined there was no cross track error. The position of the rocks as displayed on the screen correlated with their position in NZ Chart 5324 which suggests the electronic chart was reasonably accurate. Often when “GPS assisted groundings” take place the fault lies with the accuracy of the electronic chart however the reasons can be varied and complex. It is not uncommon for display screens that have been monitoring a vessel's position whilst stationary, for example whilst berthed overnight, to show positions a considerable distance from the vessel's position.

**Figure 1**  
GPS Screen as Observed by the Skipper

GPS derived positions are a useful tool in determining a vessels position but should be used in conjunction with all other means of position fixing at the navigators disposal. The temptation to push a button to obtain such data and not utilize more labour intensive, traditional methods of position fixing is, to put it bluntly, bad seamanship that puts vessels and their crew at risk.
