Accident Report

Grounding
Seawyf

26 August 2005

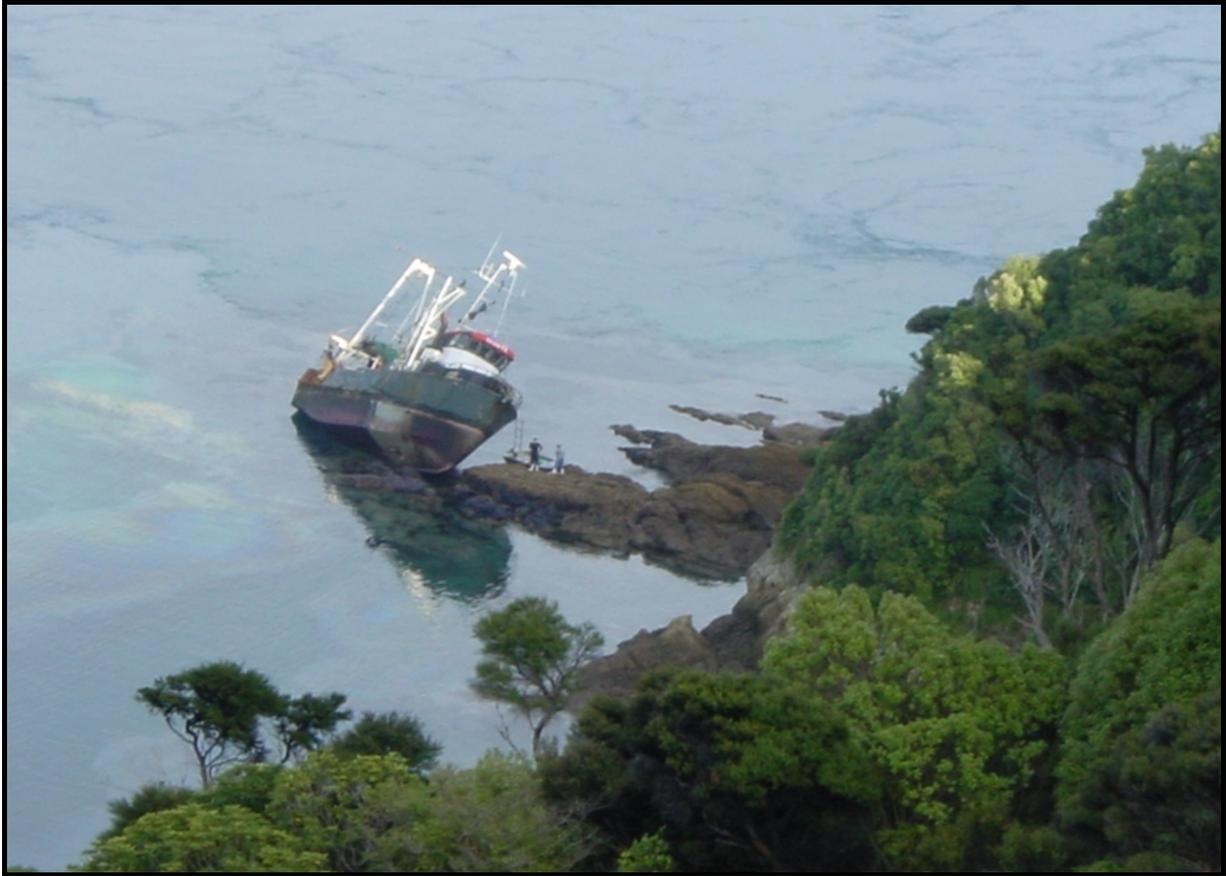
Photograph 1
Seawyf aground at French Pass

During low tide, **Seawyf** was completely out of the water and the Skipper and crew exited the vessel and made a visual inspection of the hull, which looked to be sound (See *Photograph 1*).

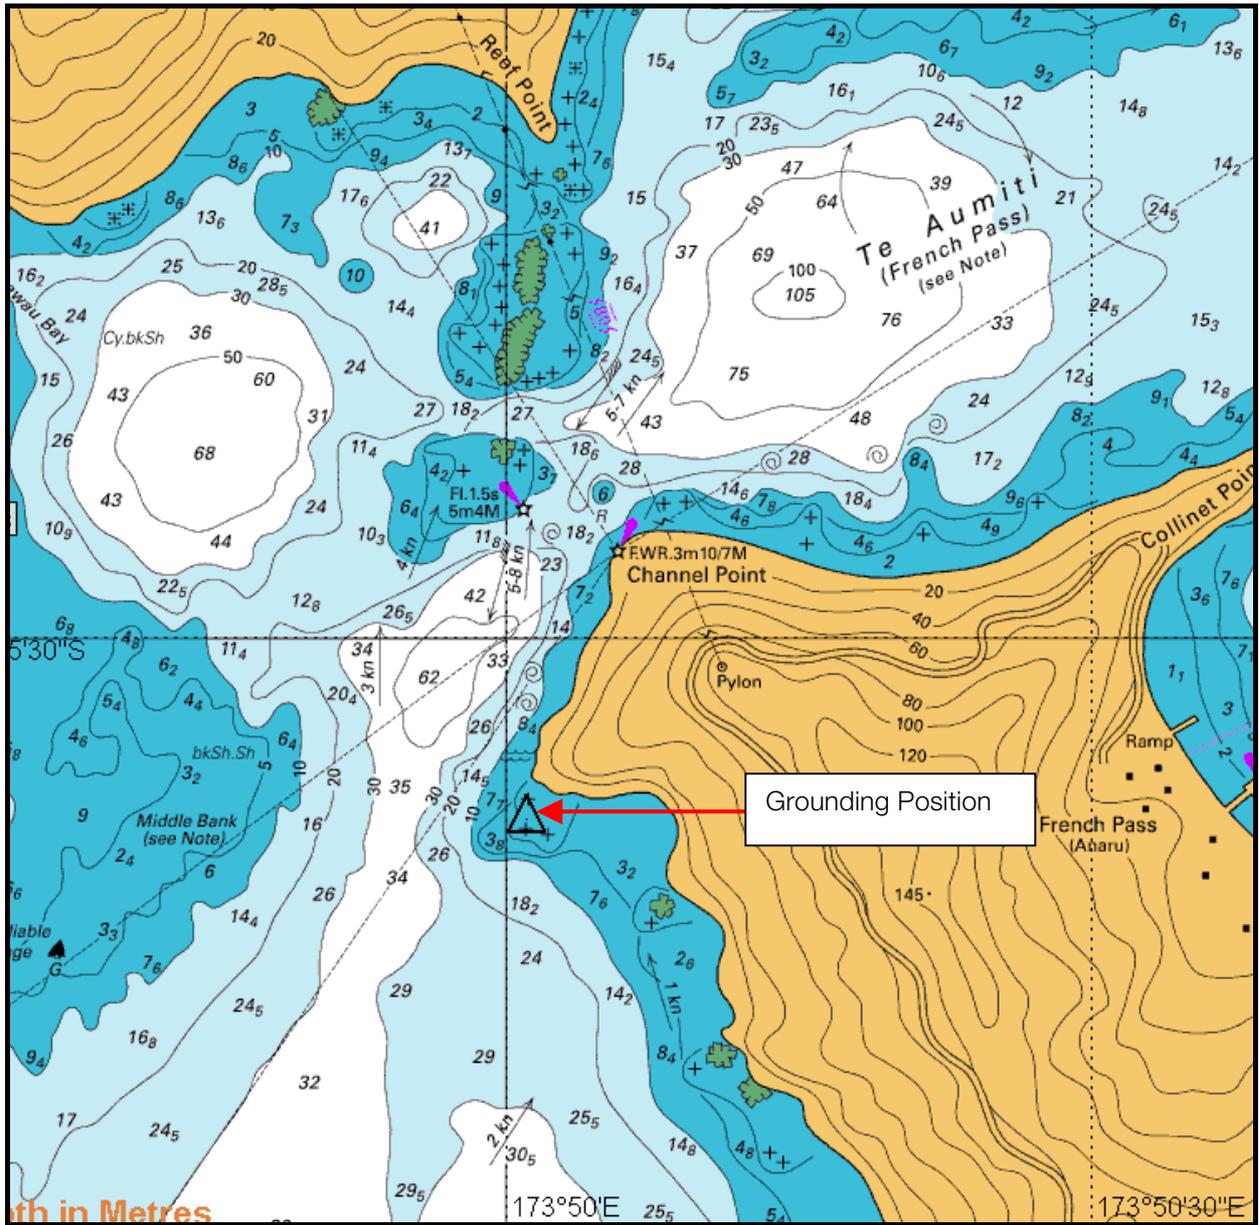
Diagram 1
Chart Extract

Seawyf grounded in position 40° 55.620' S 173° 50.618' E (See *Diagram 1*).

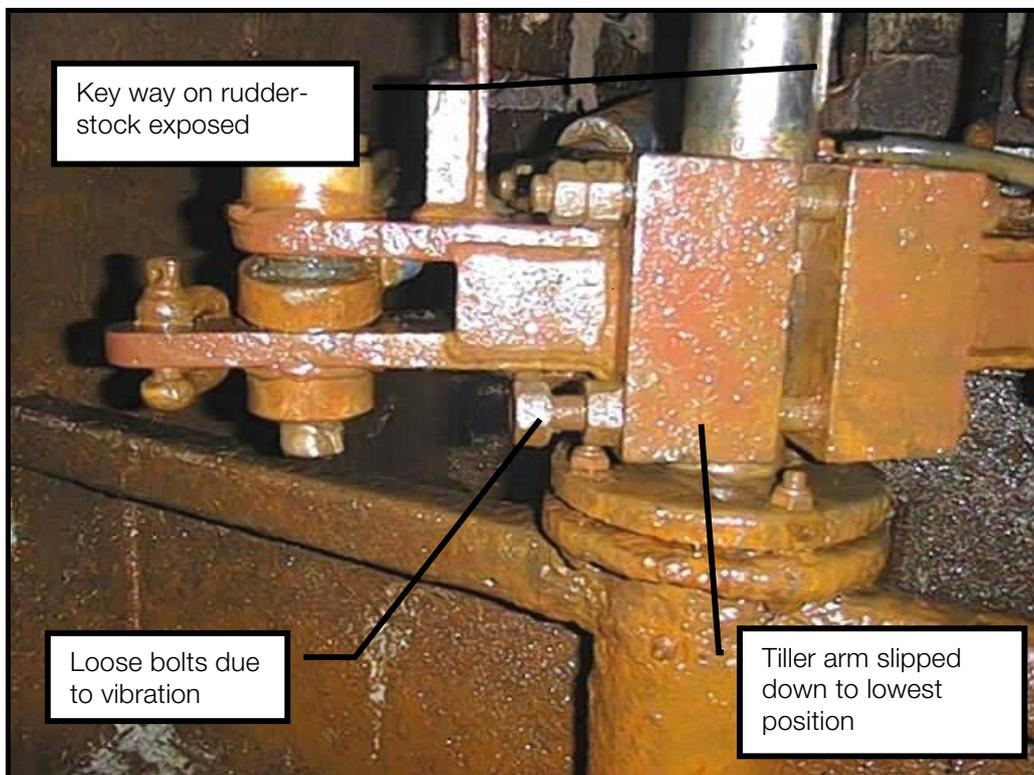
Photograph 2

Upon inspection of the steering gear it was found that the tiller arm had come loose from the rudderstock and had slipped down the shaft and off the key-way. This allowed the tiller arm to activate but did not have any purchase on the rudderstock.

Evidence suggests that the bolts attaching the tiller arm to the rudder stock were tightened but not setup in such a way as to prevent them loosening again in the future.

Since this accident, the marine engineers have now installed new high tensile bolts; they have used double nuts with the outer nut consisting of a Nylock nut.

They also installed a new key-way into the rudderstock and have attached a split collar below the tiller arm to arrest its movement should the bolts ever come loose again.
