Accident Report  
*Sinbad & Unnamed Dinghy*  
Collision at Bon Accord Harbour  
on 26 March 2005  
Class B

REPORT NO.: 05 3701

## *SINBAD & DINGHY – COLLISION*

Whilst on passage from Hokimai Bay to Sandspit, *Sinbad* was in a collision with an *Unnamed Dinghy* whilst in Bon Accord Harbour.

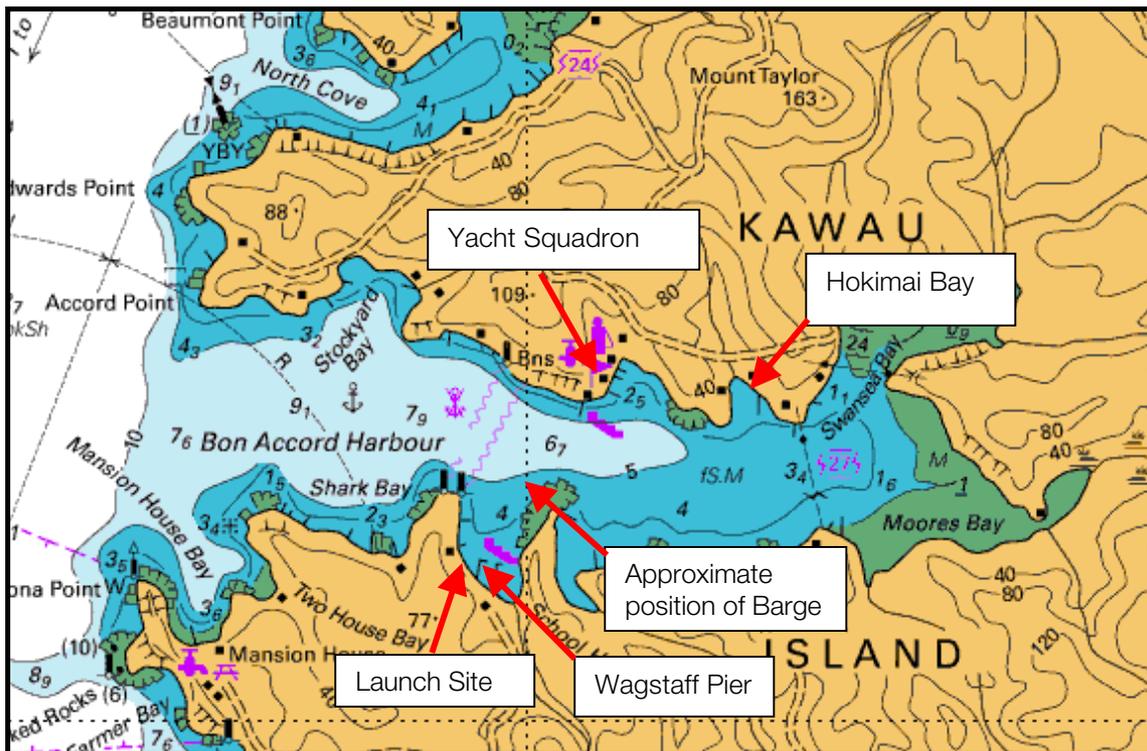
Figure 2

On Saturday 26 March 2005, at approximately 2000 hours New Zealand Standard Time (NZST), an unnamed dinghy was launched from the shore into Schoolhouse Bay, Bon Accord Harbour, Kawau Island (See Figure 2). The two crewmembers had borrowed the dinghy from its owner. The dinghy was rowed a short distance until the water became deep enough to use the outboard engine.

At approximately 2010 hours, *Sinbad* departed Hokimai Bay, Bon Accord Harbour (See Figure 2), bound for Sandspit. In addition to the Skipper, there were two adults and two children passengers onboard. *Sinbad* proceeded out of the Harbour at a speed of approximately 7 knots.

Upon passing south of the Yacht Squadron clubhouse, on the northern shoreline of Bon Accord Harbour (See Figure 2), *Sinbad* passed to port of *Lion New Zealand*, which was anchored south of the clubhouse, and the Skipper of *Sinbad* increased the engine revolutions to 3000 RPM (revolutions per minute) to give a speed of approximately 20 knots.

At approximately 2020 hours, the two Skipper's noticed the presence of each other's vessels at approximately the same time. The Skipper of *Sinbad* noticed only the white writing on the crewmembers tee-shirt. The Skipper of the dinghy only had time to put the tiller hard over to port to initiate a turn to starboard. The Skipper of *Sinbad* pulled the engine out of gear and put the helm hard over to starboard. Approximately two or three seconds later, the two vessels collided. The owner of the dinghy, who did not witness the collision, was of the opinion that it occurred close to the Schoolhouse Bay side of the harbour. The position of the collision was marked and signed by the Skipper of the dinghy on an extract of NZ Chart 5227 – Cape Rodney to Motuora Island, as being on or about the 5 metre sounding line, close to the entrance to Schoolhouse Bay and just to the north of the moored barge. The distance from this collision point to the nearest high water mark on the land is about 1 cable or about 186 metres.

- The Skipper states that the barge was moored inside the heads of School House Bay. The position of the barge on *Figure 2* is representative of the position of the barge on the chartlet drawn by and signed by the Skipper of the dinghy. The owner of the dinghy states that the barge was moored inside the heads of Schoolhouse Bay
