Accident Report

Collision

Sinbad 7 & Stingray 1

23 October 2006

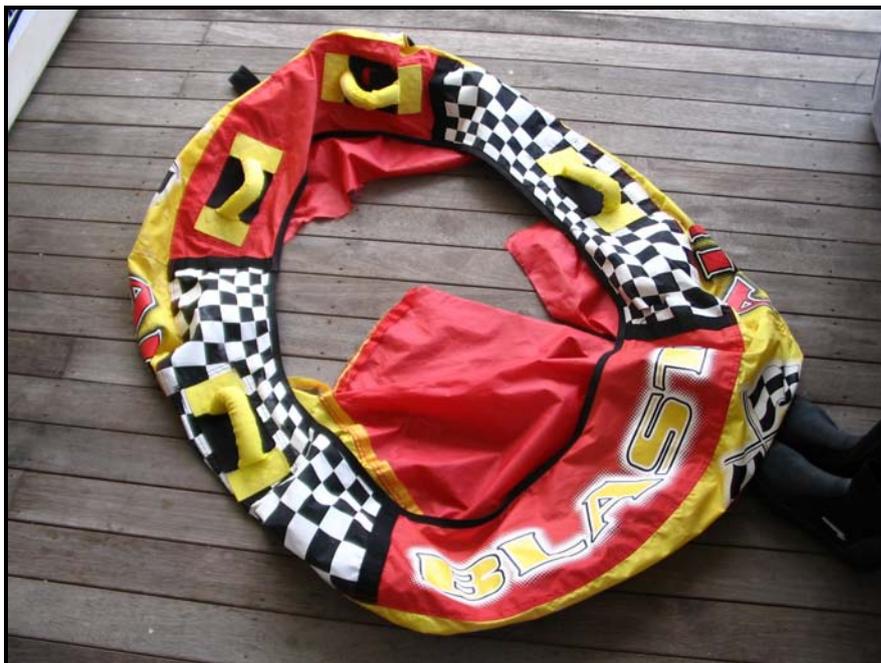
When **Sinbad 7** was approximately 25 metres off the port quarter of **Stingray 1**, the Skipper of the recreational vessel looked astern and observed **Sinbad 7** for the first time, just as the water taxi collided with the tow line of the sea biscuit. When this occurred, the child on the sea biscuit was thrown into the water and the sea biscuit was ripped apart by the propeller of **Sinbad 7**.

The sea biscuit, which was coloured predominately red and yellow, was 1.3 metres in diameter. The length of the tow a rope was approximately 27 metres. For the purposes of interpreting **Maritime Rule Part 22 – Collision Prevention**, a towing vessel and the vessel towed are treated as one vessel. Accordingly, in this accident, ***Sinbad 7***, as the give way vessel, was also required to keep clear of the sea biscuit.

Photograph 1
Remains of Sea Biscuit

It is believed that **Sinbad 7** collided with the tow line at a point close to the sea biscuit.
