Accident Report
Tamure & Unnamed Ramco
Collision - Pelorus Sound on
24 March 2005
Class B

REPORT NO.: 05 3700

TAMURE & UNNAMED RAMCO – COLLISION

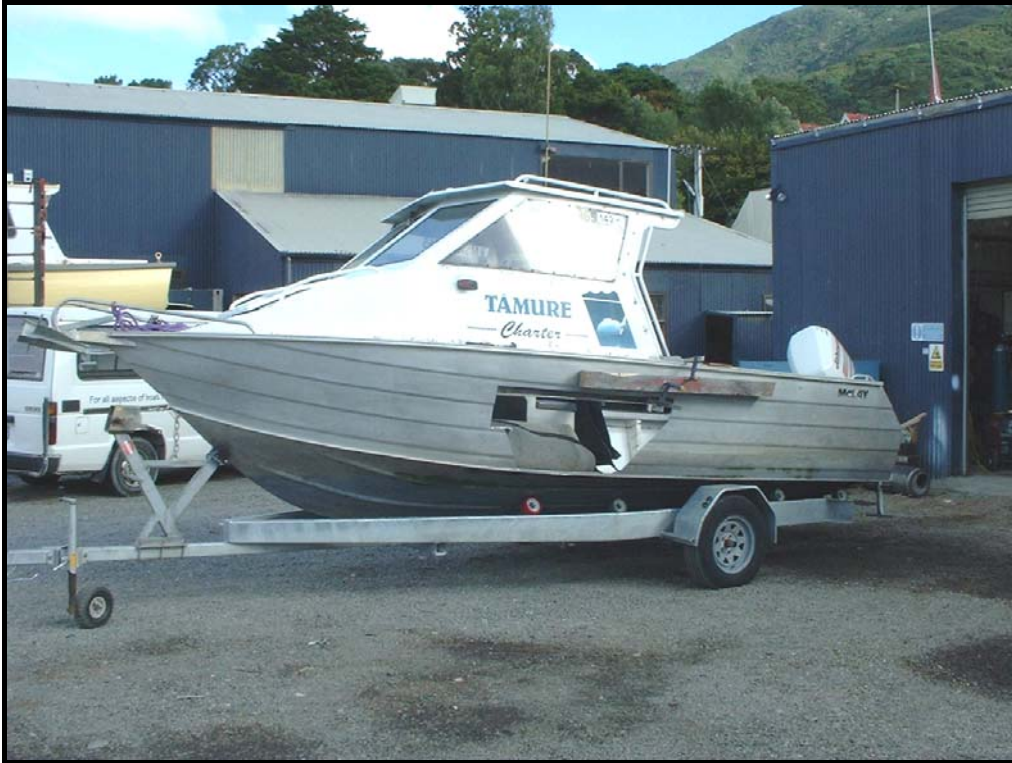
Photograph 1 – *Tamure*

The Skipper dropped off the passengers and departed Tiraora Bay at about 1900 hours. He was travelling at about 22 knots. The weather conditions had changed with just rain and less wind overall. Visibility was described as reasonable in the rain. The Skipper was following his outbound GPS track back towards Havelock. At about 1912 hours, as the vessel approached (See Figure 2 - Position 1), the Skipper saw a red and a green sidelight come into view around Turn Point. Shortly after this, he altered to starboard by about 35 degrees and continued on monitoring the situation. The Skipper continued to see both port and starboard sidelights, so decided to make a second alteration to starboard (See Figure 2 - Position 2). Shortly after this, the Skipper saw the vessel very close to port so decided to throw the helm hard over to starboard and pull the engine out of gear. Immediately after this, the two vessels collided with the bow of the other vessel puncturing the port side midships area of **Tamure**.

After the impact both vessels drifted a short distance away from each other. The Skipper of **Tamure** motored over to the other vessel and made fast to her while they all assessed the damage. **Tamure** had not made any water but the passenger seat was forcibly dislodged from its mount and thrown up against the starboard side helm position.

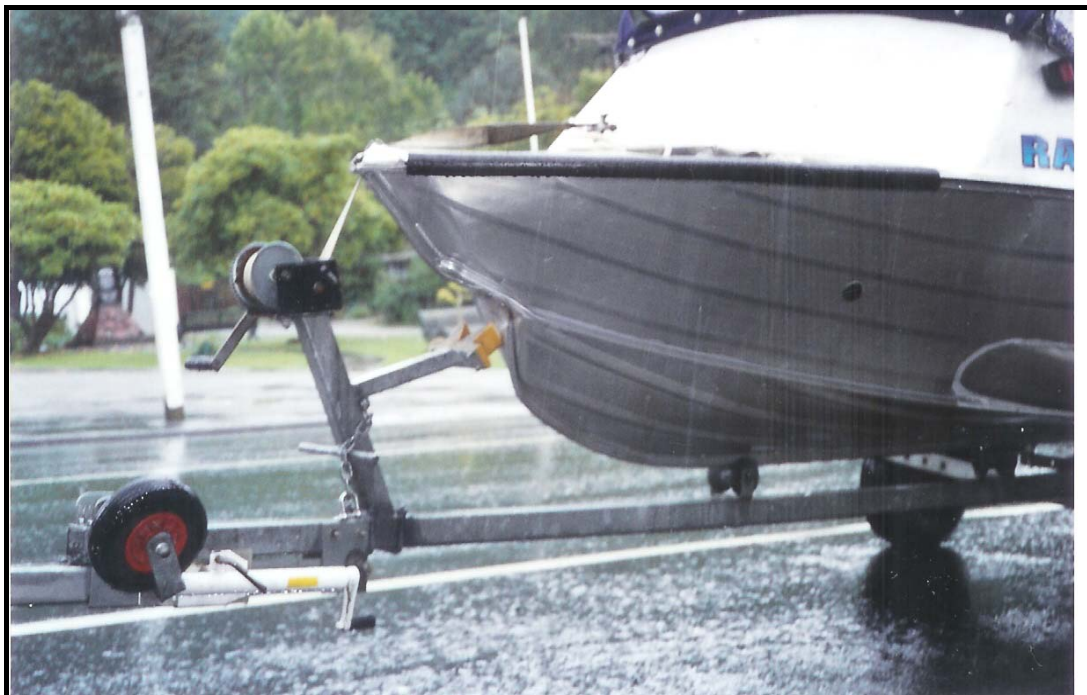
Photograph 2 – *Unnamed 'Ramco'*

The **Unnamed** vessel had broken off its bowsprit and dented the stem during impact. At first, it was thought that it was taking on water but later it was decided that the water was from the stern wake entering the vessel when it stopped suddenly after the impact.

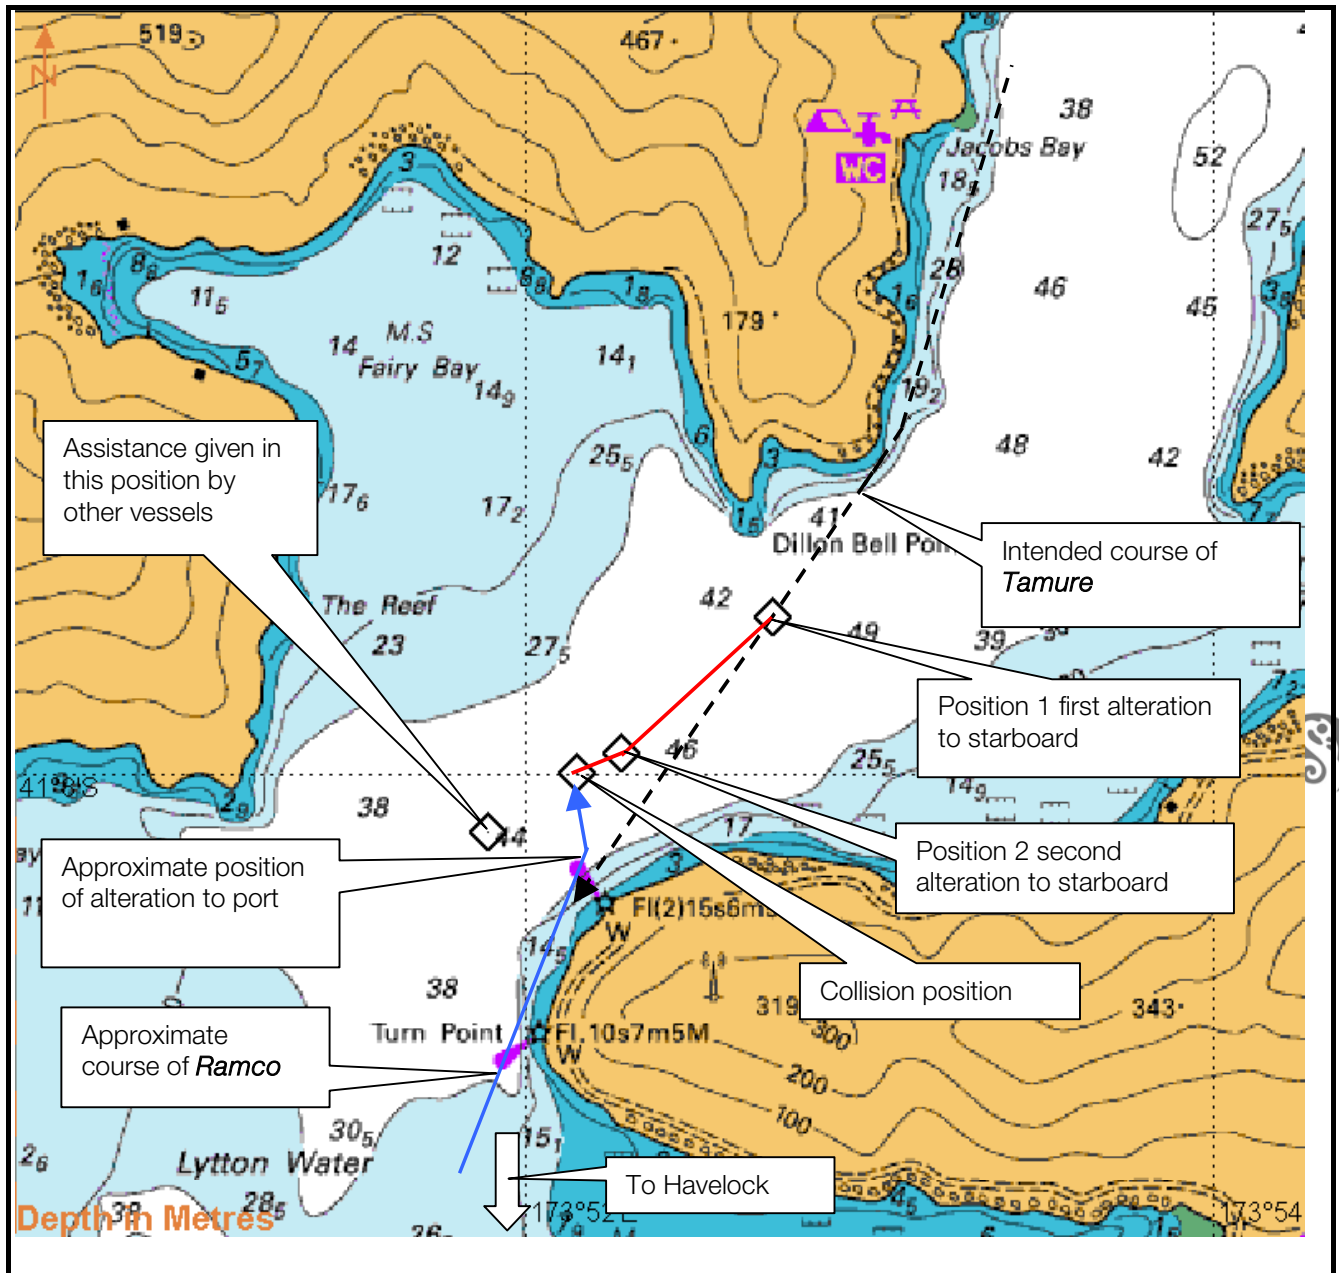
Figure 2 - Approximate Chart of Collision

They continued up Pelorus Sound in the heavy rain and poor visibility. As the vessel went past Turn Point the Skipper saw some boat lights dead ahead. The Skipper thinking they were a long way away decided to alter course to port and head across the Sound to Fairy Bay and continue the trip around Dillon Bell Point and into Jacobs Bay. The Skipper could only just make out the lights due to the heavy rain on the plastic windows, which hampered his visibility. Shortly after this alteration, the Skipper saw the other vessel ahead and immediately pulled the engine back to reverse but the engine stalled as they collided with the other vessel.

He thought he could get clear of the other vessel by heading into Fairy Bay by altering course to port. This was contrary to **Maritime Rule Part 22.14 Head-On Situation:**
