Class B Non Serious Harm Accident Report

Bledisloe No. 1 North Wharf, Auckland
on 2 July 2004

REPORT NO: 96 294

TANIWHI – INJURY TO STEVEDORE

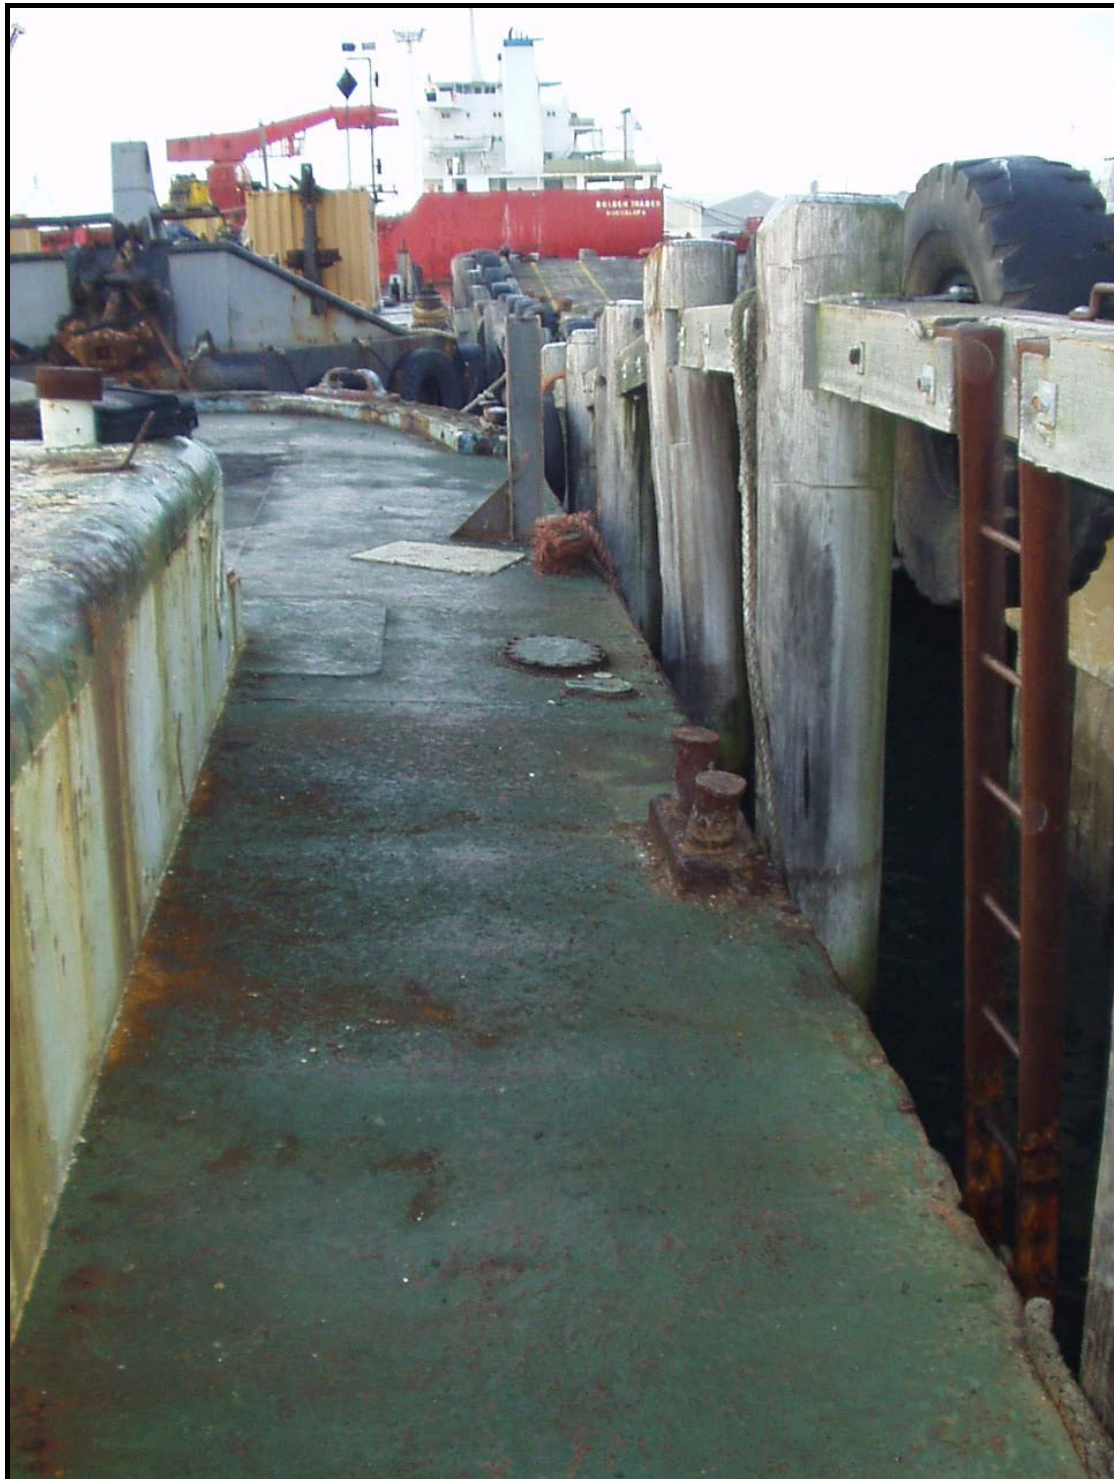
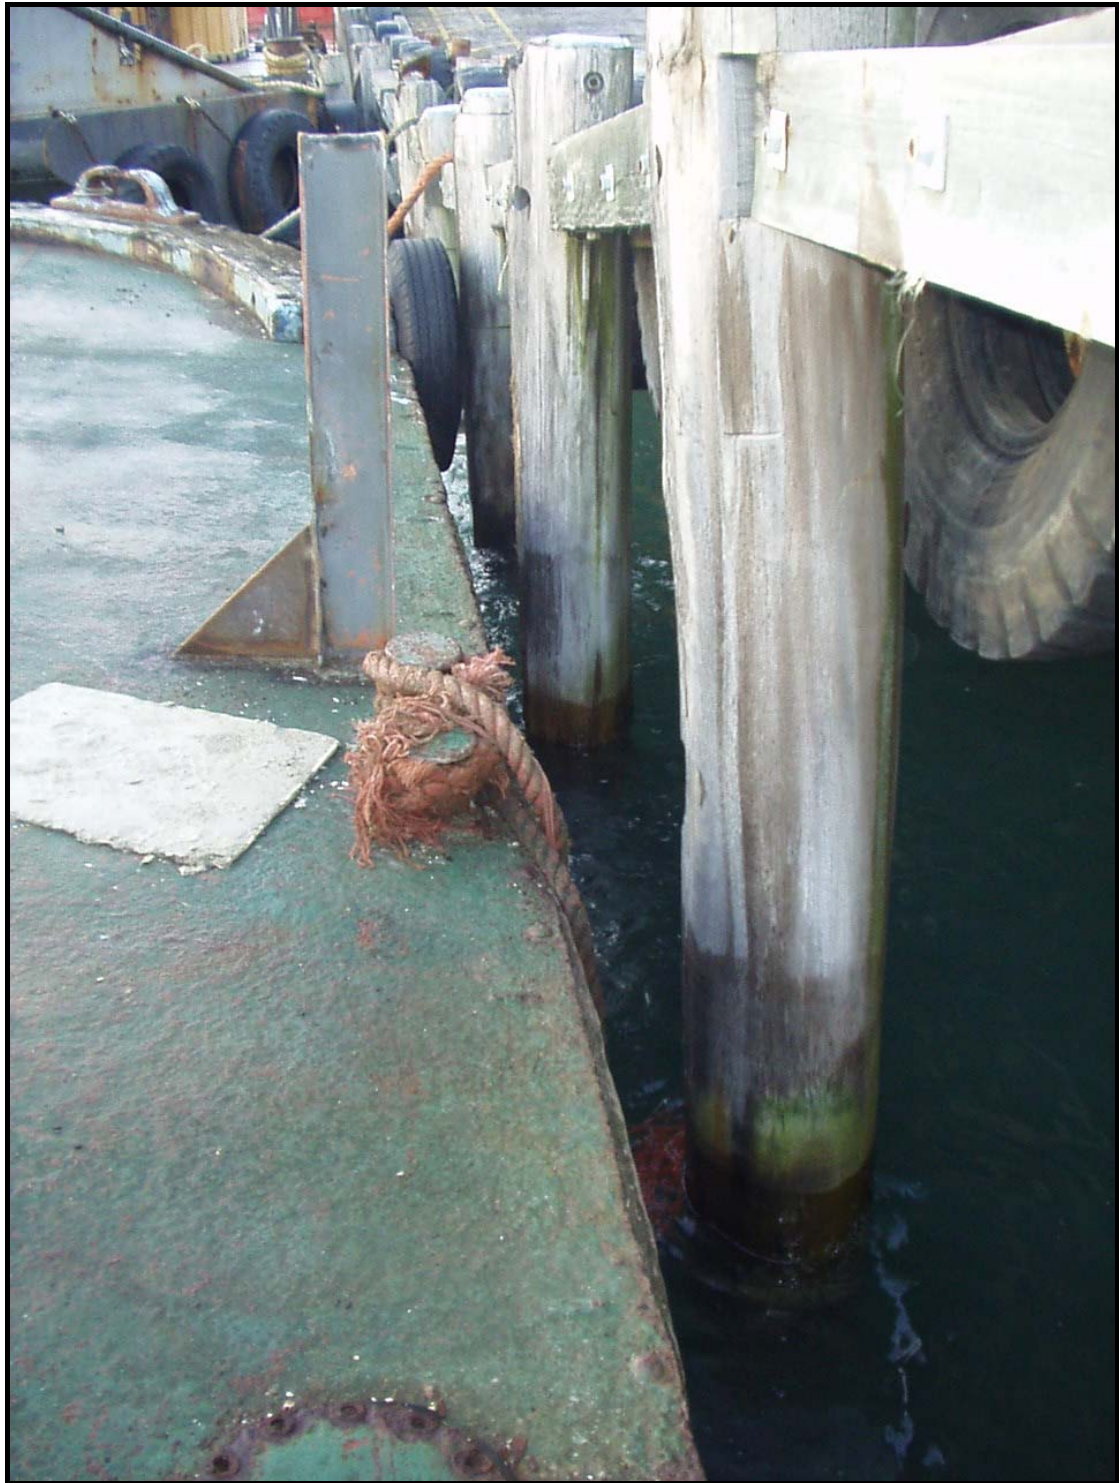
The welder was lying flat on the deck of the barge, welding stanchions to *Taniwhi*, whilst it was made fast alongside an open pile wharf. Whilst his left foot was touching one of the piles, a passing vessel caused the barge to move suddenly, crushing the welder's foot between the barge and the pile.

Photo of open pile wharf

- The hazard is minimised by the provision of adequate sized fenders of sufficient quantity between the barge and adjacent wharves/other fixed or floating object to protect employees, or
- The danger to employees is eliminated by repositioning the barge so that the side on which employees are working does not abut a fixed or floating object.
