Accident Report

Target & Unnamed Dinghy Collision

North of Urupukapuka Island, Bay of
Islands on 26 September 2004

REPORT NO: 04 3560

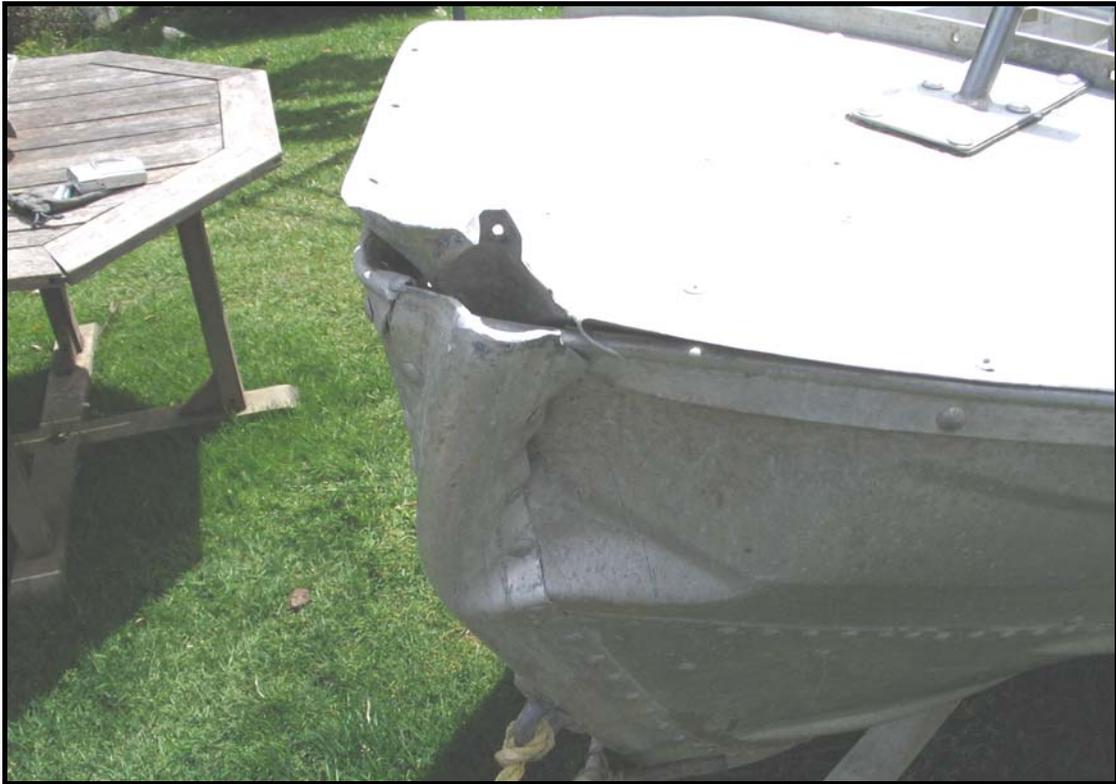
2.2.10 The damage to the dinghy consisted of a crumpled starboard bow (*See Appendix 1 – Photo 1*). The engine was also swamped and required repairs.

PHOTO 1 – DAMAGE TO BOW OF UNNAMED DINGHY

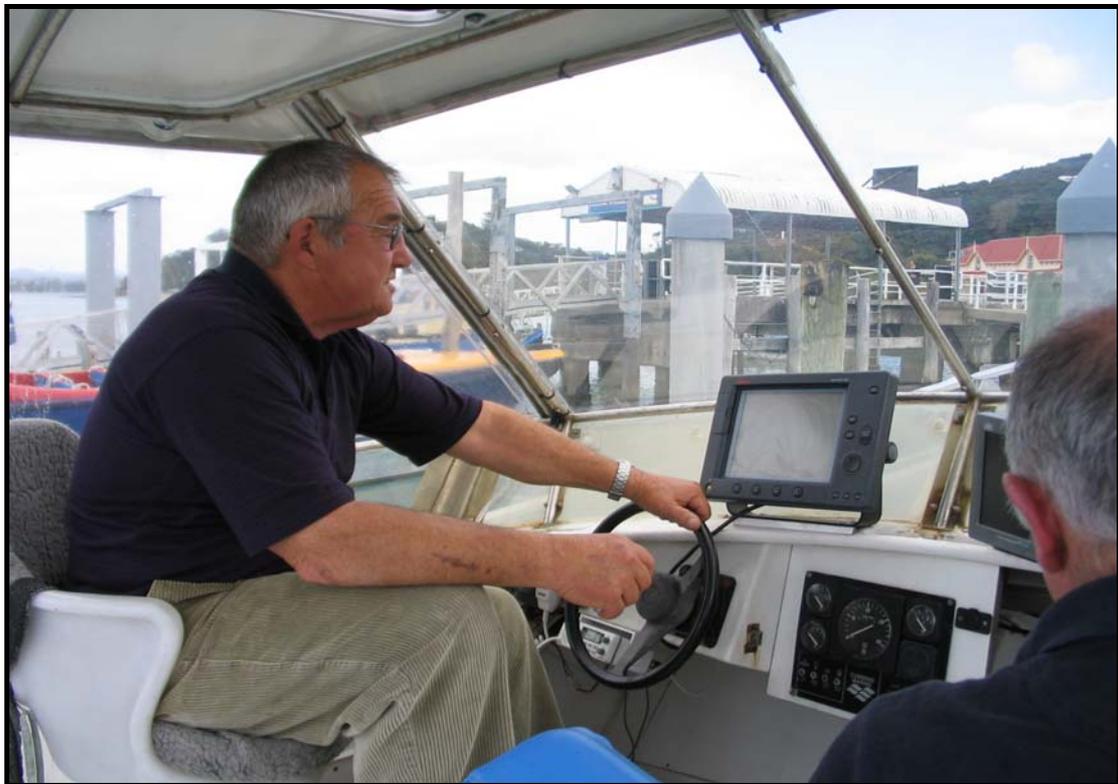
- 2.1.7** The plastic flying bridge windshield had been replaced with polycarbonate in 2003 in order to improve visibility.
- 2.1.8** *Target* is normally conned from the flying bridge as the visibility is better than from the wheelhouse.

PHOTO 2 – FLYING BRIDGE CONNING POSITION

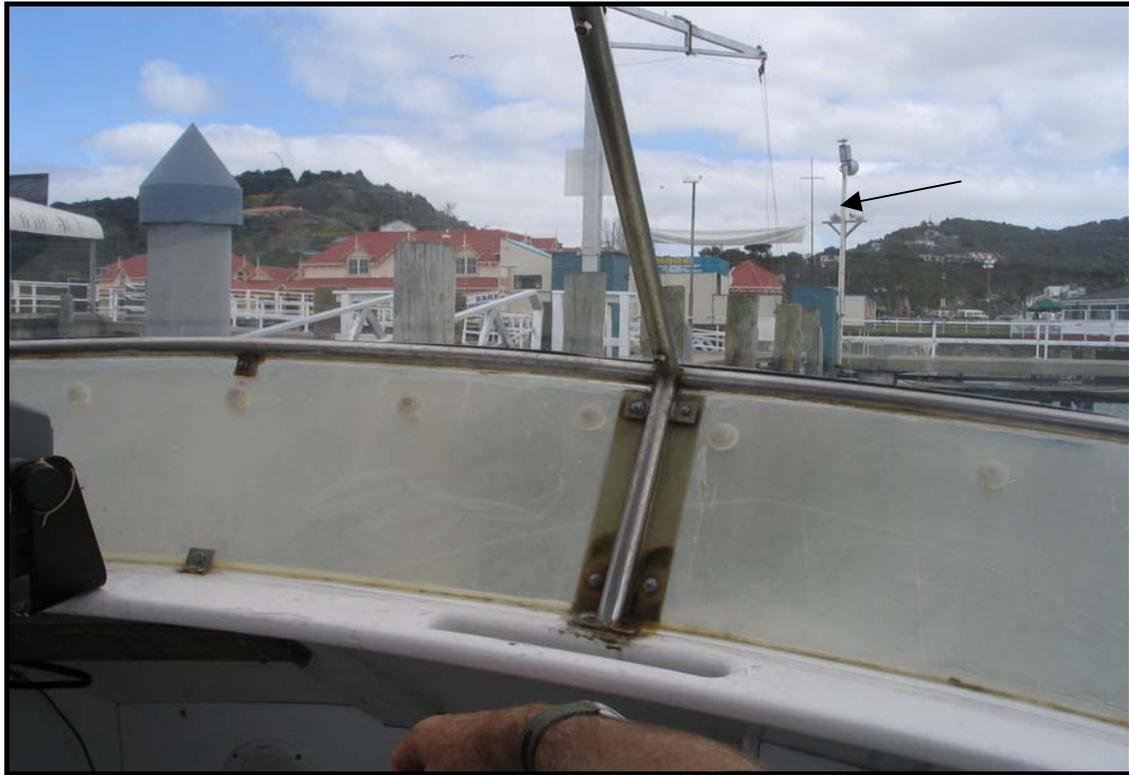
- 3.1** The position of the sun and its reflection off the water impaired the vision of *Target's* Skipper and passengers.
- 3.2** *Target's* windshield was covered in sea spray. This impaired the visibility of the Skipper and passengers.
- 3.3** The lower part of *Target's* windshield was constructed from plastic. This had become discoloured over time and was almost opaque, and impaired the visibility of the Skipper and passengers (*See Appendix 2 – Photos 2, 3 & 4*).
- 3.4** The dinghy was anchored near the interface of calm water and rough water.
- 3.5** *Target* was proceeding at a speed greater than five knots within 200 metres of the shore.
- 3.6** *Target* was not proceeding at a safe speed as defined in Maritime Rule 22.6.

- 5.1.1 A combination of sun strike and the build up of salt spray on the windshield impaired the visibility of *Target's* Skipper and passengers.
- 5.1.2 The discoloration of the lower section of *Target's* windshield impaired the visibility of *Target's* Skipper and seriously impaired that of the passengers
- 5.1.3 *Target's* speed was excessive in the prevailing circumstances and conditions.
- 5.1.4 There is some doubt as to whether the dinghy carried any lifejackets. If none were carried, this would be in breach of **Maritime Rule Part 91.4**.

PHOTO 3 – FLYING BRIDGE WINDSHIELD

- 5.2.1 The owner of *Target* should replace the lower plastic section of the windshield with new 'see through' material to improve the visibility from the flying bridge. This should be done within one month of this report being published.
- 5.2.2 It is recommended that the Maritime Safety Authority, censure the Skipper of *Target* for his failure to proceed at a safe speed.
- 5.2.3 It is recommended that the owner of the *Unnamed Dinghy* ensure that a sufficient number of lifejackets are kept on board at all times in accordance with the requirements of **Maritime Rule Part 91.4** and that these are worn in accordance with the requirements of **Maritime Rule Part 91.4(6)** which states:

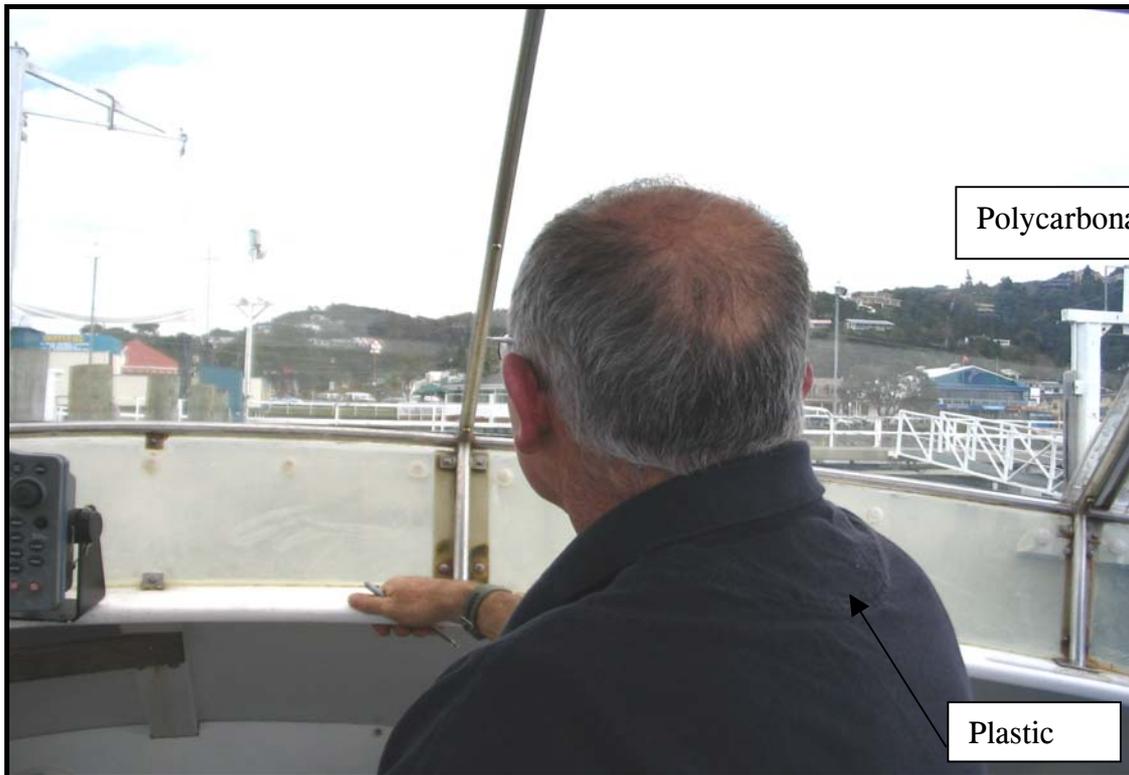
PHOTO 4 – VIEW OF PASSENGERS WHEN SITTING ON FLYING BRIDGE
