Accident Report
Collision with Fairway Beacon
Tasman Resolution
25 April 2006
Summary Report

SUMMARY

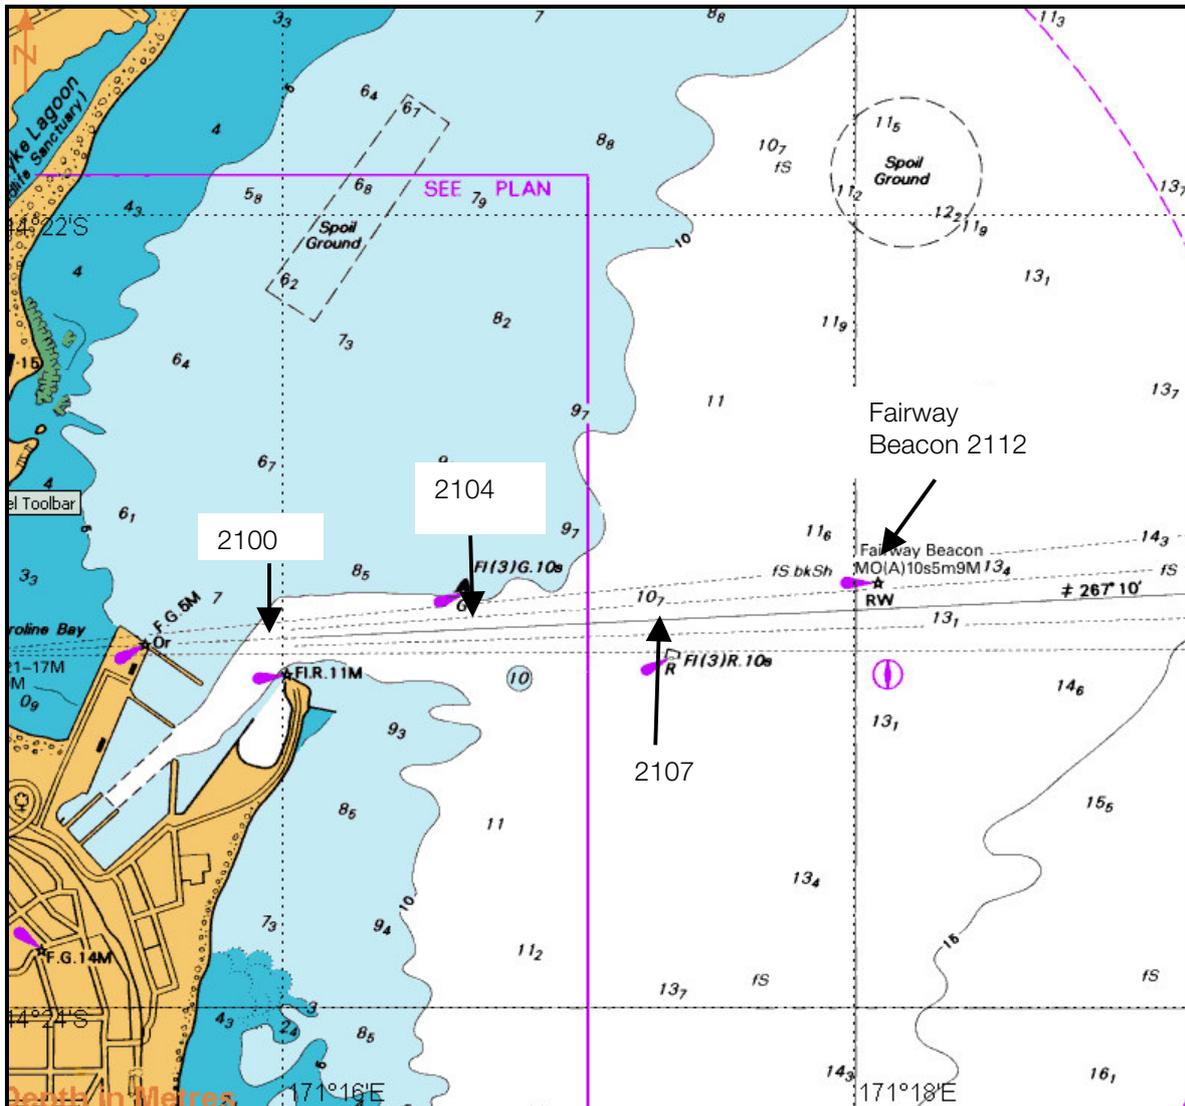
Figure 1

At 2045 hours, the vessel sailed from the North Mole container terminal at Timaru. The bridge team consisted of the Master, Third Officer, Helmsman and Pilot. At 2100 hours, the vessel was abeam of the seaward end of the southern breakwater, at the entrance to the Harbour, and altered course onto the Fairway leads on a heading of 090°(G) (See *Figure 1*).

At 2106 hours, after the pilot boat was clear, the bridge telegraph was placed to Half Ahead. This was followed at 2107 hours with an order of Full Ahead when the vessel was abeam of the red channel buoy (See *Figure 1*). At 2107 hours, the vessel altered course onto a heading of 100°(G). The Master had the con of the vessel and the Third Officer was plotting the vessel's position and writing up the movement book in the chart room.

At approximately 2111 hours, the Bosun, stationed on the forecastle, reported to the Master via radio that the vessel appeared to be setting onto the fairway beacon (See *Figure 1*). The Master observed the fairway beacon to be bearing approximately 5° off the port bow at a distance of approximately 75 metres. The Master ordered the helmsman to put the helm hard to starboard. When the beacon was off the midpoint of the vessel at a distance off of approximately 10 metres, the Master ordered the helm to be put hard to port, in an attempt to swing the stern of the vessel clear of the beacon. This attempt was unsuccessful and at 2112 hours the vessel struck the beacon in way of frames 70-80. The beacon submerged and a few seconds later, the Master felt an impact, assuming it to be the beacon's mooring chain coming into contact with the vessels propeller.

The Master admits that in steering 100°(G) to maintain a course of 092°(T), he did not allow enough for set and leeway to provide adequate sea room for the fairway beacon. By the time he realised that the vessel was setting down onto the beacon, he was in an impossible position due to the low speed of the vessel. The Master had been to Timaru on eight previous occasions.
