Accident Report

Serious Harm Injury
Tasman Resolution

20th February 2006

VESSEL NAME: *TASMAN RESOLUTION*

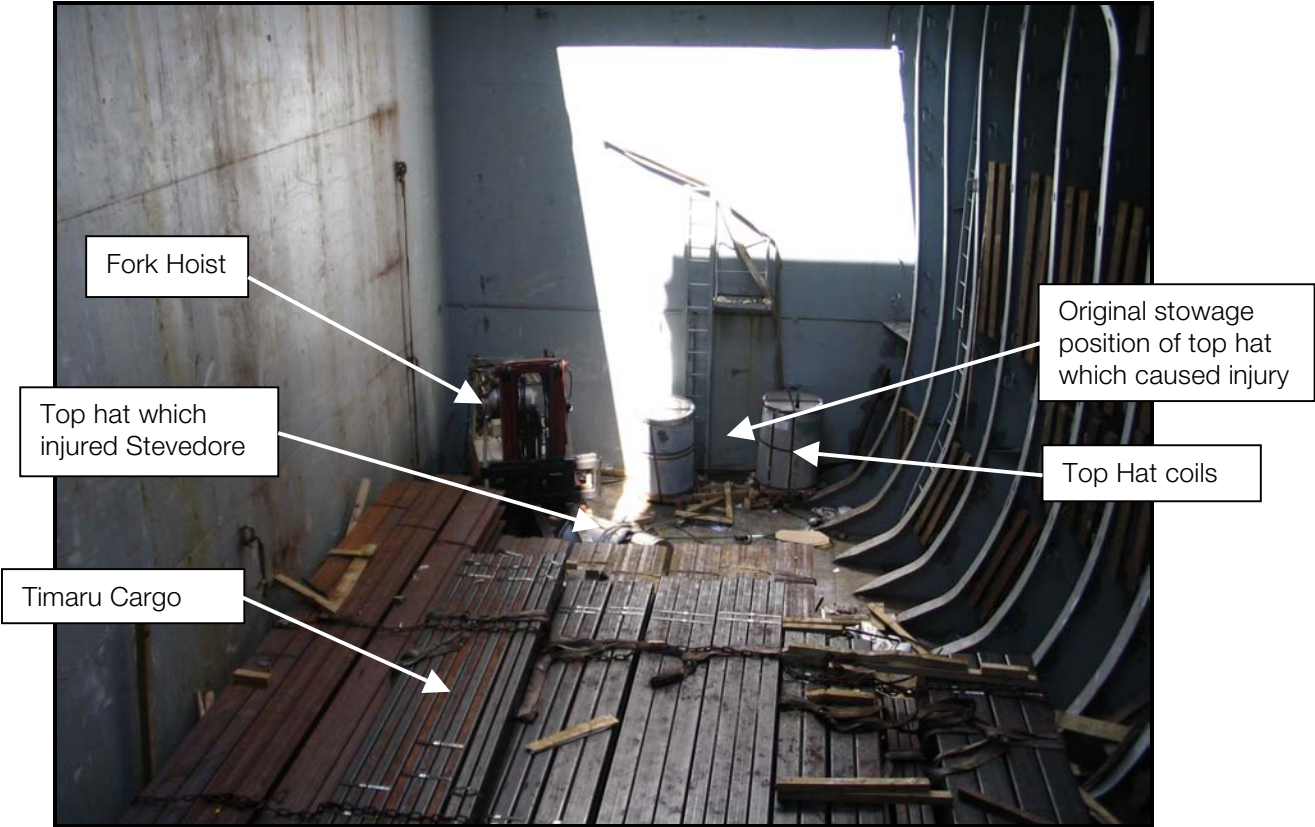
Photograph 2
View of Number 2 hatch looking forward

The cargo for discharge in Auckland consisted of steel pipes, beams and coils. The majority of the coils were stowed horizontally but there were 12 top hat coils stowed hard up against the forward bulkhead, beneath the hatch coaming. The Foreman Supervisor noticed that some of the top hat coils were labelled as being for discharge in Timaru whereas on his discharge plan they were all marked for discharge in Auckland. The Foreman Supervisor contacted the Operations Supervisor for clarification, who confirmed that the top hat coils were all to be discharged in Auckland. The remaining cargo in the hold was destined for Timaru and consisted of steel beams and pipes (See *Photograph 2*).

The stowage of the steel coils was unsatisfactory. The coils were stowed hard against the ship's bulkhead and beneath the hatch coaming. The presence of cargo bound for Timaru in the square of the hatch precluded the use of a fork hoist which would normally have been used.

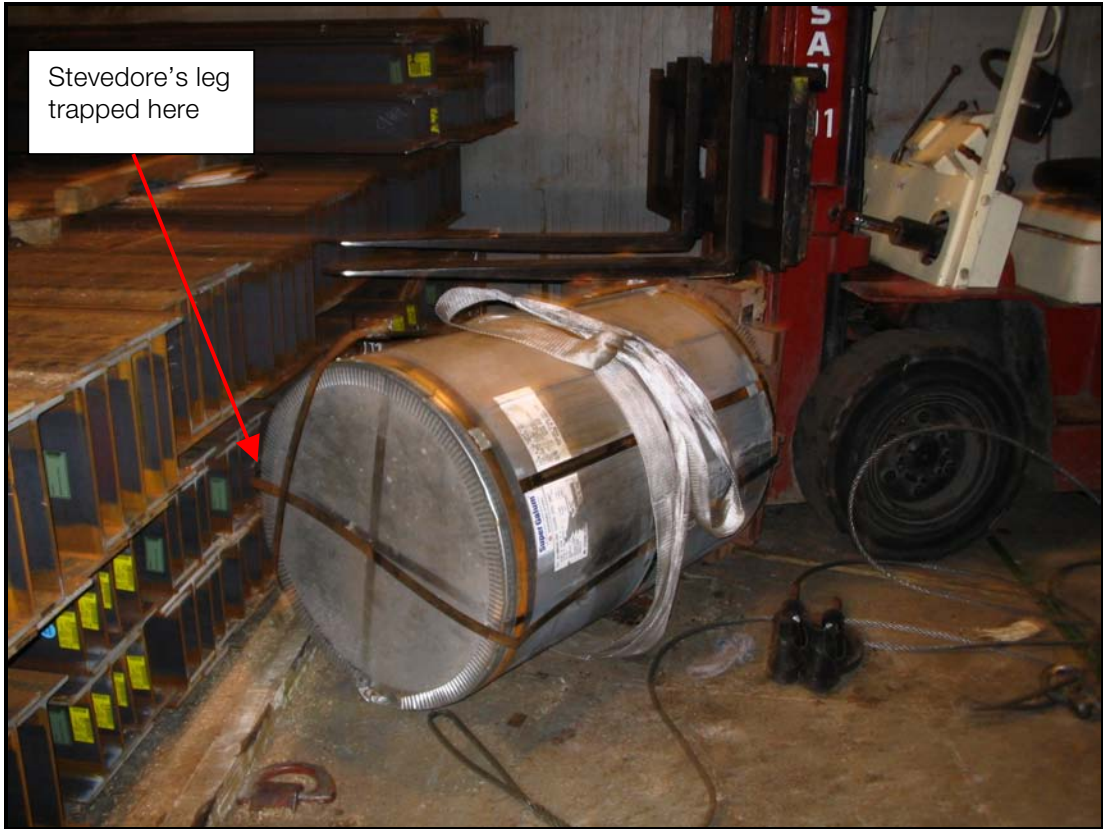
Photograph 3

Instead of standing up on end when the Stevedores attempted to right the coil, it swung across the deck. The Foreman Supervisor was standing in the way of the swinging coil and his leg was pinned between the coil and the adjacent steel beams (See *Photograph 3*).

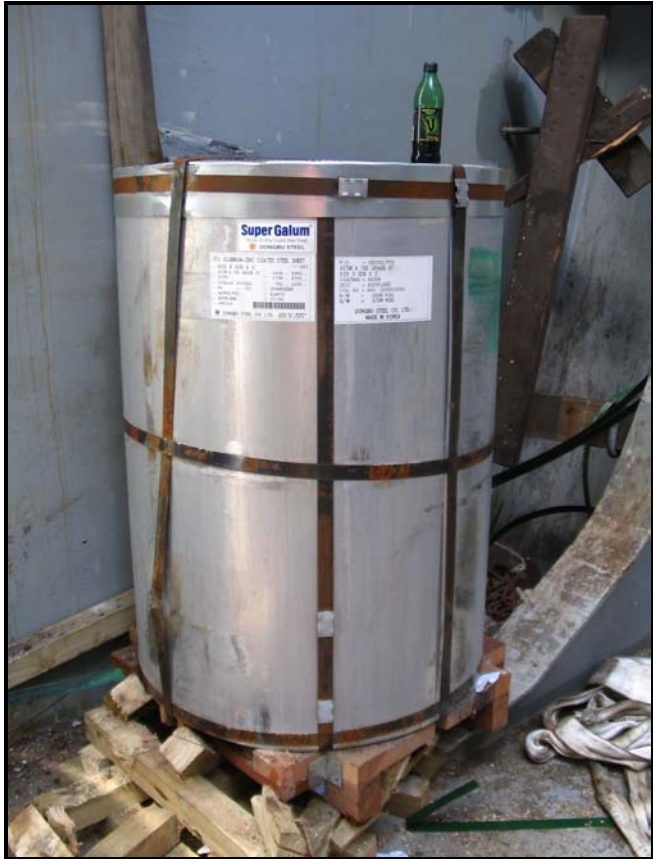
Photograph 4
Top Hat Coil

The top hat coils were secured onto individual wooden pallets. They were capped at the top. Each coil had a gross weight of 3738 Kg. The coils were 1230mm in height with a diameter of 870mm.

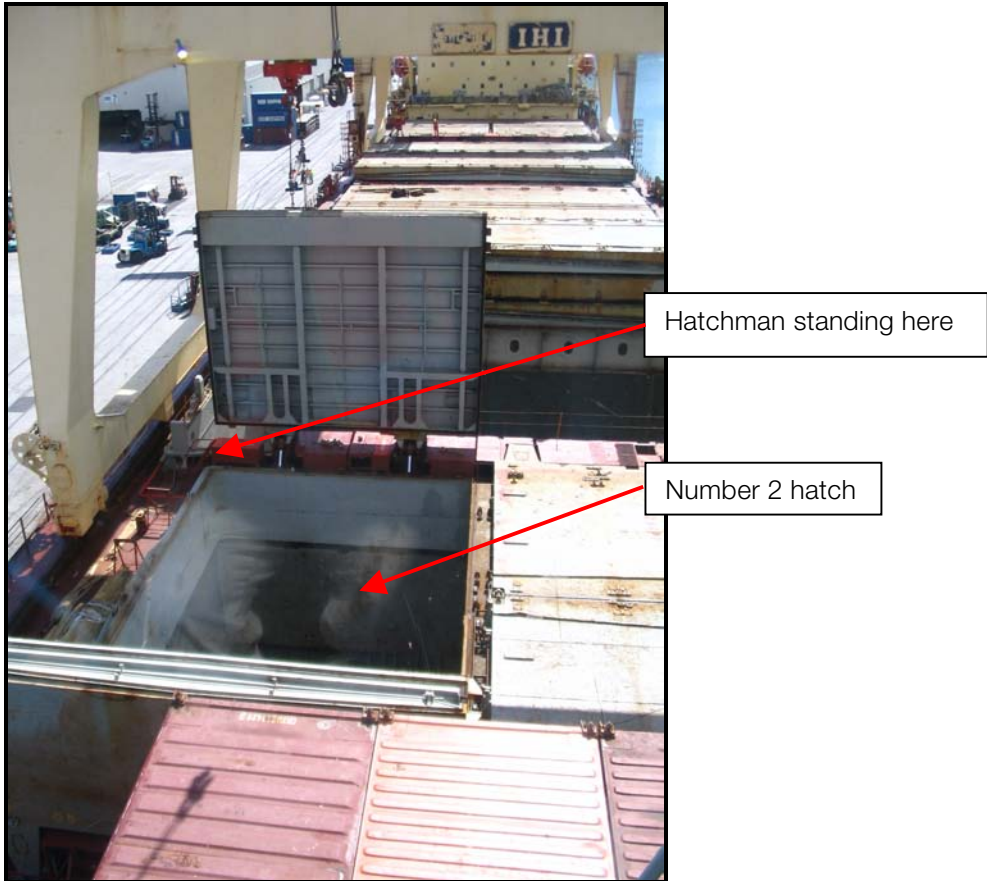
Photograph 5
View from Crane Cab looking aft

The crane driver could not see the lower hold from his position in the crane cab. He was receiving commands via radio with the hatchman who was standing on the hatch coaming. The hatchman had a clear view of the hold below him.
