Class A Accident Report

Tiger III Grounding

At Cape Brett, on 18 December 2004

REPORT NO:	04 3625
VESSEL NAME:	TIGER III
Ship Type:	Restricted Passenger Ship
Certified Operating Limit:	Inshore: Northland, Auckland, Bay of Plenty.
Port of Registry:	Whangarei
Flag:	New Zealand
IMO/MSA/Official No.:	MSA 875120
Built:	1985
Construction Material:	Aluminium Alloy
Length Overall (m):	20.92
Maximum Breadth (m):	8.70
Gross Tonnage:	181
Net Tonnage:	135
Registered Owner:	Fullers Bay of Islands Ltd.
Ship Operator/Manager:	Fullers Bay of Islands Ltd.
Classification Society/SSM Company:	Maritime Management Services Ltd.
Accident Investigator:	Andrew Hayton

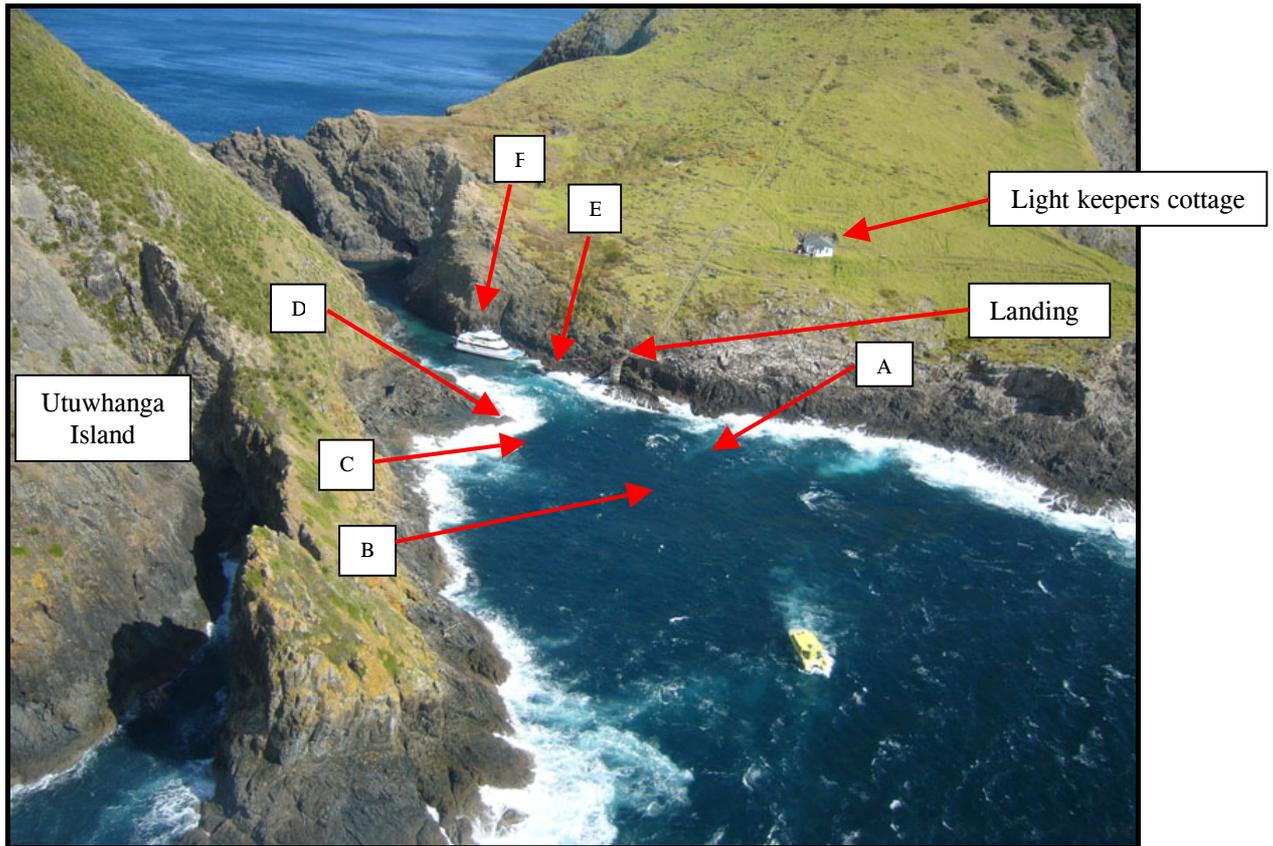
FIGURE 3. VIEW OF COVE FROM NORTH WEST
 (PHOTO COURTESY OF NEST HELICOPTER)

He attempted to take all way off the vessel using the starboard engine. This action screwed the stern of *Tiger III* around to port. The vessel stopped approximately 40 metres from the shore to the west of the landing (See Figure 3 - Position 'A').

The Skipper wanted to try and get the wind on the port quarter of the vessel and by going astern on the starboard engine hoped to be able to keep the wind on the port quarter and 'walk' the vessel astern out of the cove. He put the helm hard to port and went ahead on the starboard engine. The engine was stopped before hitting the rocks on Otuwanga Island and the vessel was set towards the 'Gut' (See Figure 2 & Figure 3 - Position 'C').

The towline was passed from *Dolphin Seeker* and the eye put over a bollard on the starboard bow of *Tiger III*. The towline was then made up on the port quarter of the towing vessel. At about this time, *Tiger III*'s port quarter made contact with the rocks off Otuwhanga Island (See Figure 3 - Position 'D'). Soon afterwards, the towline parted.

Tiger III was set towards a position where its port shoulder was close the rocks just to the east of the landing (See Figure 3 - Position E). The swell was pushing the vessel astern and the Skipper saw an opportunity to make the vessel fast alongside a natural rock ledge that was cut into the rock face. The Skipper was concerned that the vessel would be pushed further into the Gut after ripping its port side on the rocks.

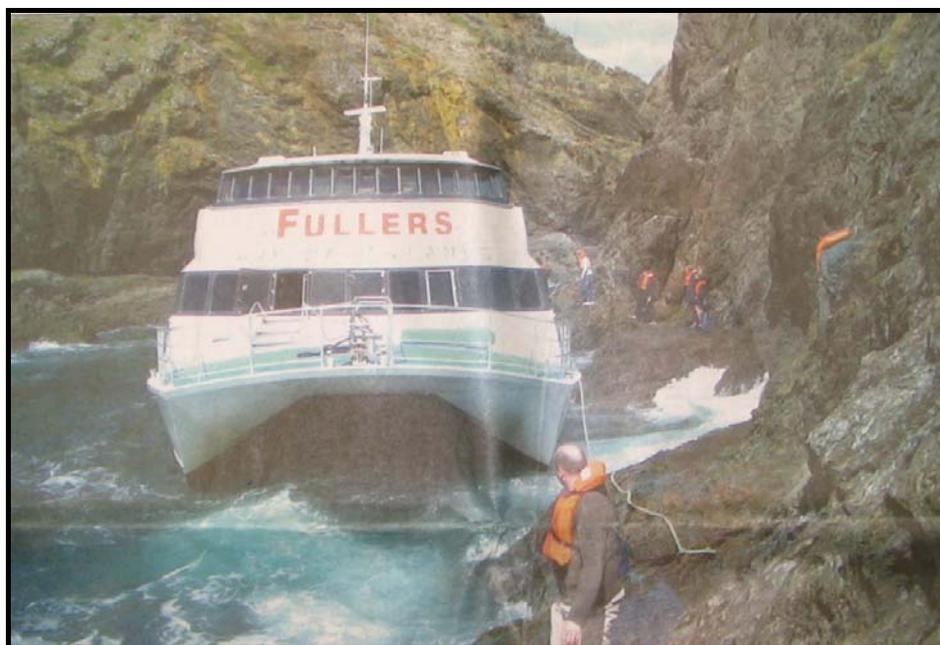
FIGURE 4 - PASSENGERS ABANDONING *TIGER III*

Once the vessel was secured, the Skipper decided that the passengers should abandon ship. With the Skipper and Deckhand 1 assisting on the vessel and Deckhand 2 assisting on the rocks, all of the passengers were disembarked one by one via the port quarter sea door. During this time, *Tiger III* was surging against the rocks. The passengers had to time their move between the waves and step down onto the vessel's belting and thence onto the rocks.

Once on the rocks, the passengers were able to make their way along a natural ledge with the aid of a safety line that the crew had rigged. They were then able to climb up the rocks and steps near the landing and onto the grassed area of Cape Brett.

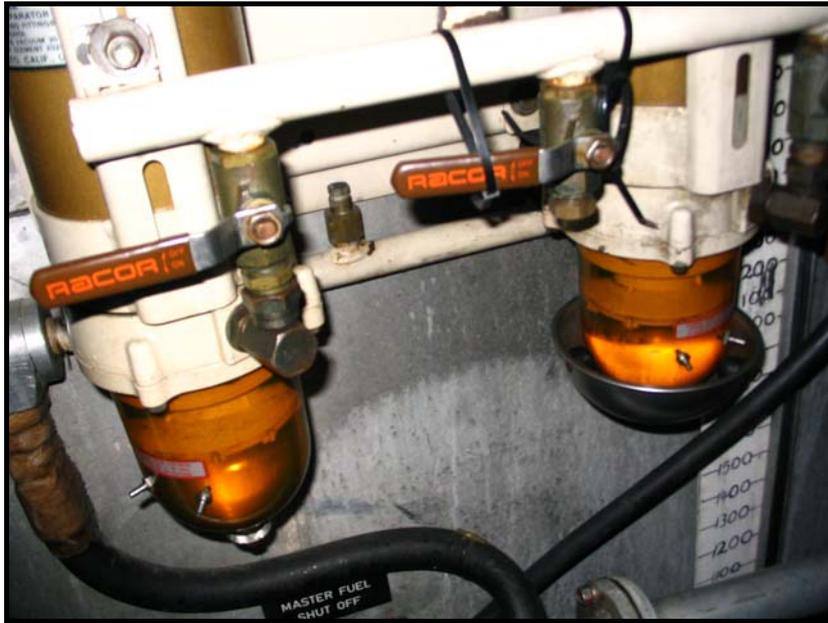
FIGURE 5 - RACOR FILTERS ON STARBOARD ENGINE.

There are two Racor fuel filters for each engine. Of these filters, only one is in use at any one time. On the port engine, the Racor filter is the primary filter for the generator as well as the engine. The filters have taps, which can be closed accidentally when checking the forward end of the engine. If closed, the engine would run for approximately 10 minutes before stopping, due to fuel starvation.

When salvaged, water was found in the primary Racor fuel filter. There was also water in the generator's secondary fuel filter. There was some dirt in the filter bulb. On each engine, there was one filter tap in the 'open' position and one in the 'closed' position, thus the tap had not been closed accidentally, shutting off the supply.

Although it is not known exactly what caused the engine to fail, it is suspected that the failure was due to an abnormality in the fuel system. This is due to the fact that both the port engine and the generator failed within a short period of time and the fact that the fuel system was one of the few common links between the two.
