Class B Accident Report

***Tokerau & Kawau Kat***  
**Collision**

At Auckland on 11 December 2004

**REPORT NO: 04 3624**

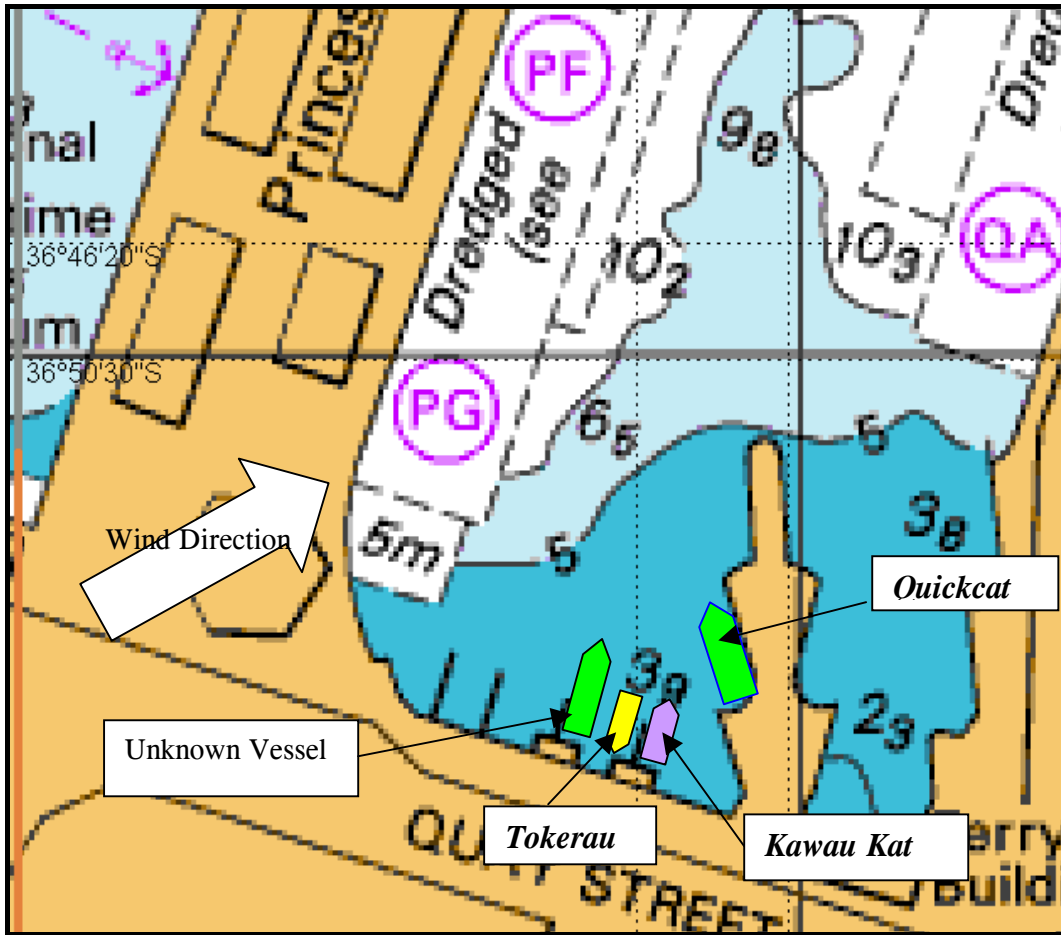
FIGURE 2

At approximately 1730 hours, *Tokerau's* mooring lines were cast off and the Skipper operated the engine astern. As soon as the stern of *Tokerau* cleared the pontoon, the wind commenced pushing the vessel's stern to port towards the berthed Fullers ferry, *Quickcat* (See Figure 2).

The Skipper put the engine full ahead and the helm hard over to starboard in an attempt to avoid colliding with *Quickcat* and in order to clear an unknown vessel berthed at Pier 3A. The vessel started turning to starboard but in doing so, *Tokerau's* port shoulder made contact with the starboard bow of *Kawau Kat*, which was berthed on the eastern face of Pier 3B (See Figure 2).

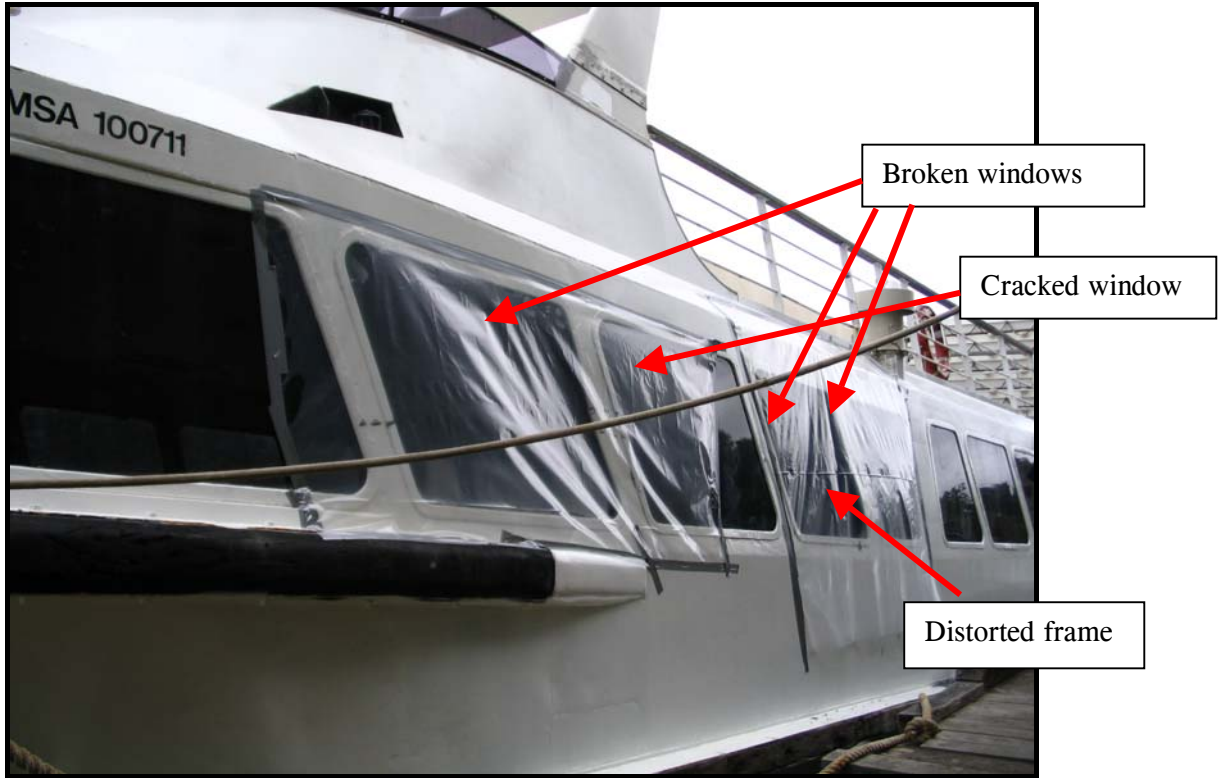
**DAMAGE INCURRED BY *TOKERAU***

*Tokerau* suffered three shattered windows and one cracked window on its port side, whilst *Kawau Kat* incurred superficial damage to its starboard bow and stem.
