Class B Accident Report

Hamilton 141

REPORT NO: 04 1141

UNNAMED – GROUNDING RESULTING IN A FATALITY

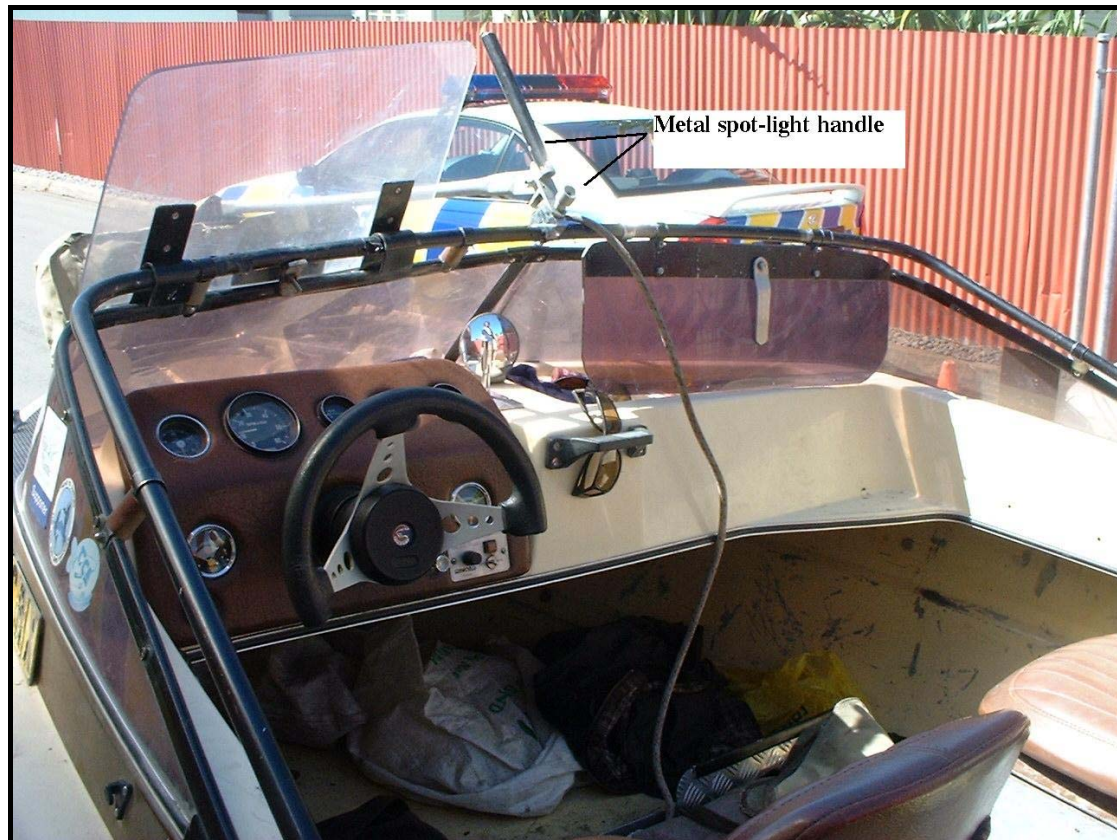
might have happened shortly before the Driver was thrown bodily towards the centre of the windscreen area, where he is thought to have impacted on the metal handle of the spot-light control.

A stone jammed the steering nozzle in the jet unit after crossing a shallow area of the river.

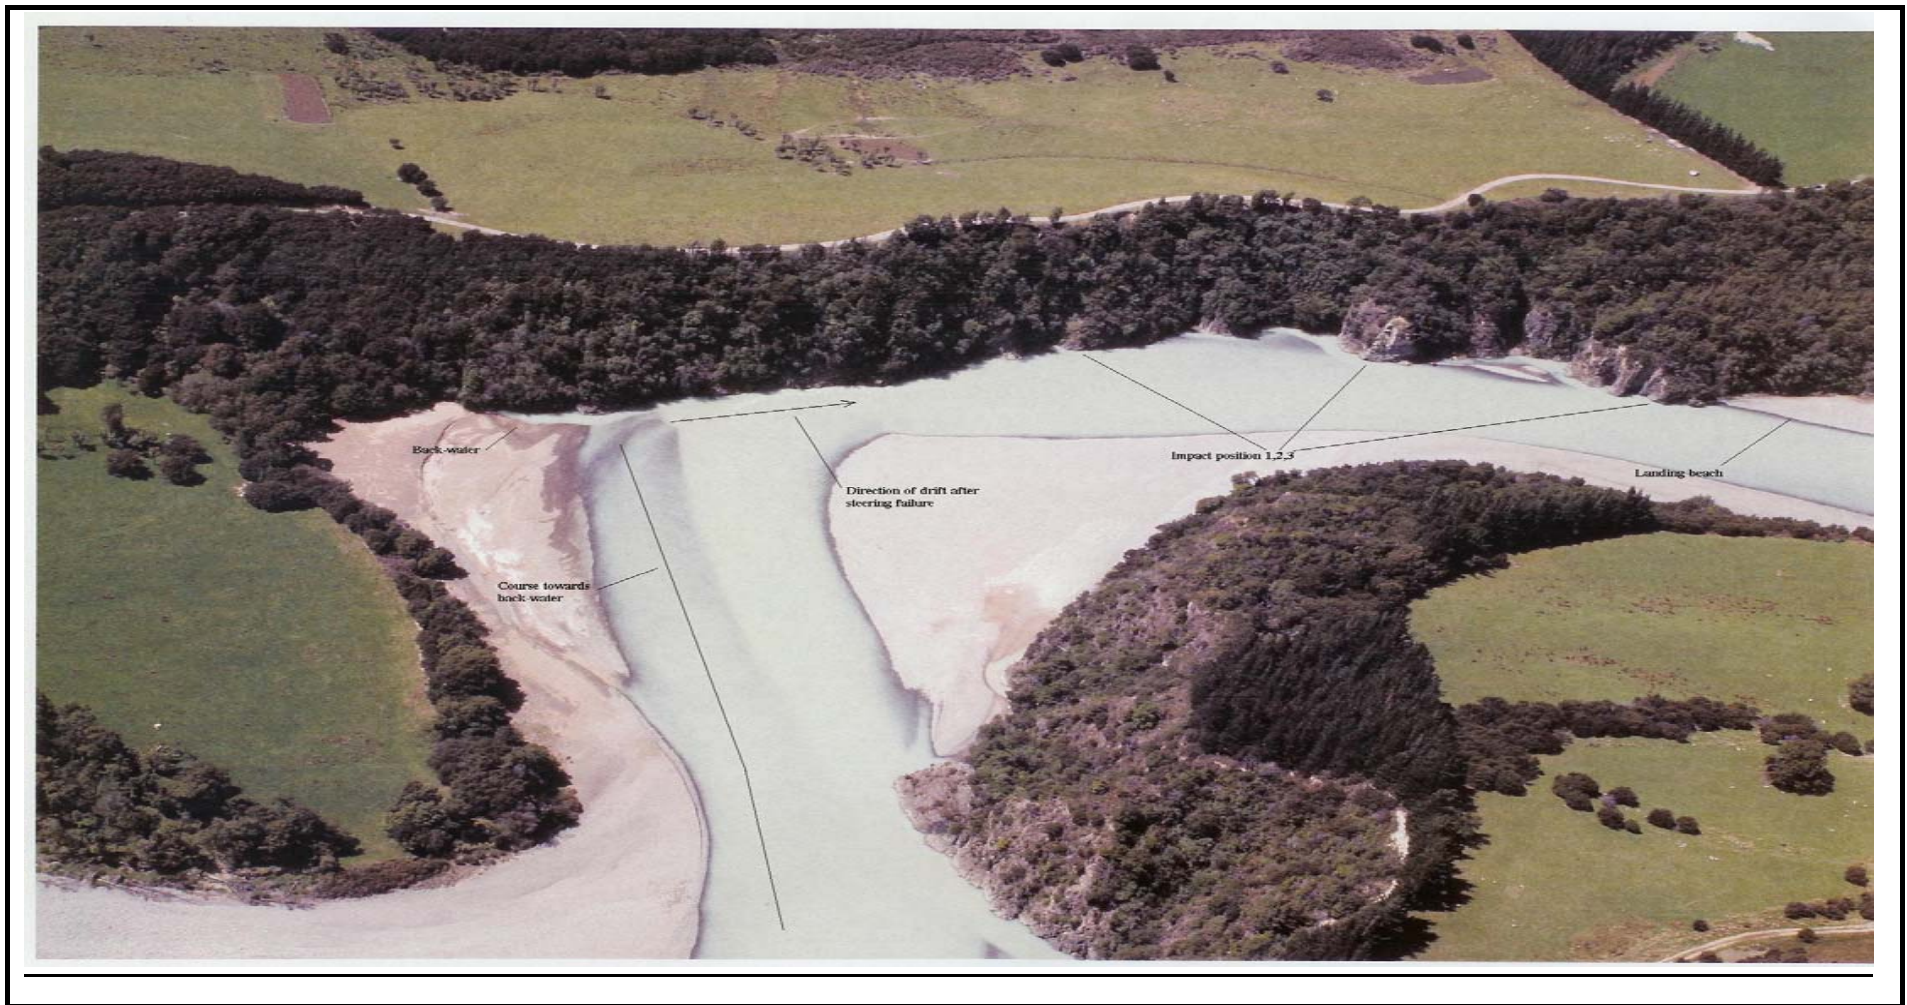
Aerial photograph of Waimakariri River, taken 1400 hours on 1 November 2004. Shows track down over single fan, backwater and drift track down to beach area. River level had dropped further since accident time on 31 October 2004.

The flow of the river had dropped which reduced the amount of water over the shingle area leading to the backwater.
