Class B Non Serious Harm Accident Report

Waima

Back Injury

Fulljames Rapid, Waikato River on 21
November 2004

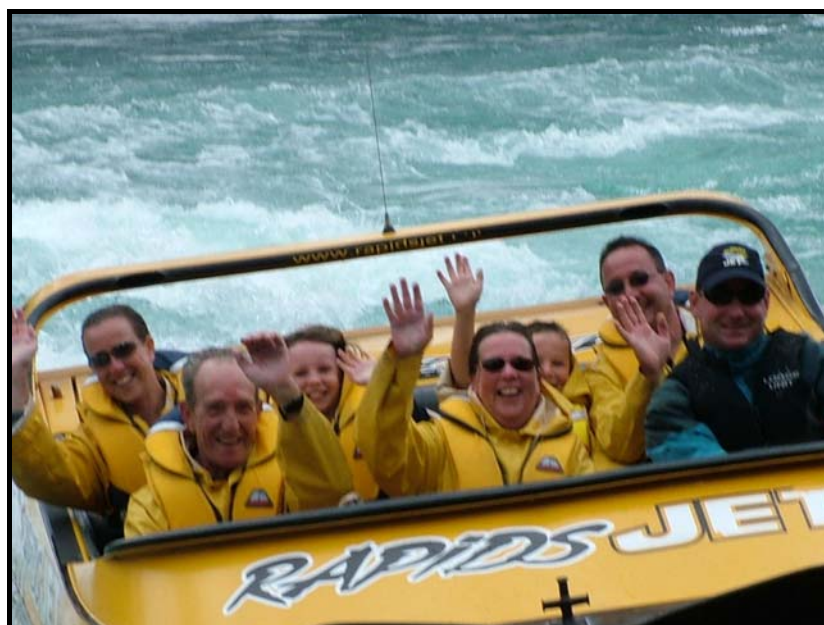
PHOTOGRAPH 1

On 21 November 2004 at approximately 1100 hours New Zealand Daylight Time (NZDT), the jetboat *Waima* was travelling in the Fulljames Rapid on the Waikato River with six passengers (4 adults and 2 children) on board (*See Photograph 1*).

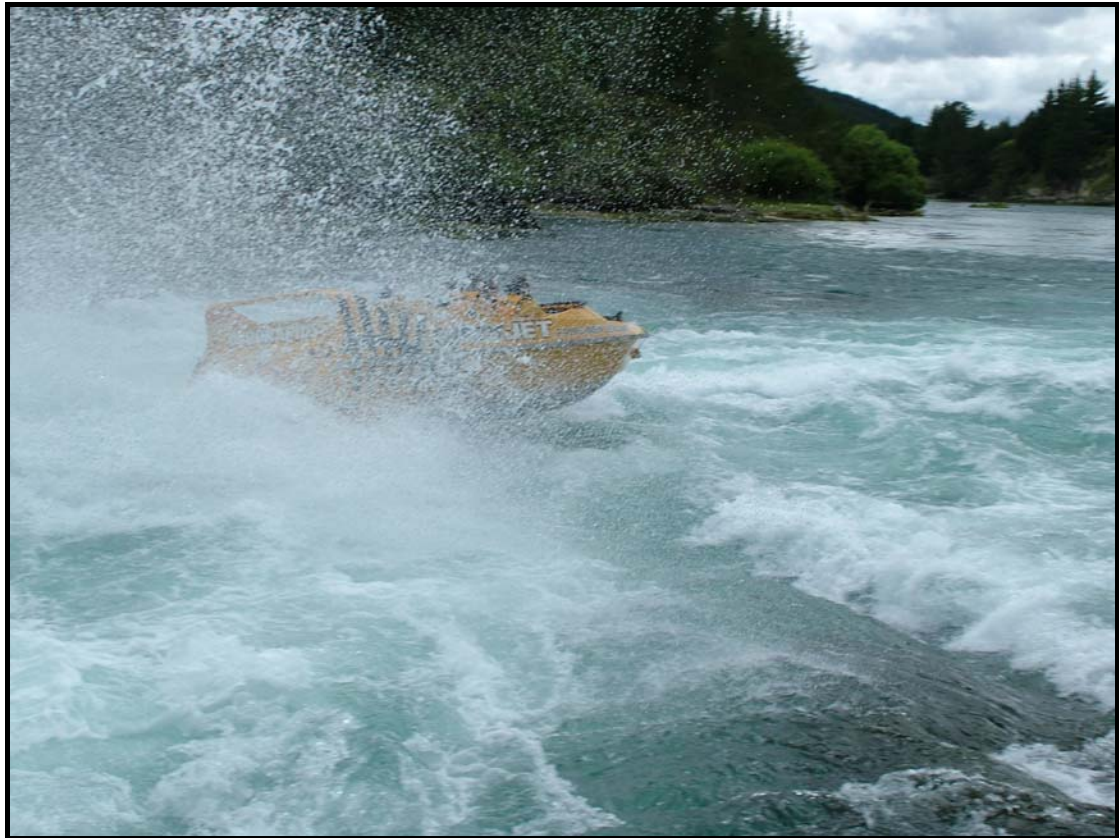
PHOTOGRAPH 2

On the 5th and final drive through the rapid's, Passenger One, who was seated in the front with her husband, next to the driver, jarred her back (*See Photograph 2*). She immediately alerted the driver to the injury. The vessel was stopped and idled to shore. The driver radioed the Safety Officer who was at the Fulljames Rapid, advising her of the injury. The Safety Officer called 111 for ambulance assistance. *In commenting on the draft report, an interested party stated that Passenger One was very insistent about wanting to sit in the front seat. So much so that she asked the office receptionist twice whilst making payment for the trip and again after the Safety Briefing Card had been read. Whilst the passengers were putting on their lifejackets, Passenger One again requested to sit in the front seat. The driver judged Passenger One and her husband to be fit and strong enough to do so. In further comments, the interested party also stated that Passenger One seemed to be enjoying the trip and having no problems whatsoever. The trip would have been going for approximately 20-25 minutes before the injury occurred.*

It appears that Passenger One did not take enough of her weight onto her legs as the vessel travelled through the rapid, causing the injury to her spine. *In commenting on the draft report, Passenger One stated that the report presumes that she did not take her weight onto her legs. The first four runs up and down the river were fine. The speed was fine and the rapids were exciting. On the penultimate run, the vessel travelled much faster and went up in the air much higher, hitting the water harder. At this point, Passenger One was going to say something to the driver, but did not want to be a "party pooper". Passenger One's daughter was also concerned as the children on board at the time were being thrown upwards on impact with the rapids and had stopped laughing. Her daughter indicated to her husband to hold the children tighter and reassured her 10 year old daughter that it would be the last run. The driver then stated that they would do one more run to get some spectacular pictures. The vessel then increased its speed which made the vessel hit the rapids much harder. On this last run, the vessel sped towards the rapid and Passenger One braced herself as instructed, but left her seat as the vessel went into the air. She hit the seat hard causing her spine to take the full impact. Passenger One and her family, who were all on board at the time, felt this would have happened regardless of how much they braced their bodies, as they had been hitting the rapid harder each time and the vessel was faster. Passenger One's daughter also pointed out, in commenting on the draft report, that the children's feet did not reach the floor, so how could they have braced themselves as instructed. The children nearly came out of the boat and possibly would have done if Passenger One's daughter and son in law had not increased their hold on them as there was no safety belt.*

In future, all older passengers will be seated at the rear of the vessel to reduce the risk of injury when encountering pressure waves. The Operator has altered his SOP to reflect the above action and has conducted driver meetings and front staff meetings to minimise the risk in future.
