Class B Accident Report

**West Bay Water Taxi
and Kontiki
Collision**

Picton Harbour on 14 November 2004

REPORT No: 04 3602

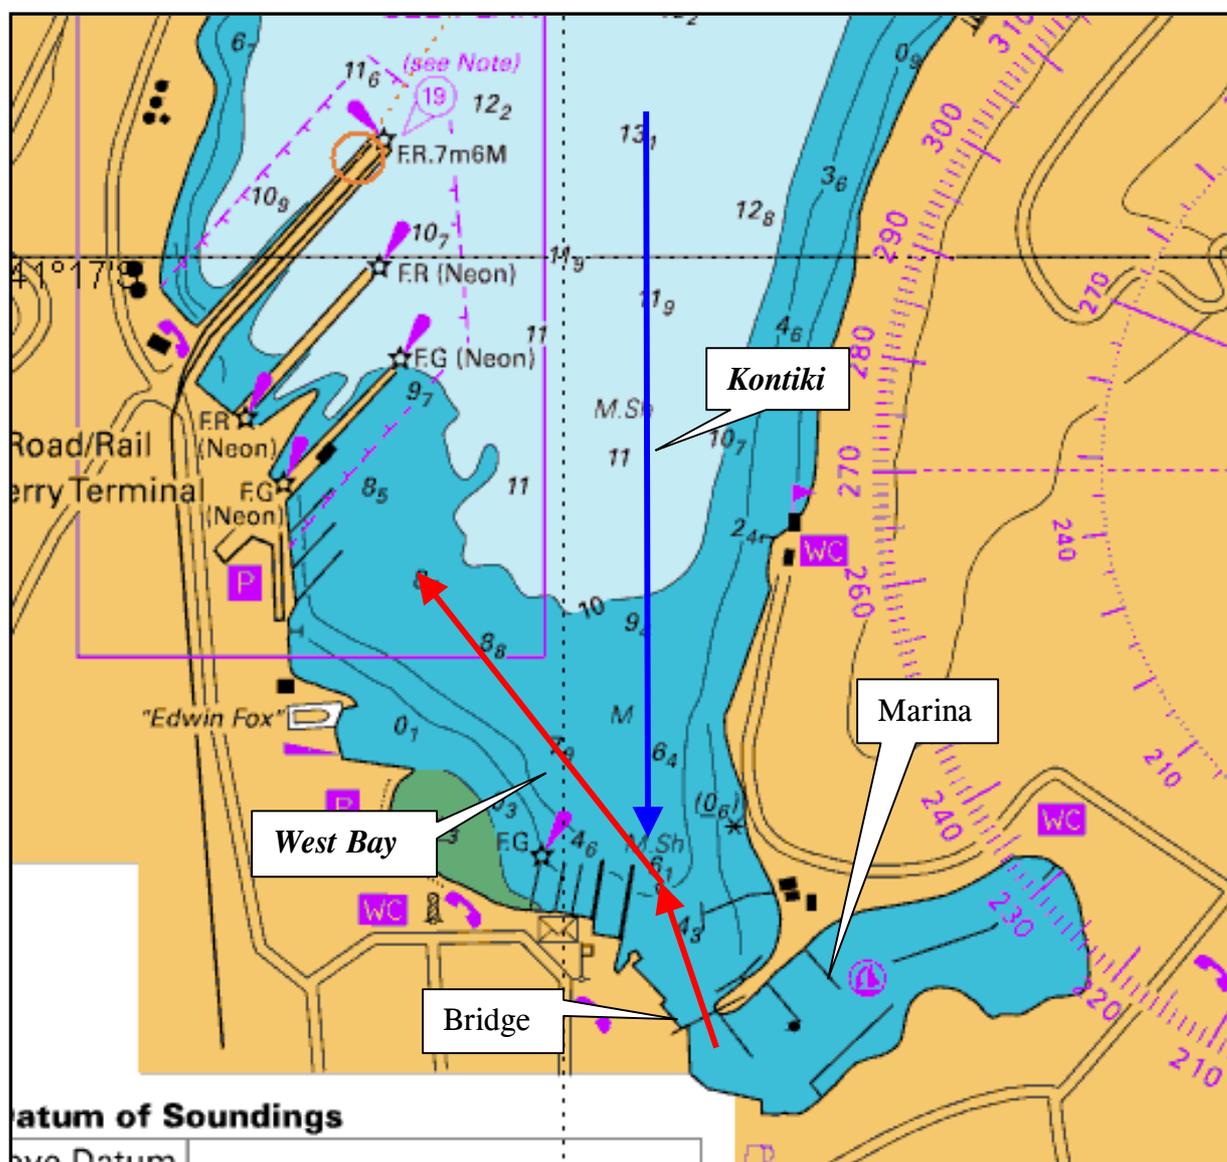
APPROXIMATE COURSES AND POSITIONS OF *WEST BAY* AND *KONTIKI*

On Sunday 14 of November 2004 at about 1501 hours New Zealand Daylight Time (NZDT), *West Bay*, whilst exiting Picton Marina at a speed of about three knots, collided with the pleasure vessel *Kontiki*.

West Bay exited the marina at three knots. When the Skipper reached the end of the town wharf, he altered course to port towards his berth at the ferry terminal. He was looking at his passenger whilst answering a question when he suddenly looked up and saw *Kontiki* for the first time, about five metres off his starboard beam.

Kontiki observed *West Bay* exiting the marina. *West Bay* was the give way vessel. The Skipper was expecting her to alter course to starboard around their stern. The Skipper of *Kontiki* started to veer to starboard, as he was unsure whether *West Bay* would give way. At this stage *Kontiki* was about 40 metres off the marina breakwater.

The Skipper of *Kontiki* could see that the Skipper of *West Bay* was not looking ahead; he appeared to be talking to the passenger beside him to his left. When the two vessels were about 20 metres away from each other he realised that *West Bay* was not going to give way so he put his engine astern to avoid collision. The engine then stalled.

Kontiki hit *West Bay* head on at about one knot and then rode up her starboard side midships pontoon.

The Skipper admitted to not seeing *Kontiki* as he was answering a question from a passenger at the time. By failing to see *Kontiki* the Skipper of *West Bay* failed to keep a proper look out in accordance with Maritime Rule Part 22 5- Lookout:

It is recommended that the Skipper of *West Bay* be censured for failing to keep a proper lookout and subsequently endangering life and property.
