LESSONS LEARNT
BY ACCIDENT

LOOKOUT!

SEPTEMBER 2007 ISSUE SIX

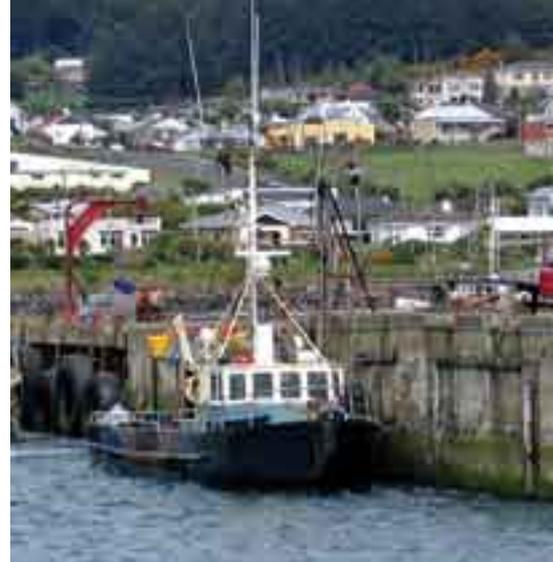
▲ BY STRETCHING OUT IN THE CHAIR, THE WATCHKEEPER COULD CANCEL THE WATCHKEEPING ALARM WITH HIS TOES.
▲▲ THE FISHING VESSEL REQUIRED REPAIRS TO THE PROPELLER, RUDDER SHAFT, TAIL SHAFT AND HULL.

2. As the high level alarm never activated, the watchkeeper must have cancelled the low level alarm several times with his toes during the time he remained asleep.

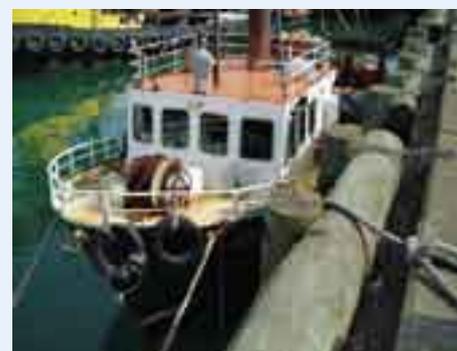
▲ THE FISHING VESSEL. ▲▲ THE FISH HOLD DID NOT HAVE A SUITABLE ACCESS LADDER.

2. The vessel always berths on its port side for unloading, and the freezer truck crane always operates into the port side of the fish hold. The skipper should instruct crew to enter and exit only via the starboard side of the fish hold to minimise the likelihood of obstructions below and unloading hazards above.

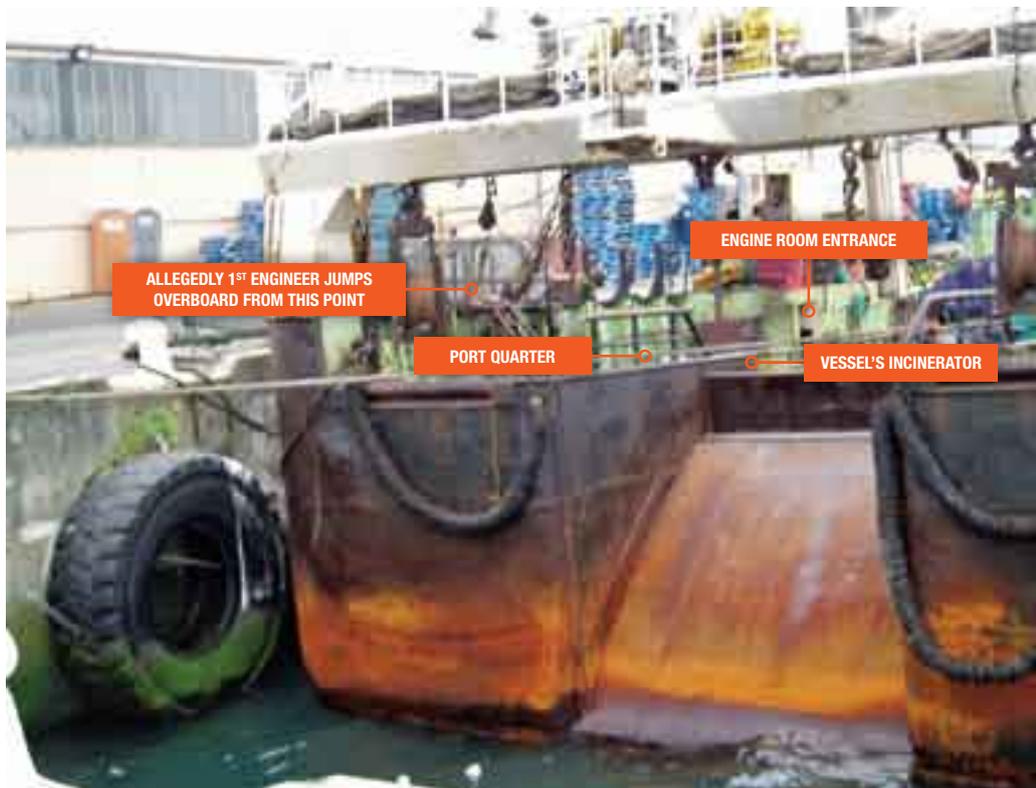
An explosive fire broke out, while using the oxygen/acetylene equipment, trapping the two injured men on the port quarter of the vessel. The first engineer suffered burns to his right arm and face, and the second engineer's clothes were set on fire. Both jumped into the sea to extinguish the flames.

▲ THE CHIEF, 1ST AND 2ND ENGINEERS WERE UNDERTAKING REPAIRS TO SOME HYDRAULIC PIPING ON DECK, AT THE PORT QUARTER OF THE VESSEL, ADJACENT TO THE TRAWL RAMP AND GATE.
▶ THE FISHING VESSEL.

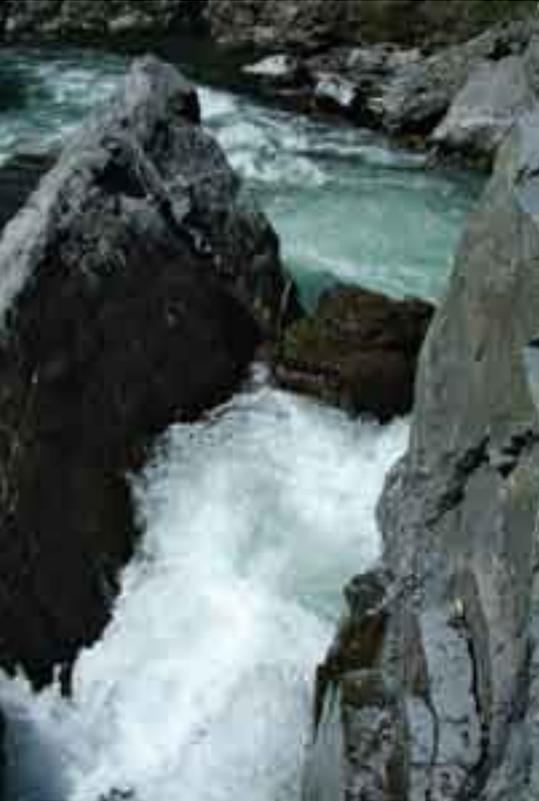
THIS IS HOW THE CHANNEL LOOKED AT THE TIME OF THE INCIDENT, HOWEVER, THE ROCK ON THIS RIVER IS PRONE TO FREQUENT EROSION AND CHANGE AND THE SIEVE IS NOW GONE.

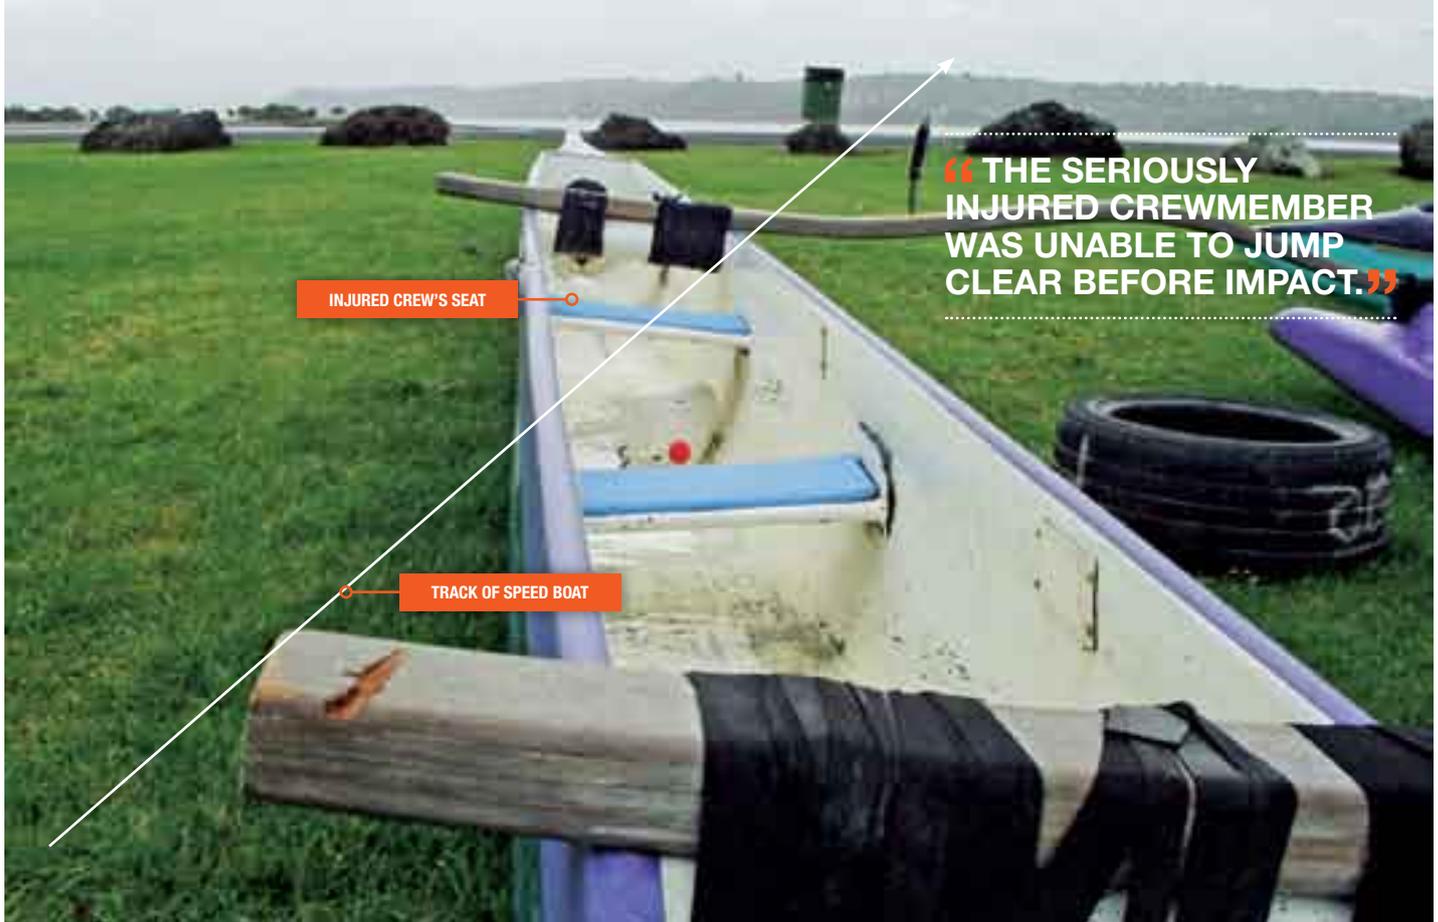
THE SPEED BOAT HIT THE WAKA JUST AFT OF AMIDSHIPS.

The speed boat rode over the waka and came to rest on the other side. It is believed that some of the serious injuries inflicted were caused by the speed boat's propeller.

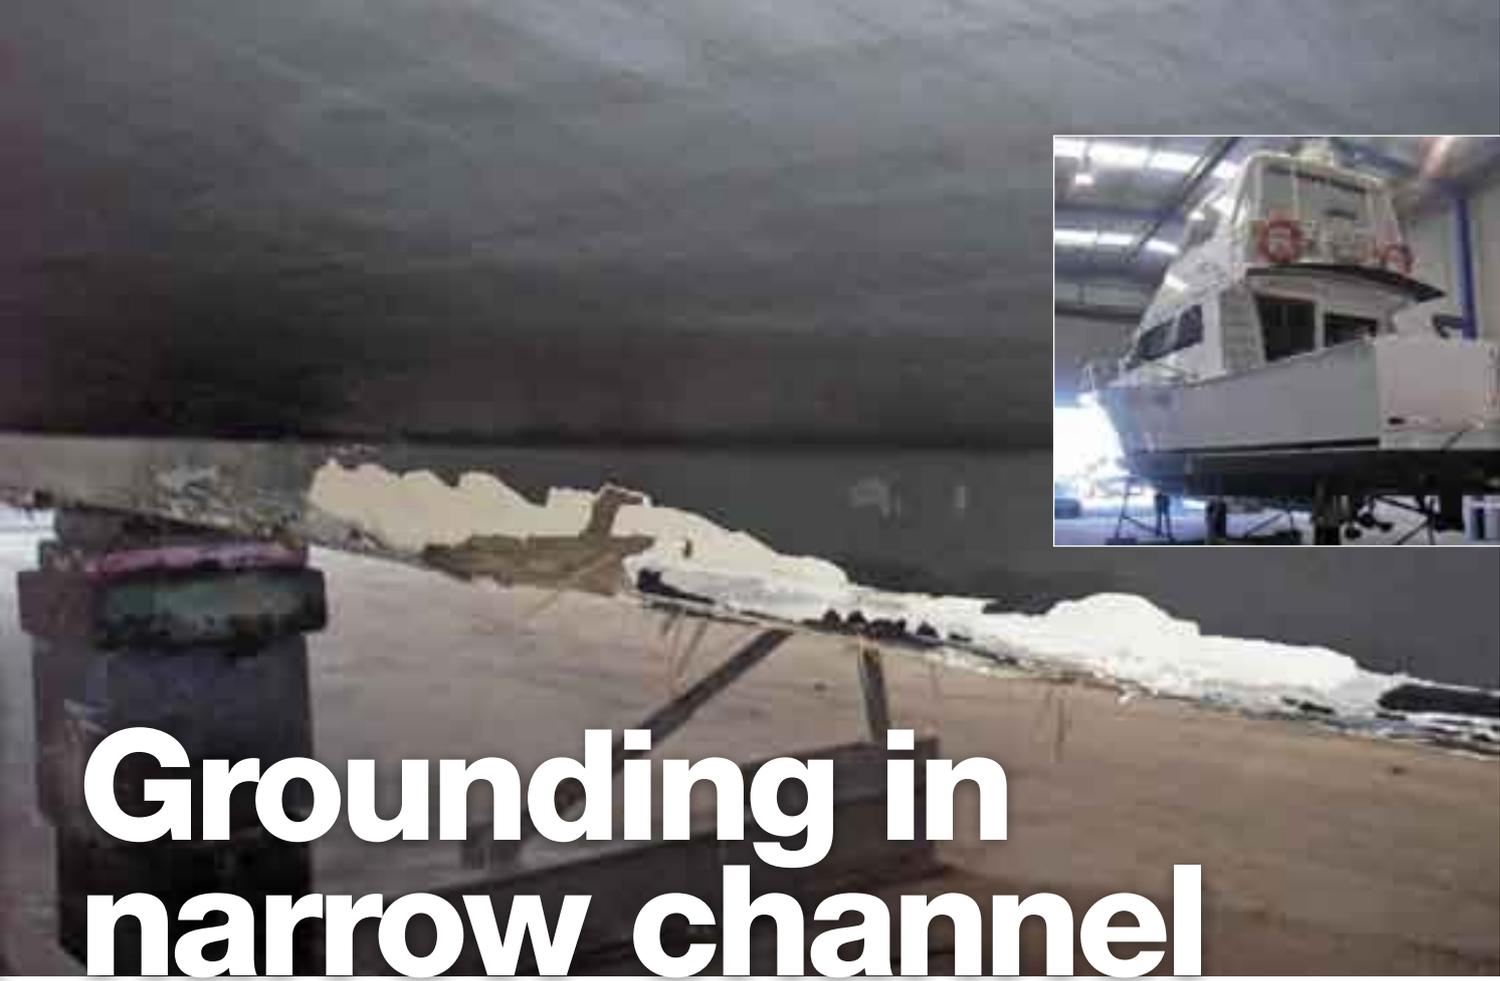
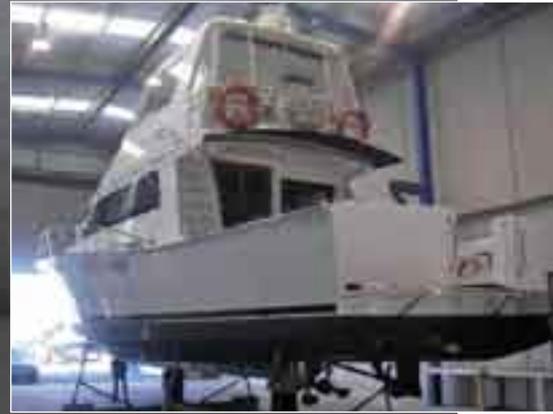
▲ THE VESSEL SUFFERED SEVERE DAMAGE TO ALL RUNNING GEAR.
▲▲ THE KEEL.

It was later determined that the rudder had protruded through the hull. The vessel suffered severe damage to all running gear. Propellers, rudders, shafts and struts were replaced and both gearboxes were removed for servicing.

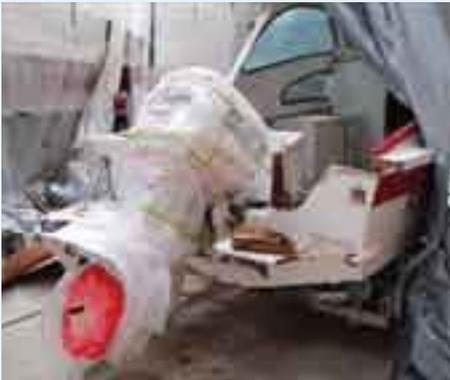
▲ DAMAGE TO THE TRANSON OF THE PLEASURE BOAT.
 ▲▲ THE CHARTERED FISHING VESSEL.

All three were uninjured thanks to their quick decision to jump for safety. The fishing vessel struck the pleasure boat causing extensive damage including internal structural cracks, a damaged transom, loss of the auxiliary outboard engine, damage to the gearbox and bilge pump, and the loss of personal items including fishing rods and a wallet.
