LOOK LESSONS LEARNT *BY ACCIDENT* OUT!

THIS ISSUE A rescuer's story **04** Runaway boat risks lives **05** Fish processing workers suffer frostbite **06**
Serious 'slip-up' on slipway **08** Safety feature: Be safe be seen – swimmers, snorkellers, divers, spearfishers and boaties **10**

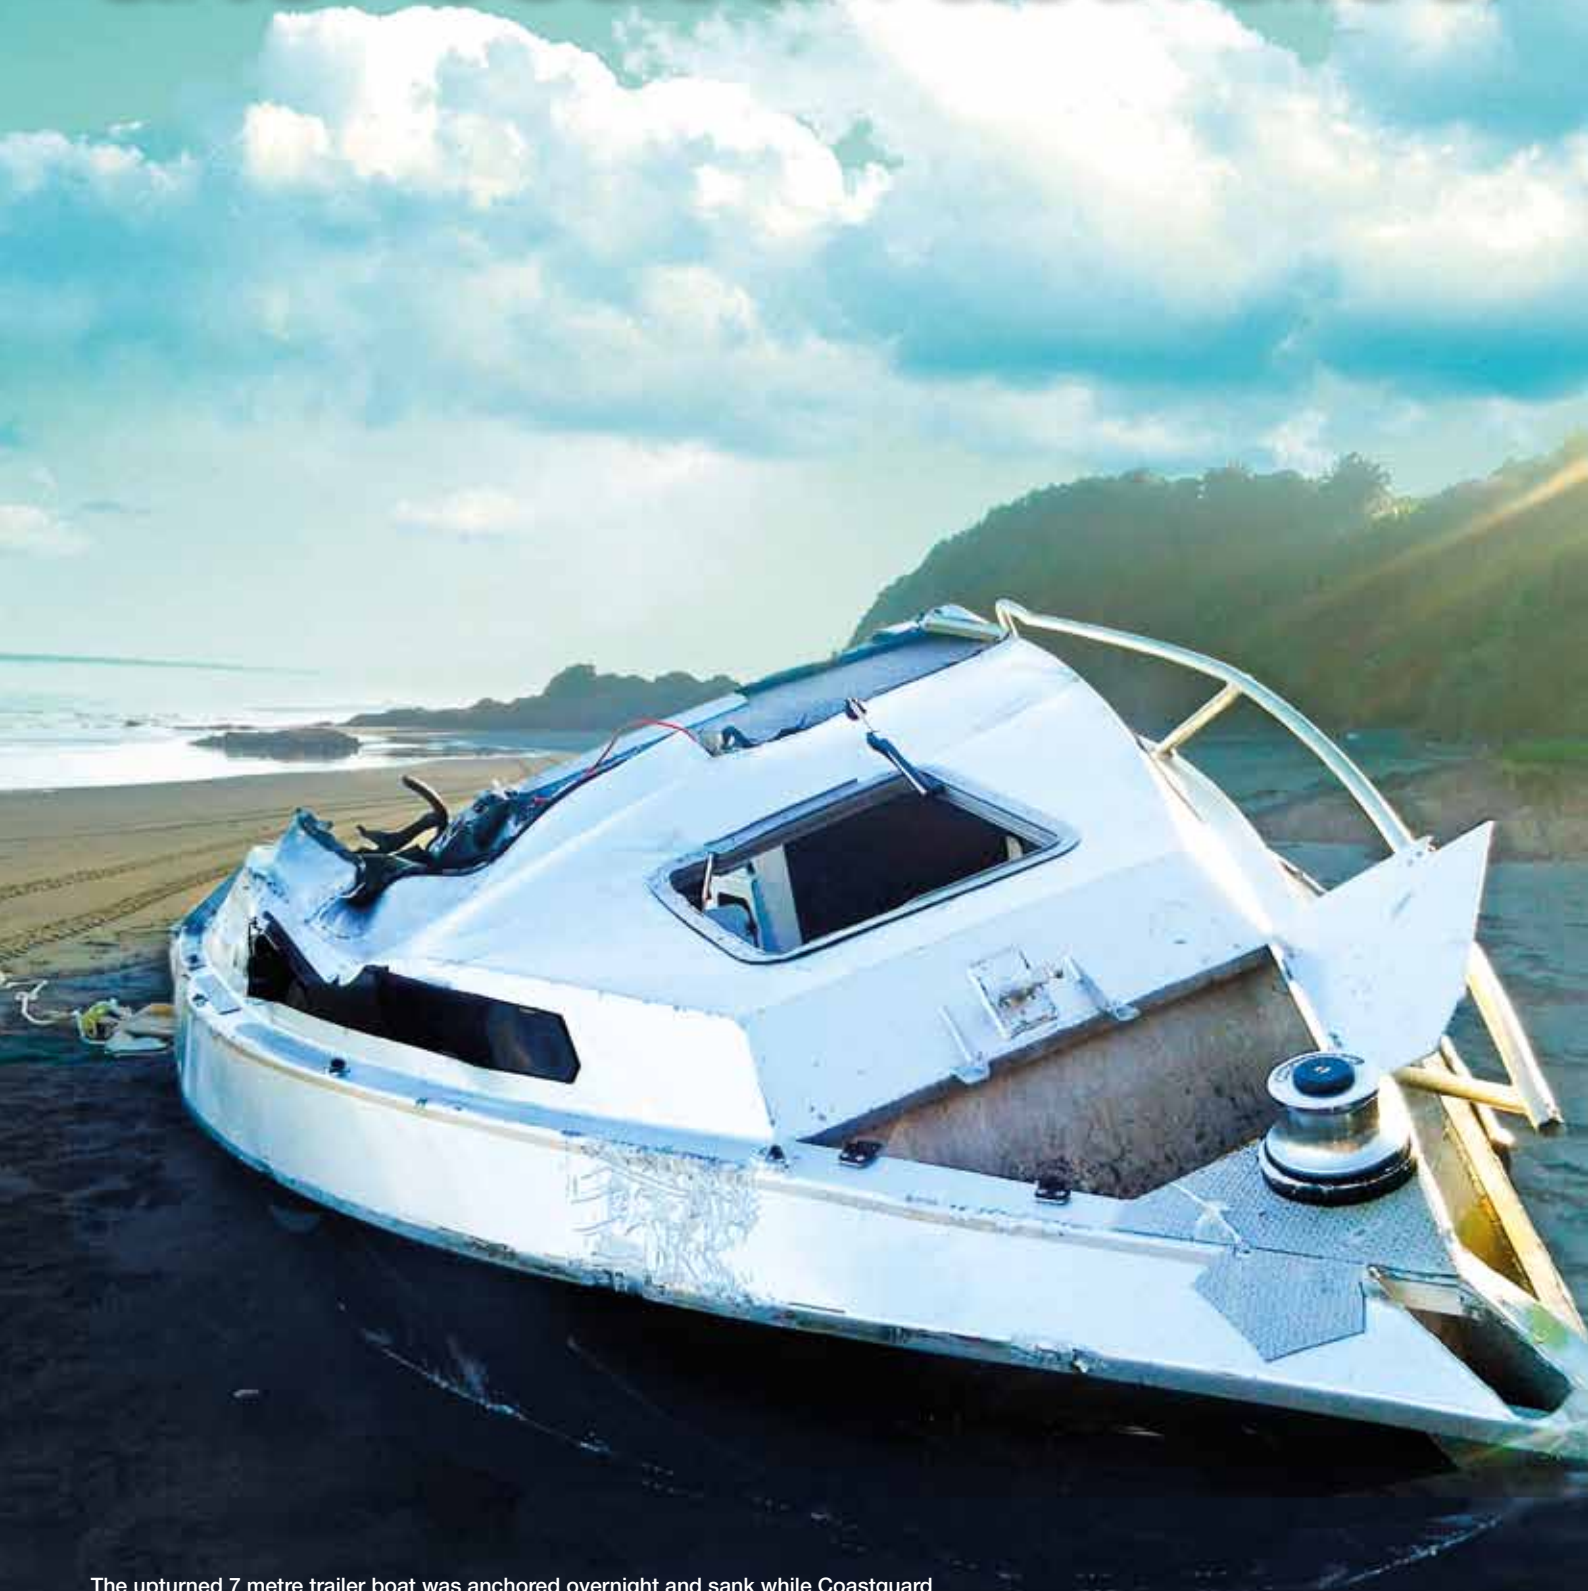
The upturned 7 metre trailer boat was anchored overnight and sank while Coastguard was attempting to retrieve it the following morning. It was later recovered.

When they returned to try once more to uplift the snagged anchor, they tied the anchor warp to a cleat on the transom and the short length to a nearby handrail. The skipper revved the motor to try to free the anchor from the stern but the cleat gave way and hit one of the

The skipper then throttled back and went aft to cut the rope, but the boat was swamped and turned upside down within seconds.

■ Retrieving a snagged anchor is a potentially risky situation and it would have been prudent for all on board to have been wearing lifejackets while they were attempting to do this. The men's attempt to retrieve the anchor by pulling it up from the stern, using the boat's engine, is likely to have caused the swamping.

Using the boat's engine caused the anchor rope to act like a bungee – when revs were lowered, the tension in the rope pulled the vessel's stern down under the water. The stern platform then acted like a giant scoop, flooding the vessel's stern. The rapid water ingress is likely to have dramatically affected the vessel's stability, causing the capsize.

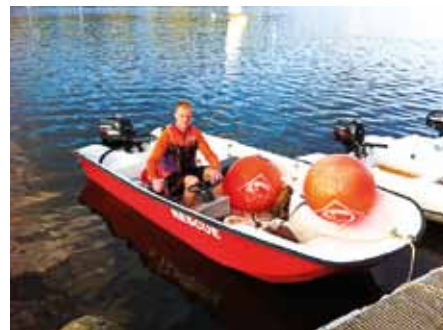
A sailing club member with course marks in the patrol boat that had the accident.

■ A fault was also identified that may have contributed to the seriousness of the incident. Other club members who had used the patrol boat had noticed that it had a tendency to turn

when the wheel wasn't held. An examination of the steering correction trim tab found that it was angled in the wrong direction. The club was unable to determine why or how the tab had been moved.

■ Had there been two people in the boat, as the club rules required, the incident would have been unlikely to occur. A second person would have been able to take control of the boat and prevent it accelerating and turning abruptly when the skipper fell. If events had occurred too quickly to prevent the man being thrown from the boat, a second person could have quickly brought it to a stop.

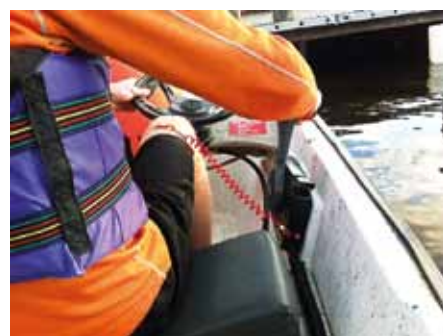
A sailing club member with a cut-out cord attached to his leg.

■ The incident is also a clear example of the value of people on motor boats wearing a kill or cut-out cord, which stops the engine when the operator falls overboard or away from the motor. A lanyard (short piece of cord) extends from the engine shut-off switch on the tiller to a clip designed to be attached to the operator's body. When the operator falls overboard or away from the motor, the lanyard tightens and pulls out the ignition shut-off switch, cutting the motor off and causing the vessel to stop.

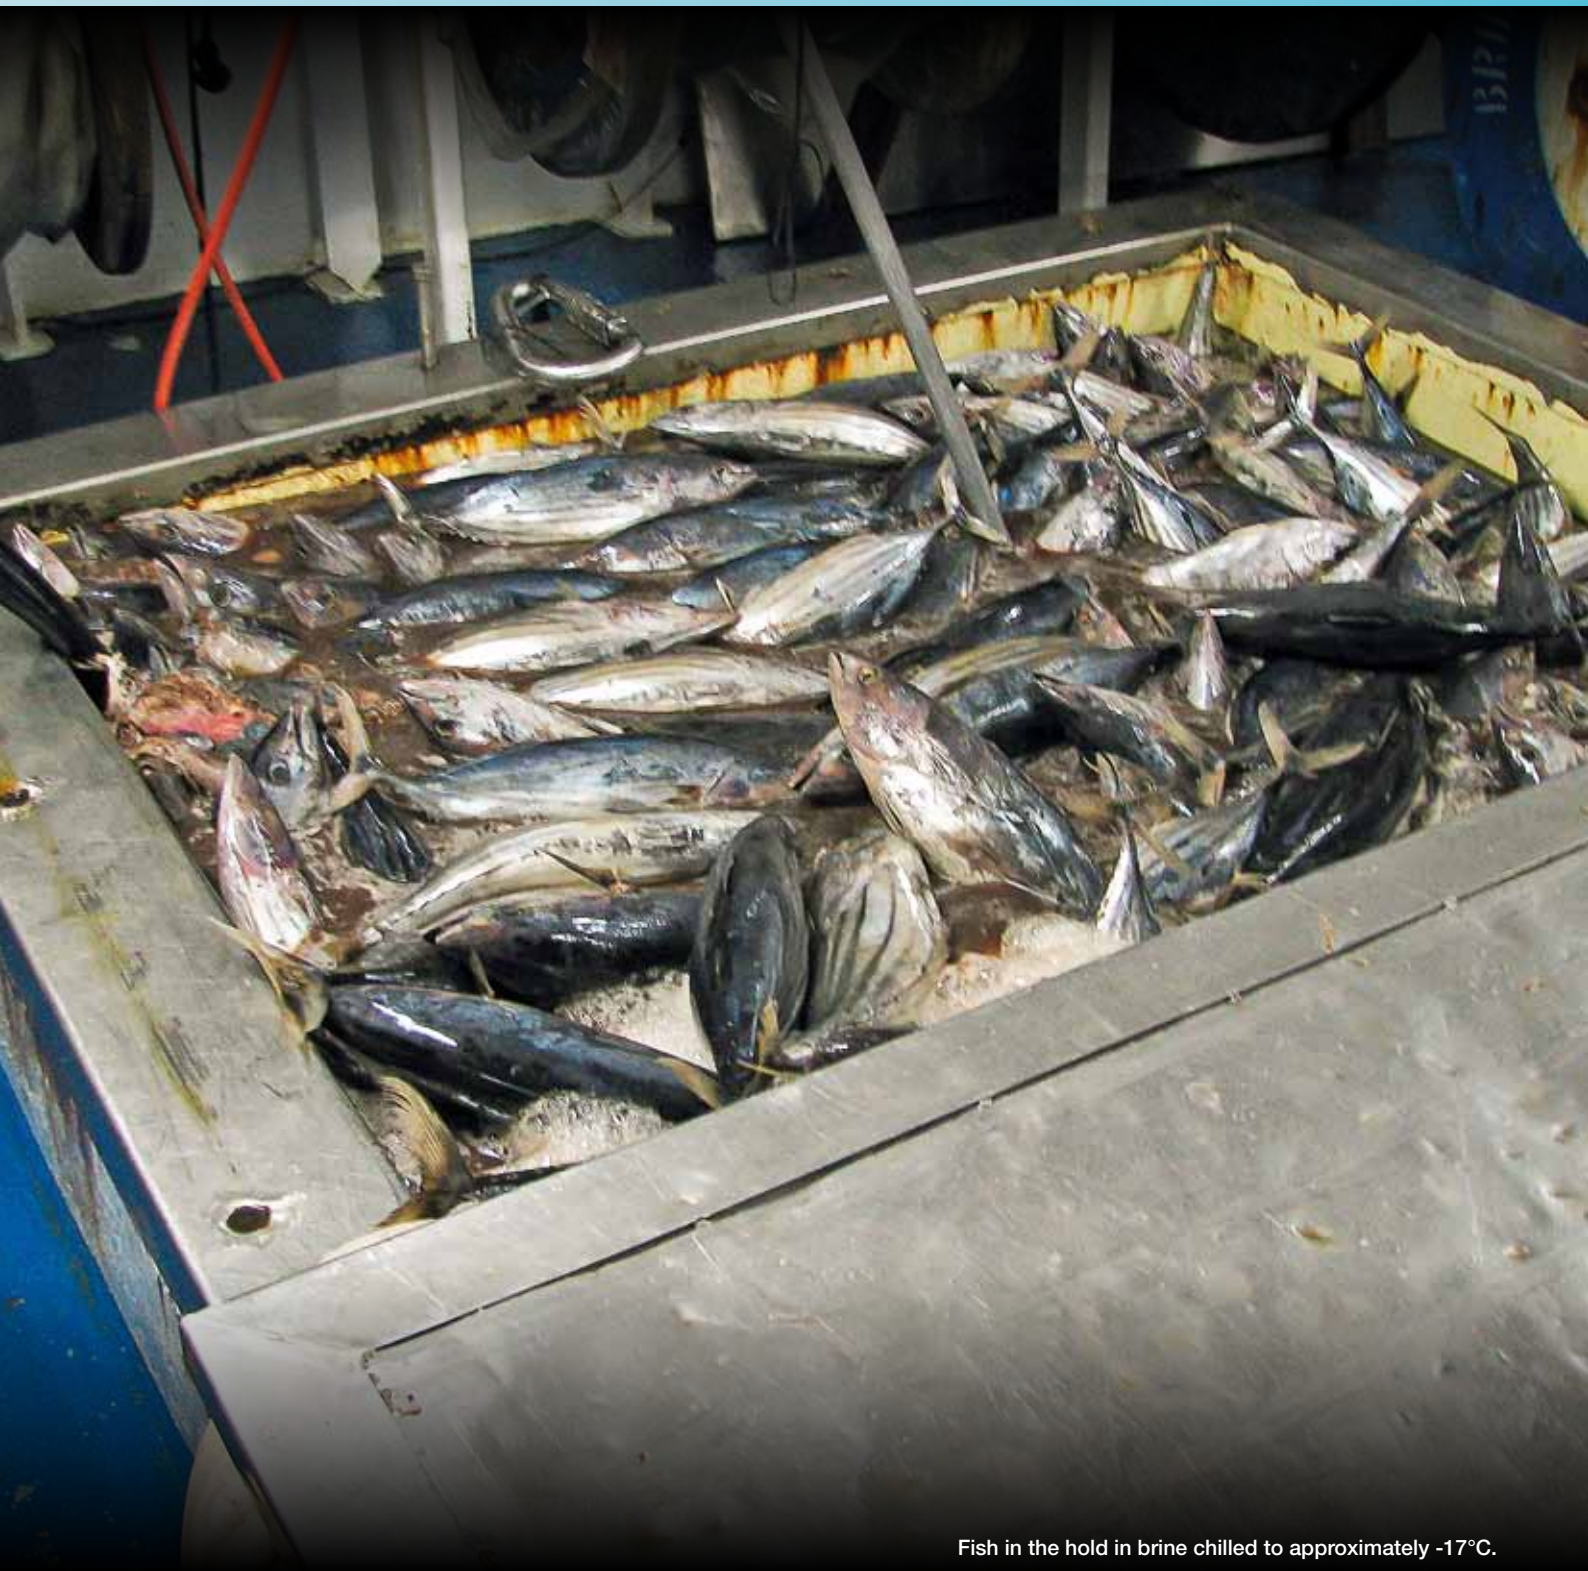
Fish in the hold in brine chilled to approximately -17°C .

On the same day two employees, both with minimal experience, suffered from frostbite while unloading fish from the holds of a purse seine vessel. The holds had been filled with brine and chilled to approximately -17°C . In the fish processing process, chilled brine causes the fish to float to the surface, where they can be manually loaded onto conveyor belts.

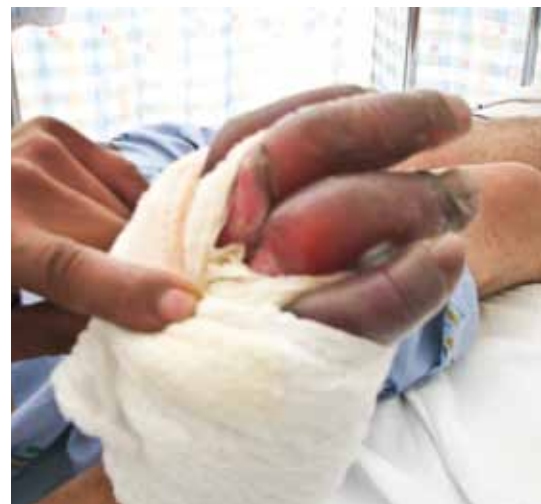
He noticed that his right hand had gone hard, and when he removed his glove at lunchtime, two of his fingers had gone black. The employee then notified his supervisor who immediately arranged for him to be transported to hospital where he was diagnosed as having frostbite. He was hospitalised for two and a half weeks.

His fingers remain swollen and stiff, with the joints locked in a fixed position. He must continue to wear compression garments, and is likely to have permanent limited mobility in the four fingers. His treatment is ongoing.

The first employee suffered serious frostbite and his treatment is ongoing.

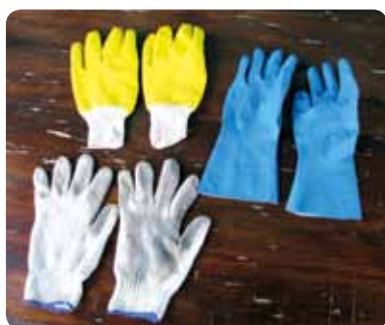
- All employees received a pair of thin rubber gloves and cotton glove liners, as well as other waterproof clothing. Both employees suffered frostbite as a result of working with their hands in extremely cold brine.

Both had also torn their gloves on fish spikes, which allowed brine to get into their gloves. In the first case, the employee obtained a new pair of gloves and, in the second case the employee put on a second pair of gloves.

Neither of these actions provided adequate protection from the cold. Just providing safety equipment is not sufficient – all practicable steps must be taken to mitigate or eliminate the hazard.

Actual gloves used.

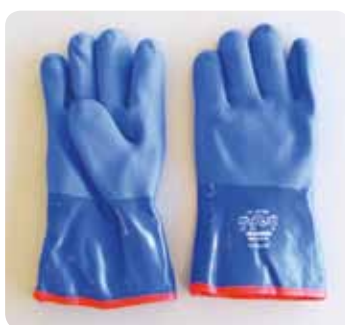
Recommended minimum gloves.

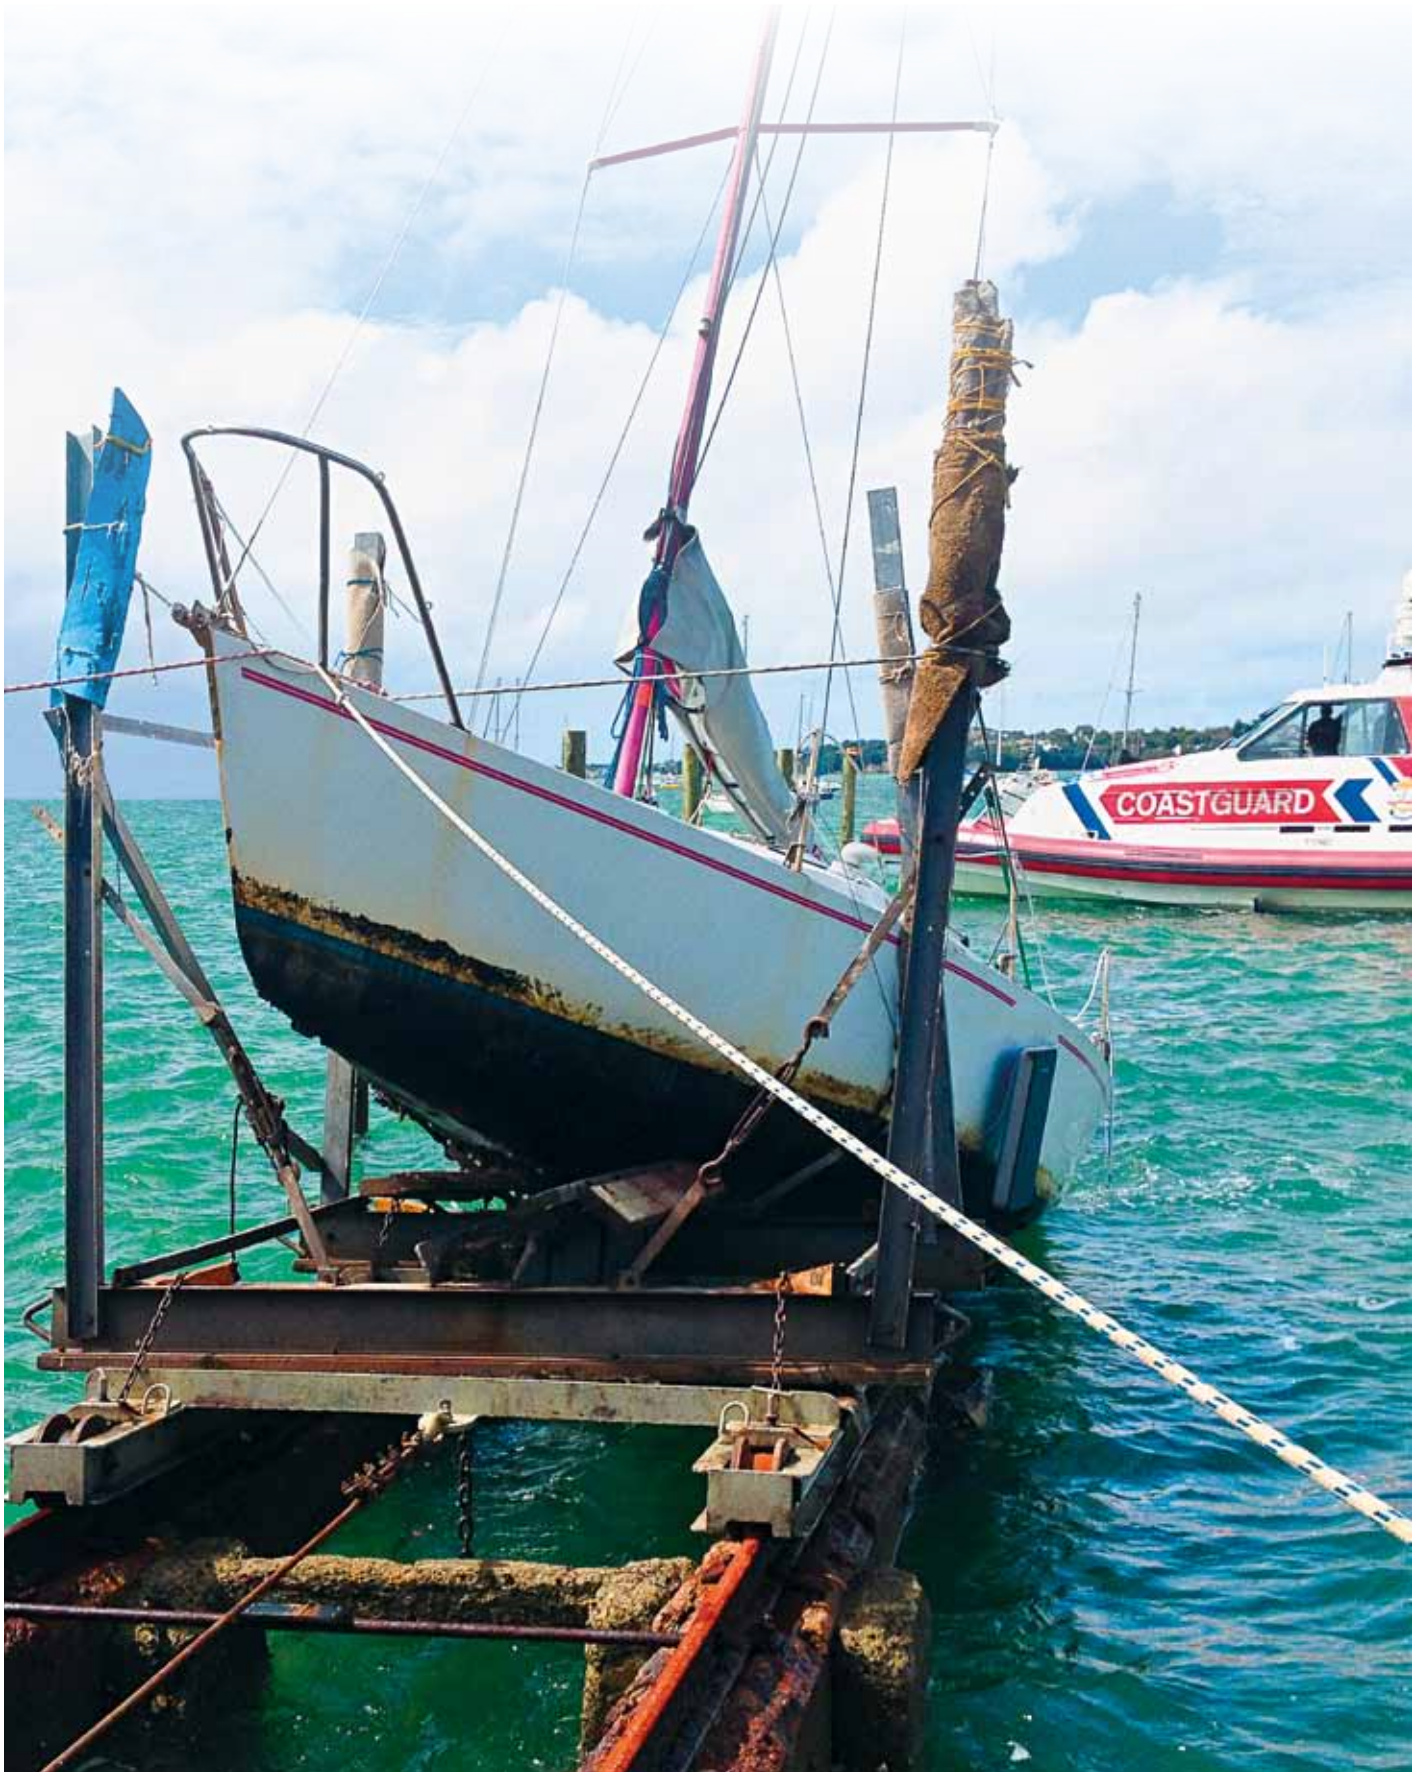
Three men were injured when they attempted to slip a yacht.

As the men attempted to secure the yacht to the cradle, the winch operator started hauling without warning. The yacht immediately tilted up at an angle of 45 degrees as the keel slipped backwards. The winch operator had assumed the vessel's keel design was similar to another type of vessel with a longer keel, but this was not the case.

As the hauling continued, the yacht's bow rose higher, before dropping suddenly, which caused the keel to fall off the cradle entirely. All three men were sent into the air. One came down on the bollard on the bow, smashing his femur in two places, and another slid down the deck and broke two toes. The third man went over the side but fortunately managed to hold on. He suffered extensive bruising.

- All slipways need to give clear guidance to yacht owners before they slip their yachts. Terms and conditions, including health and safety requirements, should be agreed and signed before slipping vessels. Boat owners should be briefed on how to secure vessels to a cradle, and on yard safety procedures.
- Keel design and shape need to be confirmed with the slipway, so that the most appropriate cradle can be used. This is vital to stop vessels falling off cradles. In this instance, the cradle was not appropriate for the yacht.
- Clear communication procedures must be established before slipping a vessel (eg VHF radio or mobile phone).

- It is essential to have a team of experienced people on hand to assist with slippings. Manning levels in the yard and on board need to be appropriate to the task.
- Yards need to have a good working knowledge of their obligations under the Health and Safety in Employment Act 1992 – the society has obligations under the Act for the safety of yacht crews.
- Under the Marine Transport Act, both yards and vessel owners are required to report accidents/incidents to MNZ.
- Since the accident, the yard has extensively improved its safety and hazard management system, putting new in-depth procedures in place to ensure safer operation.
