**Official Information Act request: Report into *MV Aratere* Oil Content Meter Tampering Investigation**

# Memorandum

DATE 08 August 2018

OUR REF Aratere OCM

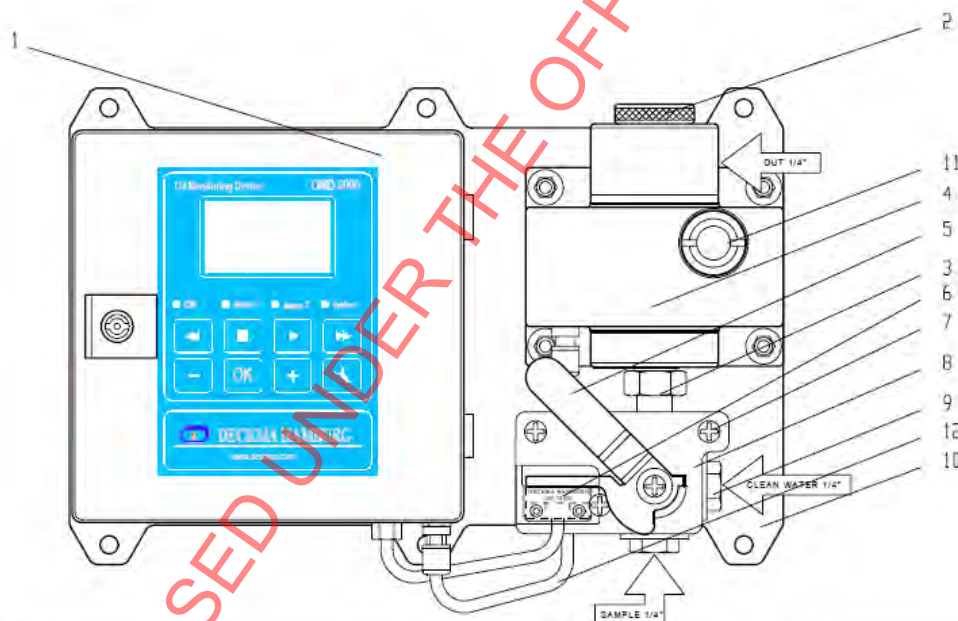
**Figure 1 Deckma OMD-2005 diagram.**

██████████ stated that Deckma advised him that the OCM was not malfunctioning and was working properly. Although the video appears to show that water is leaking from the head screw (#2 in Figure 1 above), Deckma apparently told ██████████ that it was pressure tested to 10 psi and was not found to be leaking.

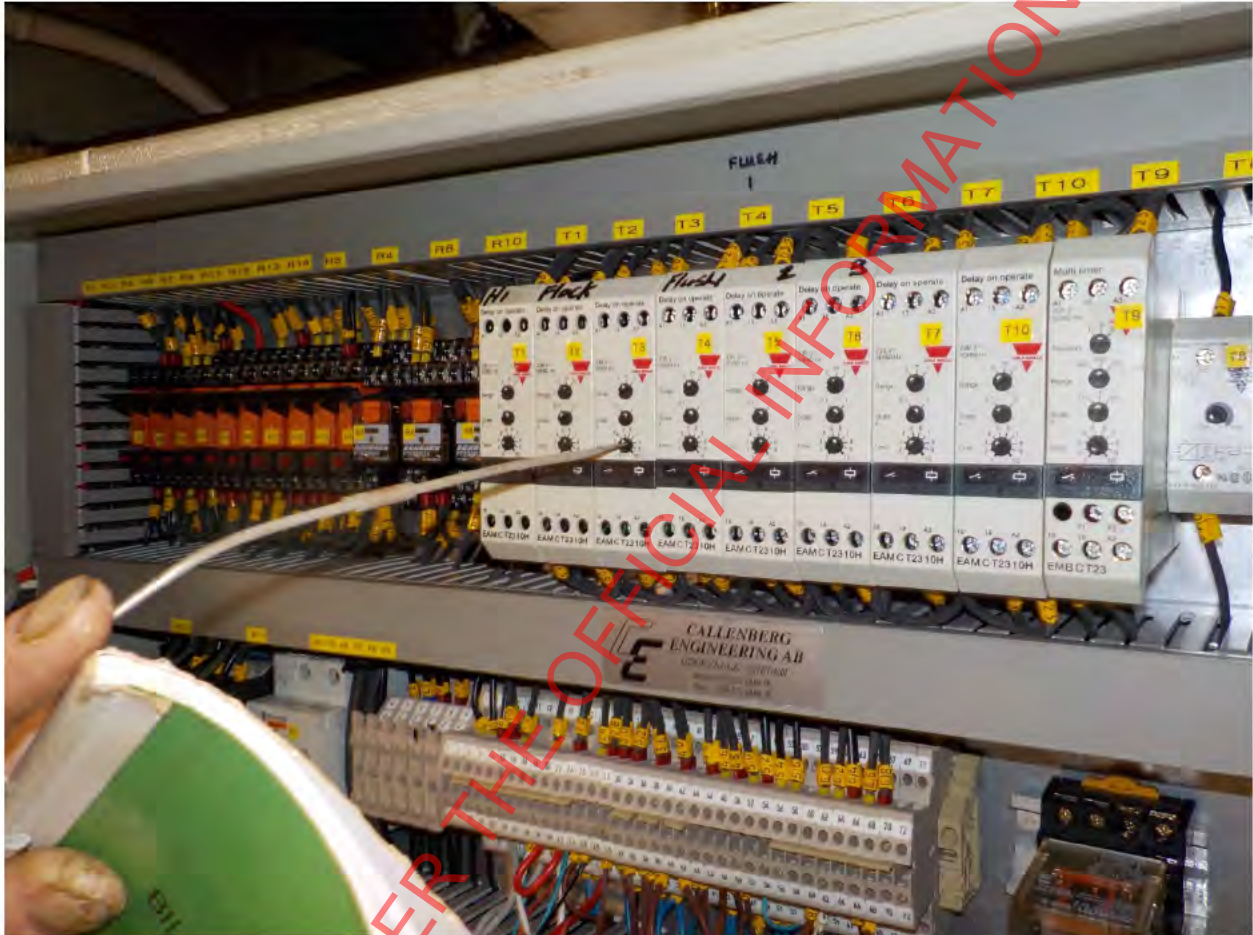
When [redacted] and [redacted] visited the vessel on 20 June 2018 the sealed cabinet was opened (with the approval of [redacted] Interislander Strategy Manager). A similar wire was found with insulation still on part of it. The insulation on the wire would NOT allow the bridging of the reed switch. It was found that the wire fit in the small screws found inside the cabinet. See Figure 3 below. These screws adjust the timing of the system.

Figure 2. Wire found in the sealed cabinet being used as screw driver for changing times on relays

5. The suspicious looking rod could have actually been used to turn the timing screws inside the cabinet to alter timings as needed.
6. The fresh water solenoid fitted for use for the previous OCM (but which remained in this system set-up) prevented the tricking of the system as described if the wiring on the vessel corresponds with the wiring diagram from the OWS manual according to [REDACTED]

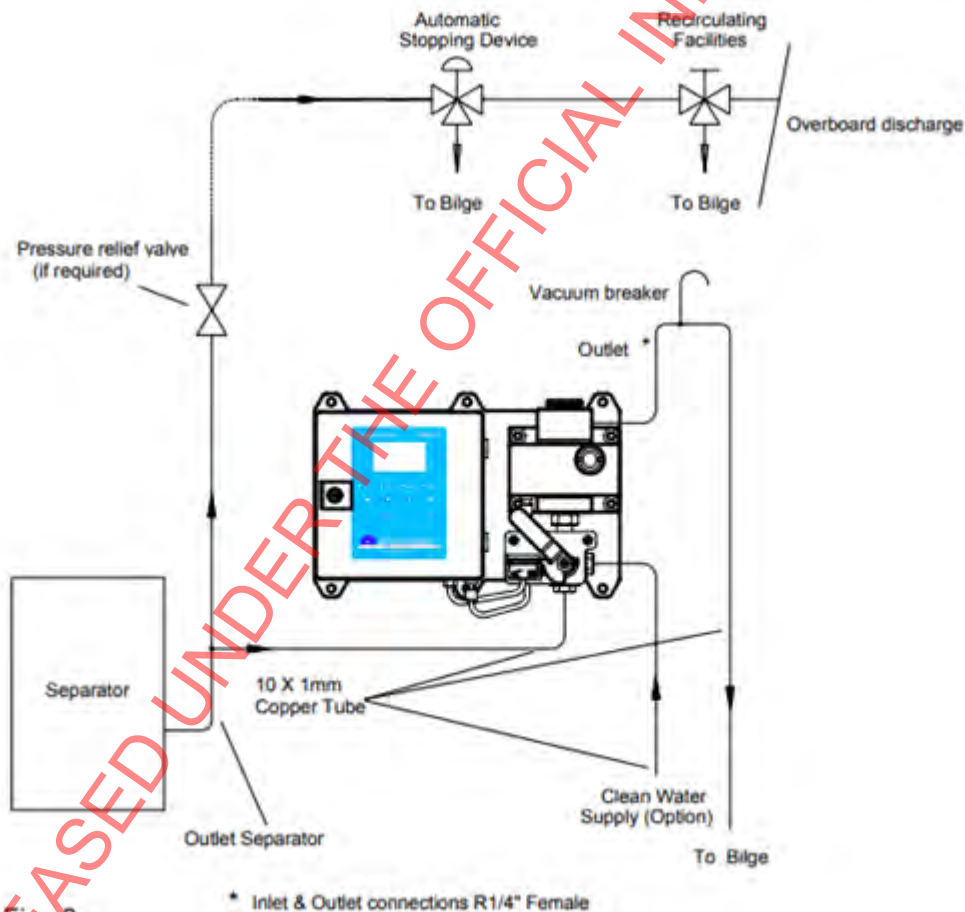
Also, it was brought to our attention that the OCM sample line had not been installed in accordance with the manufacturer's requirements. In the DECKMA OMD-2005 manual it states the sample point of the oily water separator should be located above the outlet of the monitor to ensure the sample cell is flooded at all times. It was determined the sample point on the Aratere is below the OCM. See Figures 3 and 4.

Figure 3. From the DECKMA OMD-2005 manual showing where the sample line should be installed

- If so, it is recommended that the valve be closed during operations. Before a new OCM is installed this should be tested to ensure there are no leaks. This is the most likely scenario on the face of it, but probably in conjunction with point 2. The OCM should also be mounted according to manufacturer's specifications.

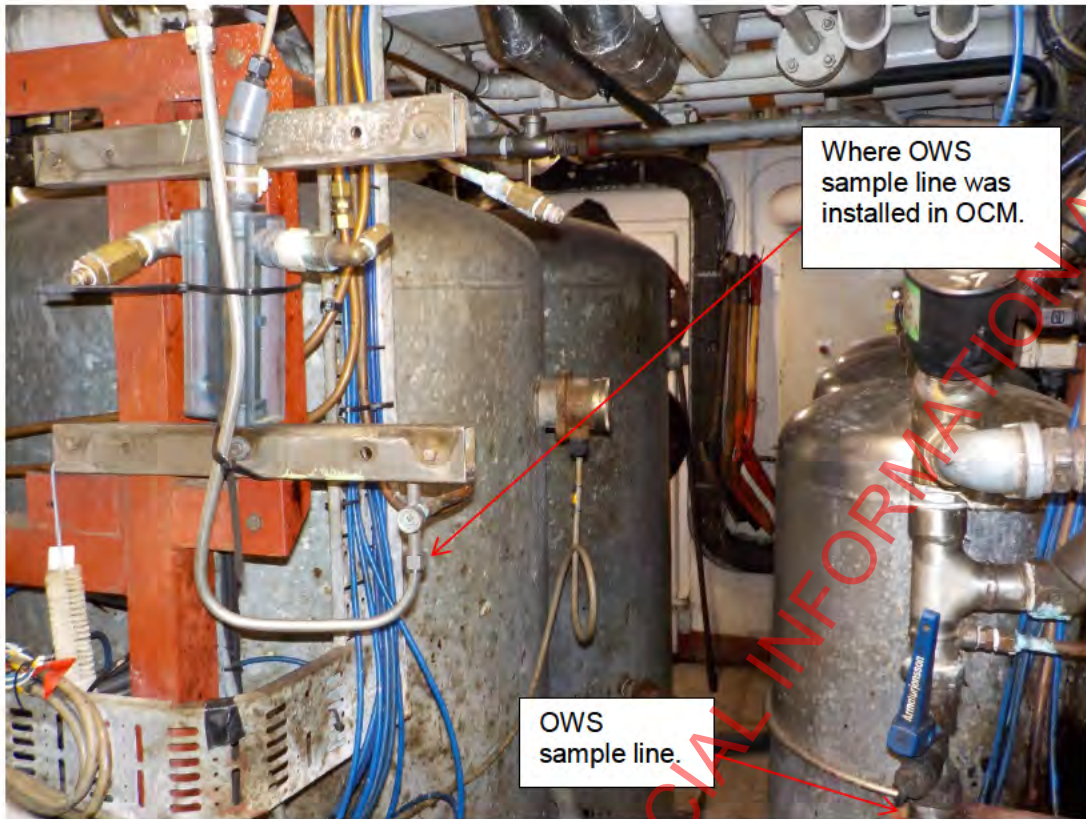
**Figure 4.** Showing location of where OCM was located and the OWS sample line location.

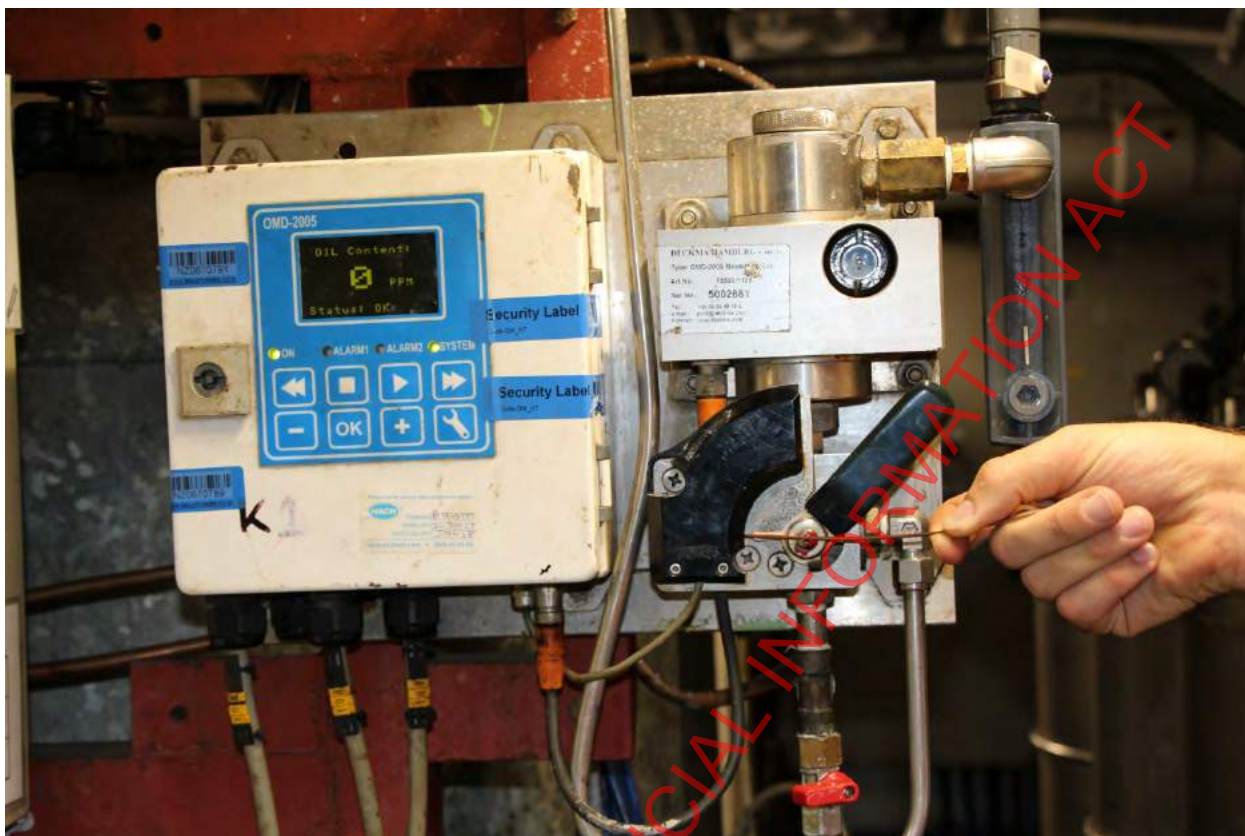
Figure 6

██████████ showed how by inserting a bare copper rod, flattened at one end into the gap between the valve plate and the handle he could 'trick' the OCM into thinking that (Figure 6) the OCM was getting the sample fluid from the discharge pipe when in actuality the fresh water flushing line was activated. If the copper rod was not inserted in this position the alarm would sound and send the OWS discharge back to the sludge tank. If the copper rod was inserted and then the fresh water flushing line was activated no alarm would sound.

Showing how the bare copper wire “tricked” the system into thinking the OWS sample line is supplying the liquid to the sensor when the fresh water sampling line is actually supplying the fluid to the unit.

The Deckma OMD-2005 OCM appears to be very easy to trick (on systems without a solenoid to prevent this). Inserting a thin wire with a flattened end into the gap next to the 3/2 way valve handle is one way, and there is anecdotal evidence to suggest that magnets will also trick the system. However, the fresh water solenoid on this system appears to prevent this from having any effect. The solenoid remained from a previous OCM/OWS arrangement, and in this particular setup prevents tampering of this nature.

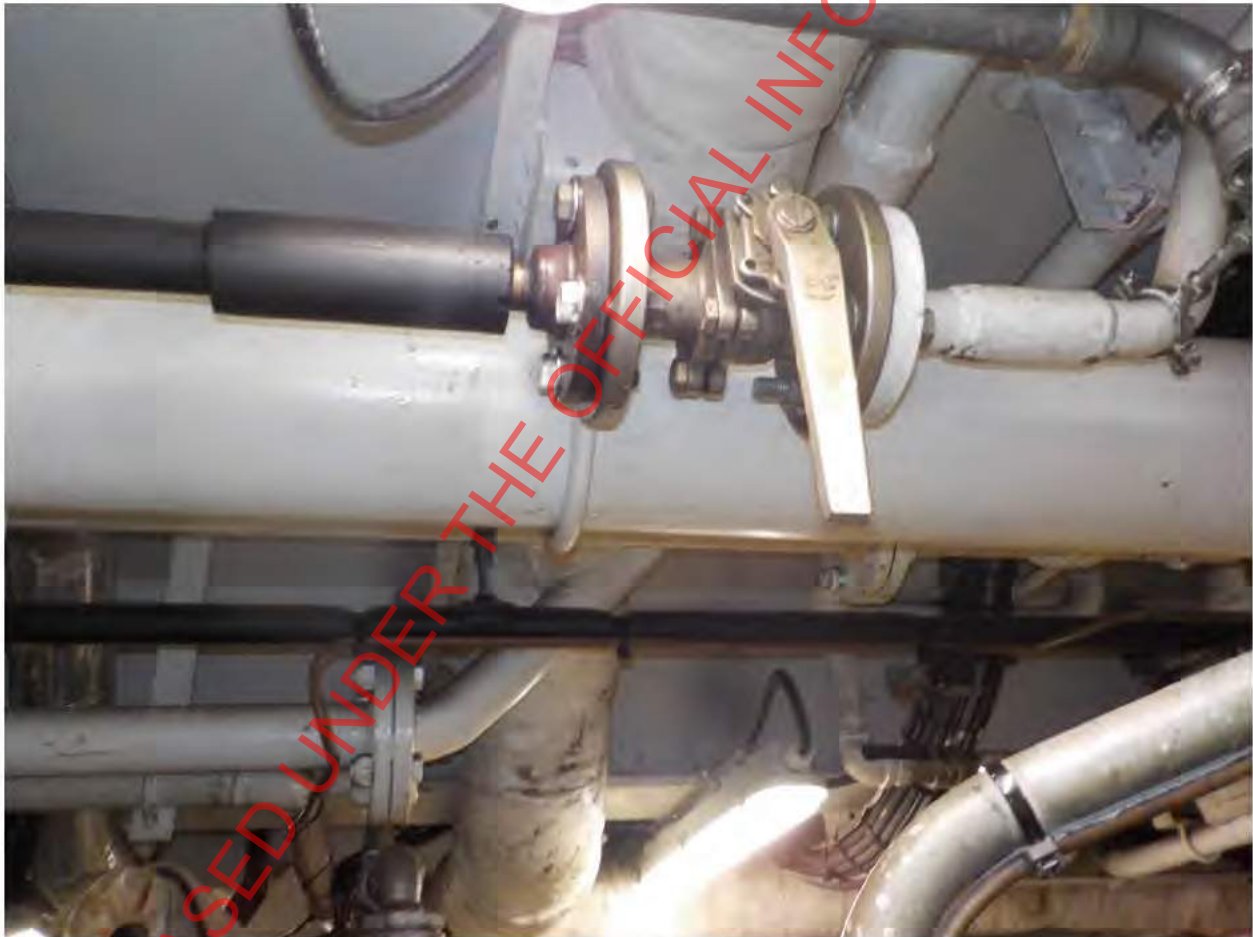
██████████ stated that he operated the system with the manual water supply valve (Figure 7 below) turned on and it appears ██████████' shift did not do this. If the OCM had a leak at the 3/2 valve this would mean that the ██████████ shift would unintentionally be diluting the OCM sample which could make the reading be zero. However, ██████████ showed the wiring diagram for the OWS system. If this is still how the system is wired, once the bilge pump for the OWS is started the fresh water solenoid is closed (this is a small valve right before the OCM (not the valve pictured below in Figure 7). Therefore, even with the manual fresh water valve open it would require changing the wiring or the failure of the solenoid AND a leak on the 3/2 valve inside the OCM.

Figure 7 The fresh water supply valve which feeds the fresh water flushing system on the OCM.

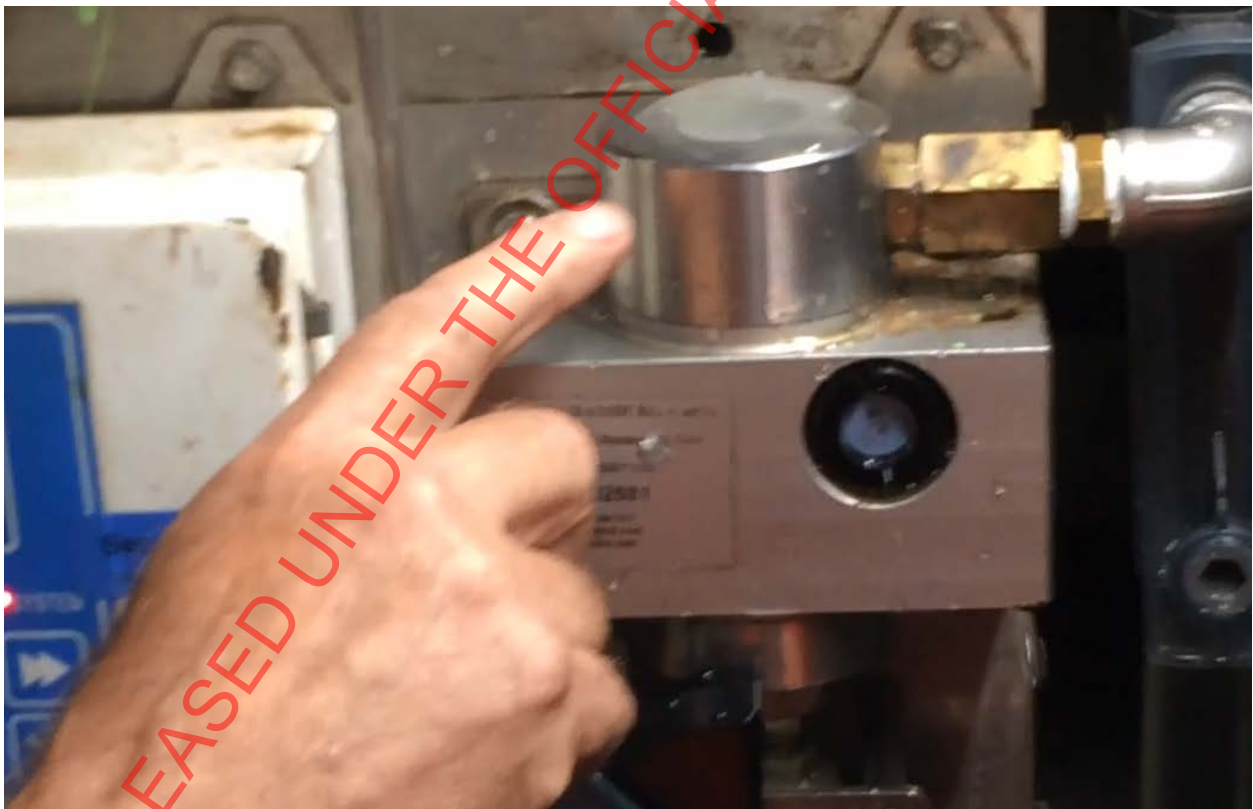
Figure 8

When [REDACTED] (Antelope – NZ service agent for Deckma) looked at the system on board he is heard on the video to say 'that valve's bugged'. His thoughts at the time were that water was pushing up past the valve, which it should not have done (Figure 8).
