Request for information about age and safety of ferries in Cook Strait

Safety and Maintenance Incidents Involving Inter-islander (KiwiRail)

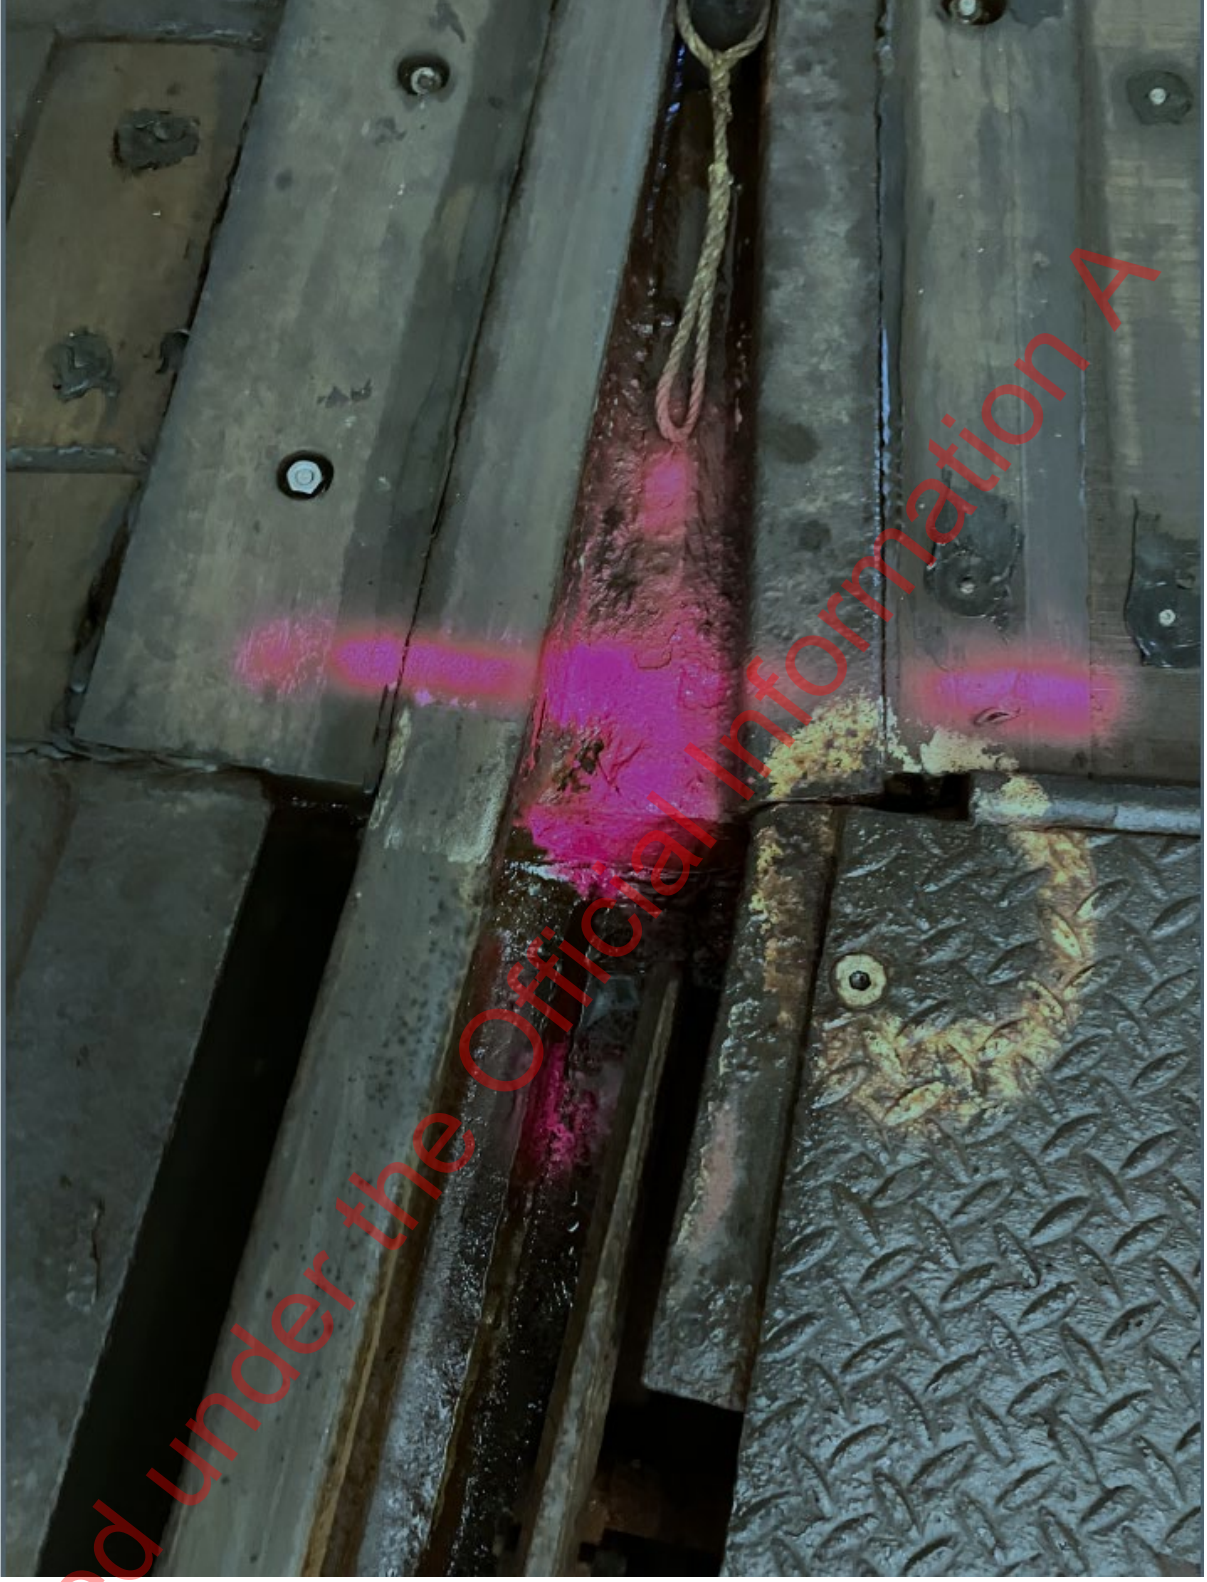
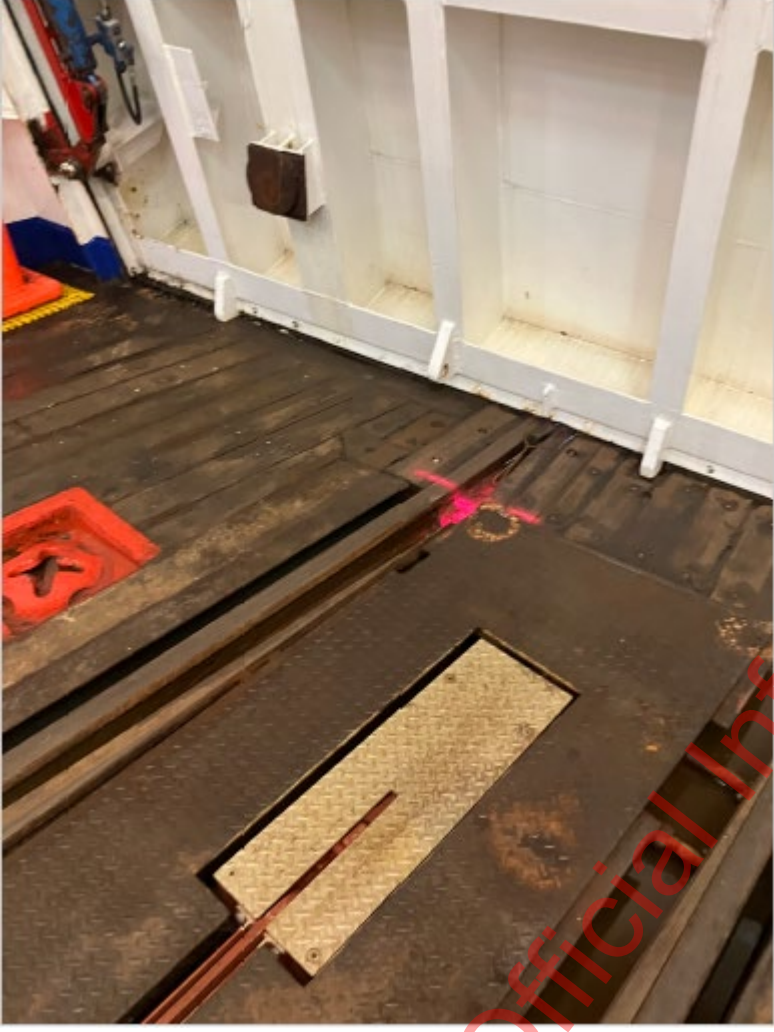
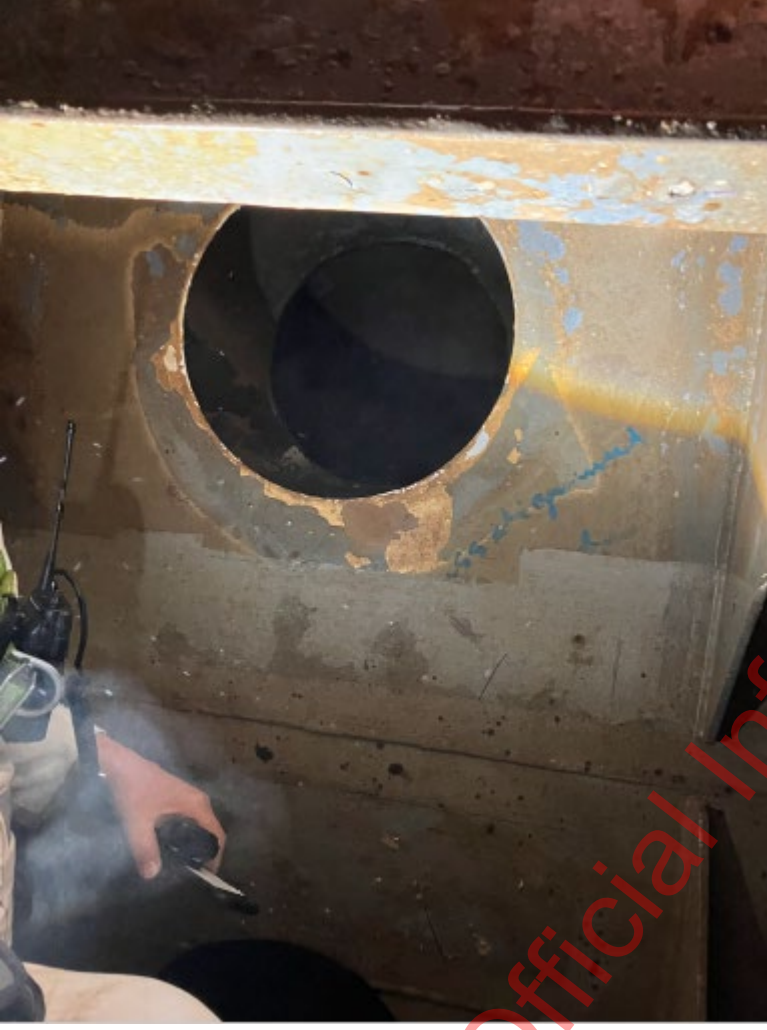
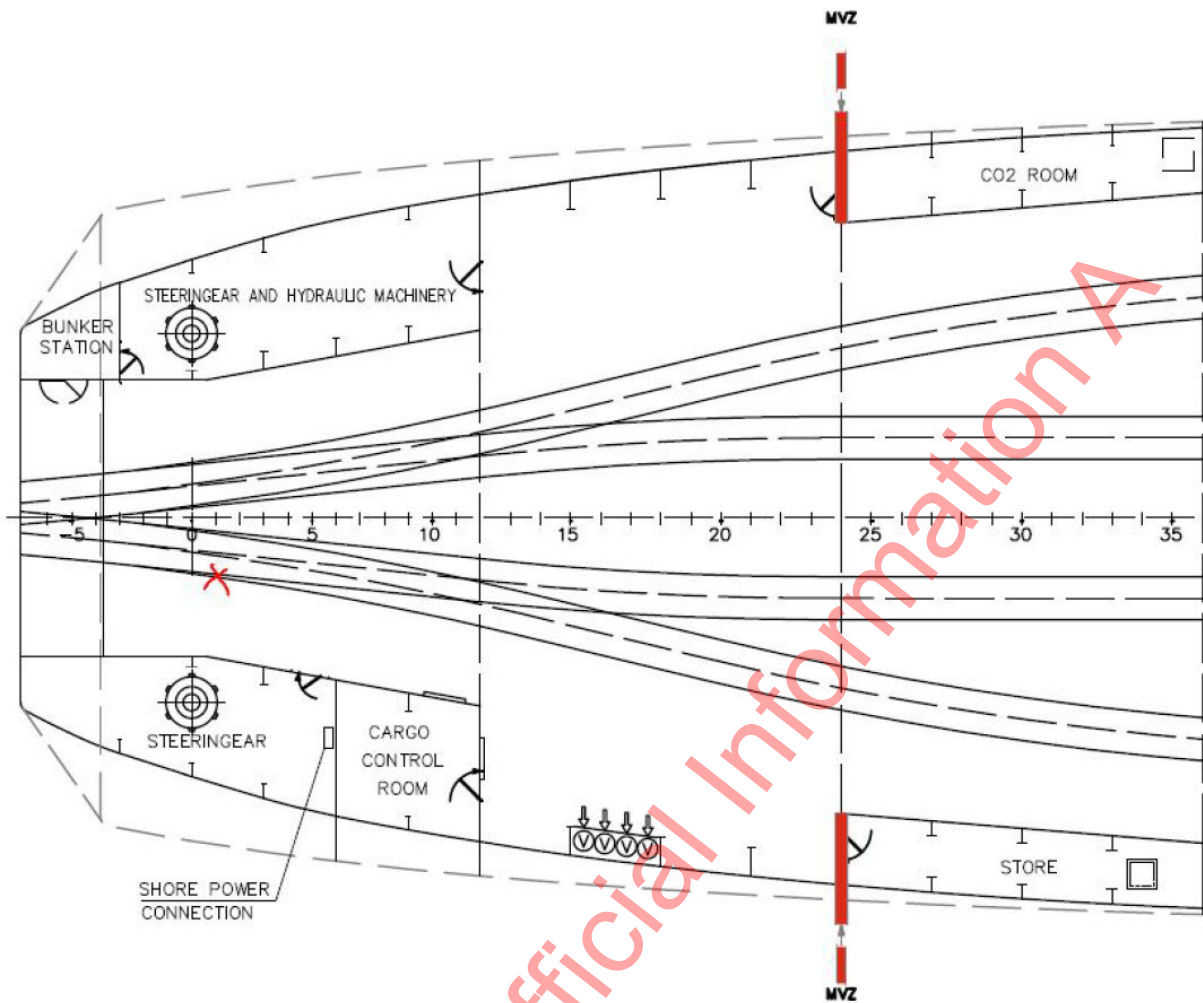
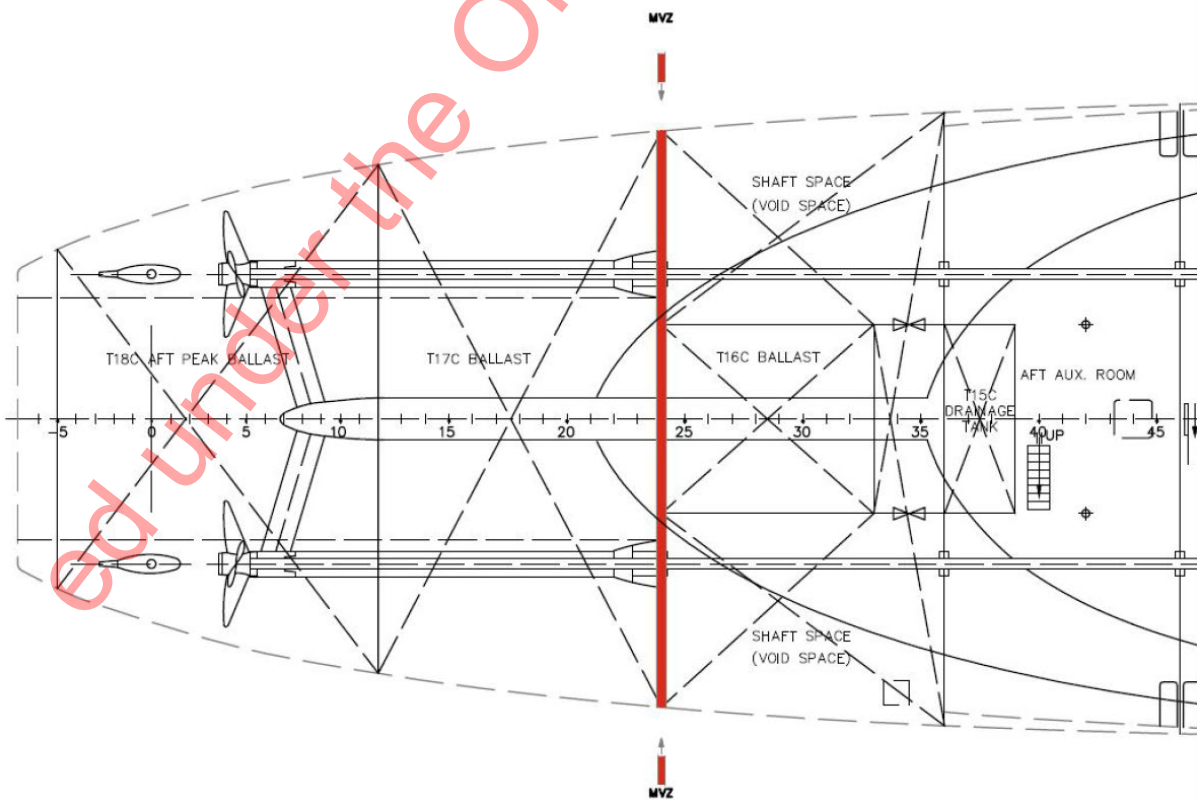
This is to report a small crack on Aratere tank top (refer GA snapshots for location). This crack develops from time to time on the tank top beneath the rail tracks .

Recently a minor crack was identified at the aft end of 18C tank top on the Starboard outer rail at approximately frame#1. Attached are photos and marked plan of the area.

Tank entry was made to assess the possibility of repair from below, unfortunately the access is extremely limited, there are X2 holes 400mm in diameter at a height of 1300mm that provide access to a space not large enough for any person to enter to complete a repair from inside the tank.

Ontrack attended and it was agreed that in the upcoming layup (12-15th August) they will arrange to have a replacement rail and will be able to lift the rails, gouge or grind the area and carry out weld repairs from the top.

DNV has been informed of above and are in agreement towards the repair plan.

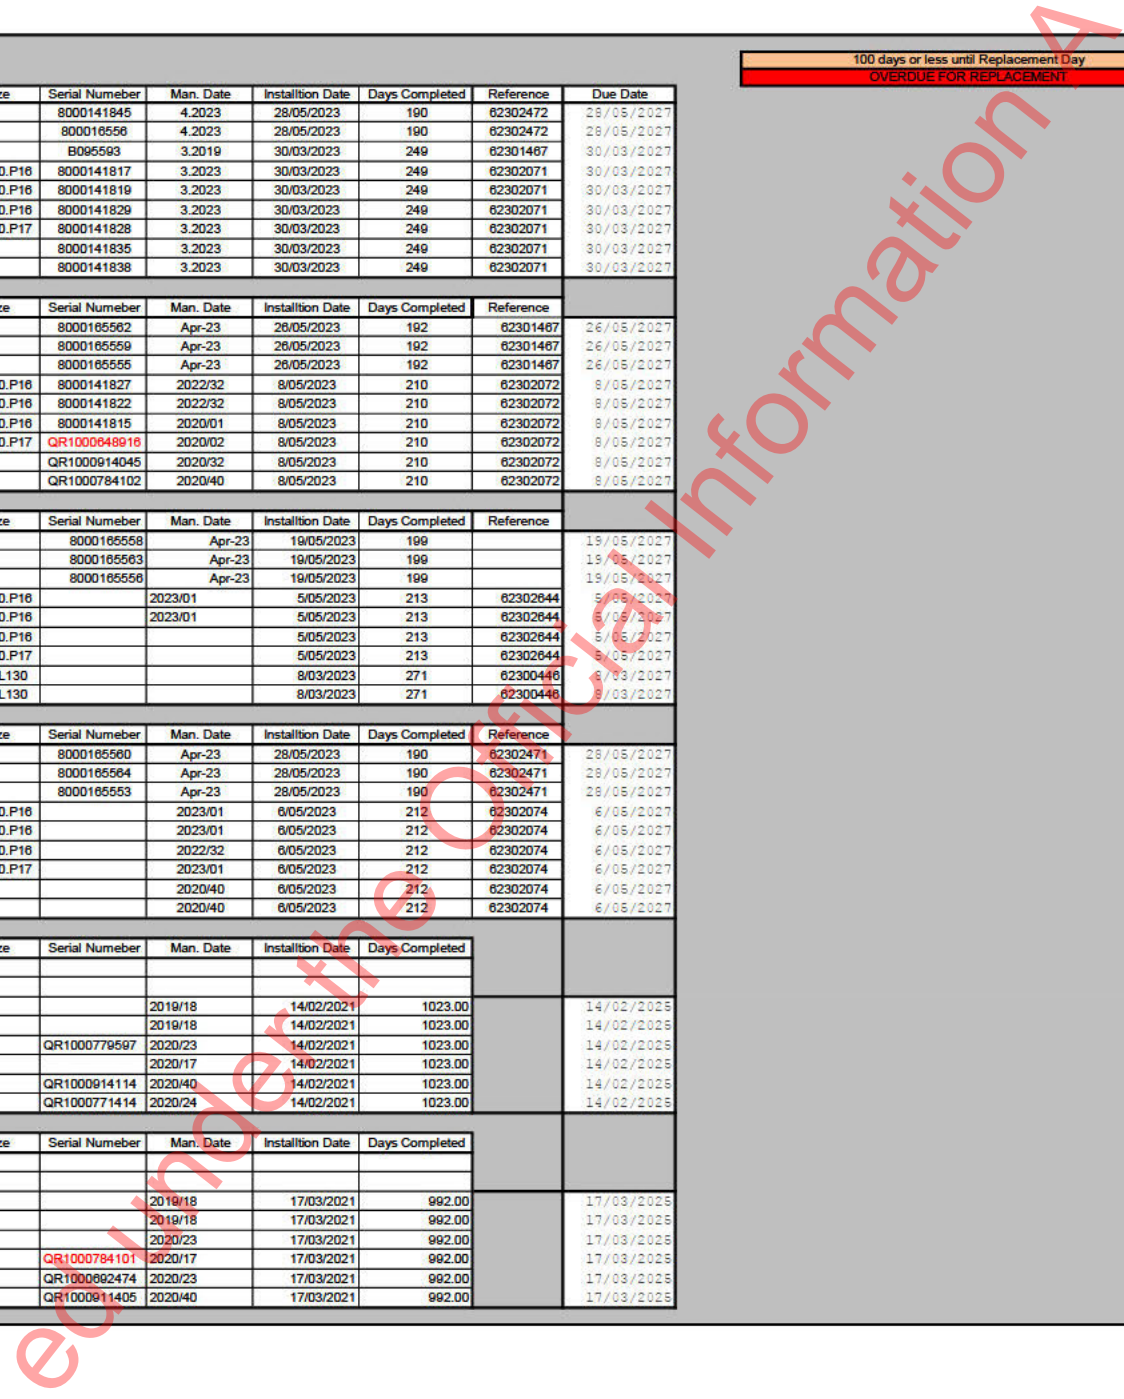
100 days or less until Replacement Day

OVERDUE FOR REPLACEMENT

DG#5 Run Hours:	42409		Type/Size	Serial Number	Man. Date	Installation Date	Days Completed	Reference	Due Date
F722.70.03	LT	Inlet	DN80/125		2019/18	14/02/2021	1023.00		14/02/2025
		Outlet	DN80/125		2019/18	14/02/2021	1023.00		14/02/2025
	HT	Inlet	DN65/125	QR1000779597	2020/23	14/02/2021	1023.00		14/02/2025
		Outlet	DN65/125		2020/17	14/02/2021	1023.00		14/02/2025
	Alternator LT	Inlet	DN50/125	QR1000914114	2020/40	14/02/2021	1023.00		14/02/2025
		Outlet	DN50/125	QR1000771414	2020/24	14/02/2021	1023.00		14/02/2025

DG#6 Run Hours:	54426		Type/Size	Serial Number	Man. Date	Installation Date	Days Completed	Reference	Due Date
F722.70.03	LT	Inlet	DN80/125		2019/18	17/03/2021	992.00		17/03/2025
		Outlet	DN80/125		2019/18	17/03/2021	992.00		17/03/2025
	HT	Inlet	DN65/125		2020/23	17/03/2021	992.00		17/03/2025
		Outlet	DN65/125	QR1000784101	2020/17	17/03/2021	992.00		17/03/2025
	Alternator LT	Inlet	DN50/125	QR1000992474	2020/23	17/03/2021	992.00		17/03/2025
		Outlet	DN50/125	QR1000911405	2020/40	17/03/2021	992.00		17/03/2025
