Accident Report
Miss Otago
Serious Injury, Tasman Bay on
28 July 2005
Class C

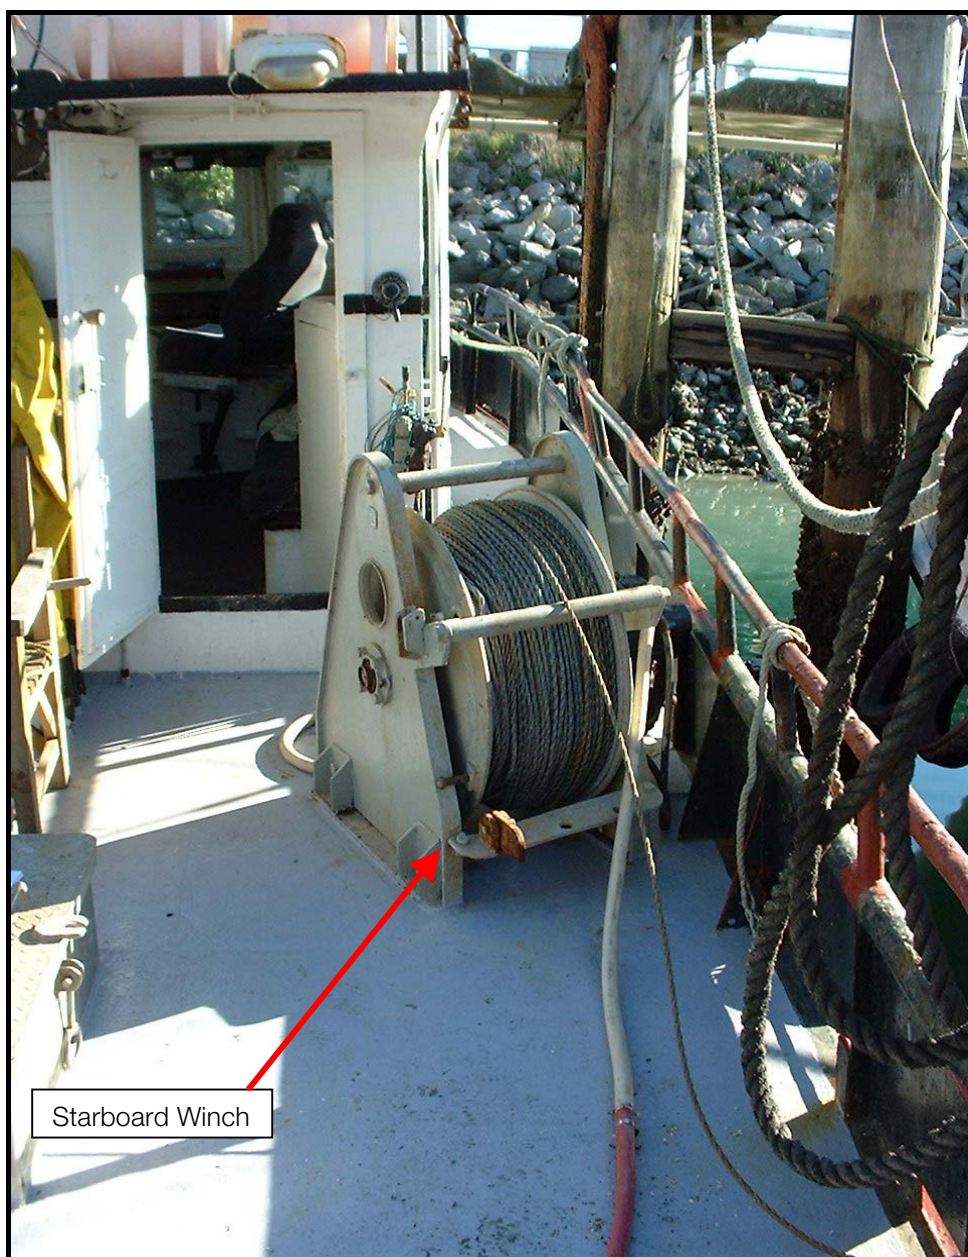
Photograph 1

The Skipper hauled both dredges to the surface and stopped the winches. He put a locking bolt on the starboard winch while emptying the port dredge. The Skipper returned the port dredge to sea and hauled up slightly on the starboard winch to free the locking bolt (See *Photographs 1 & 2*).

The Skipper reached for the bolt with his right hand. As he grasped the locking bolt, the winch crept out, trapping his thumb between the bolt and the wind bed support. Using his left hand, the Skipper hauled in on the winch and freed his thumb.

- The Skipper has instructed a local engineering firm to re-commission the ratchet lock (See *Photograph 3*) that is fitted to the starboard winch and to fabricate one for the port side winch, so as to hold the winches and prevent them from creeping out when under load.
