Accident Report

Onetangi & C Walker Collision

On Auckland Harbour on 9 April 2005

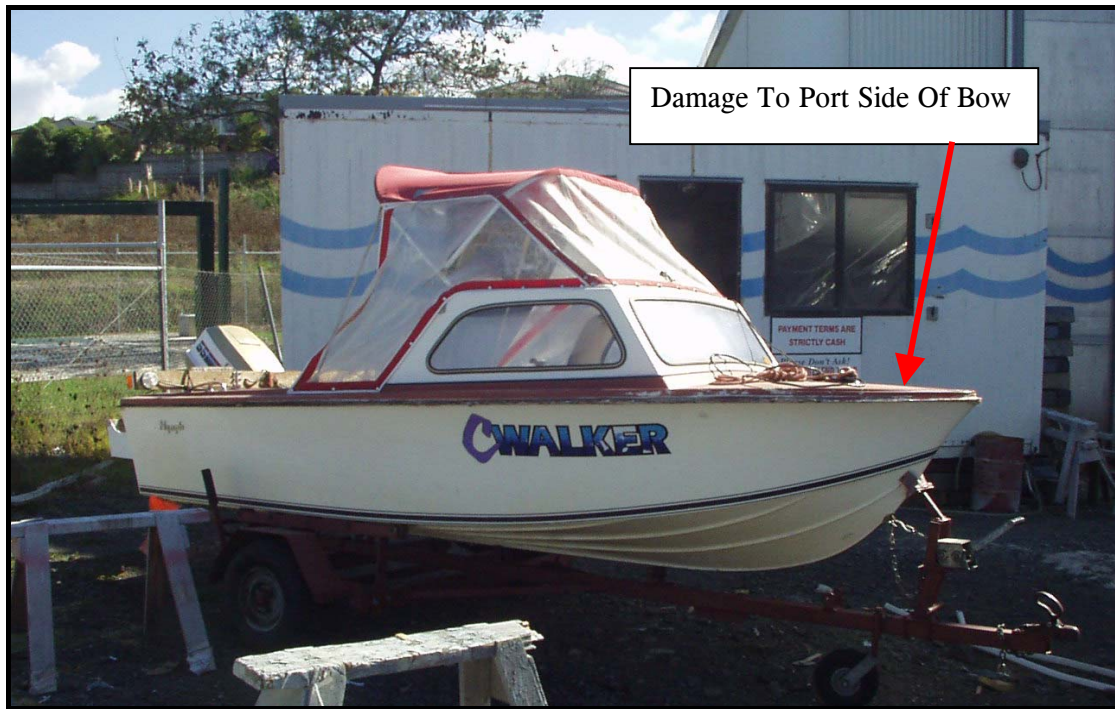
FIGURE 2 – PHOTOGRAPH OF *C WALKER*

C Walker is a 4.8 metre white fibreglass cabin boat. At the time of collision she had a red awning that extended some distance above the cabin top. The Skipper is an experienced recreational boatman (See Figure 2 - Photograph of vessel).

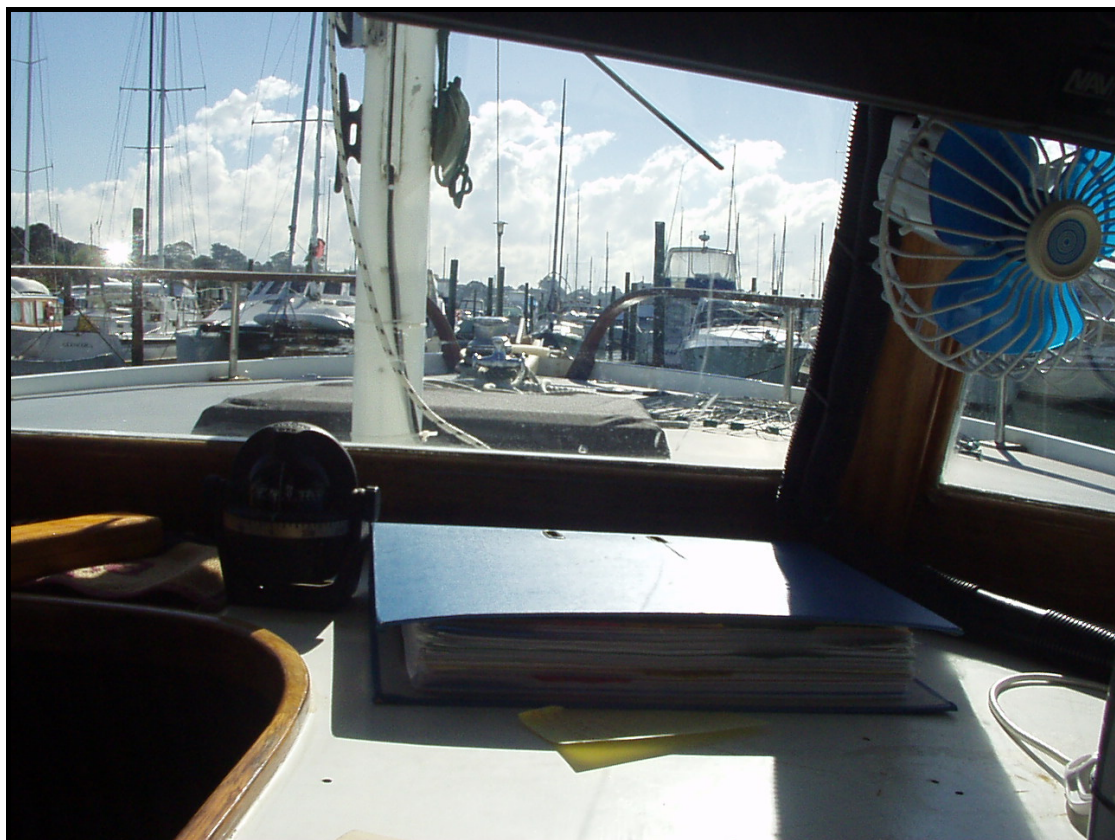
FIGURE 4

Onetangi is a 10.5 metre displacement launch that sails out of Westpark Marina. The vessel is well equipped with navigational and safety equipment including radar. The vessel has a raised bow and foredeck. When approaching a small vessel, on closing, the vessel is lost to the helmsman's vision under the bow (See Figure 4). The Skipper is an experienced recreational boatman with 35 years experience.

He believes *C Walker* was in line with the port hand channel mark and his failure to observe the vessel was due, in part, to both the mark and the awning of *C Walker* being the same colour (See Figures 3 & 4 - Photographs showing interior of cabin and Skipper's vision forward from the helm)
