Class B Non Serious Harm Accident Report

Taniwhi Injury

Bledisloe No. 1 North Wharf, Auckland
on 2 July 2004

TANIWHI – INJURY TO STEVEDORE

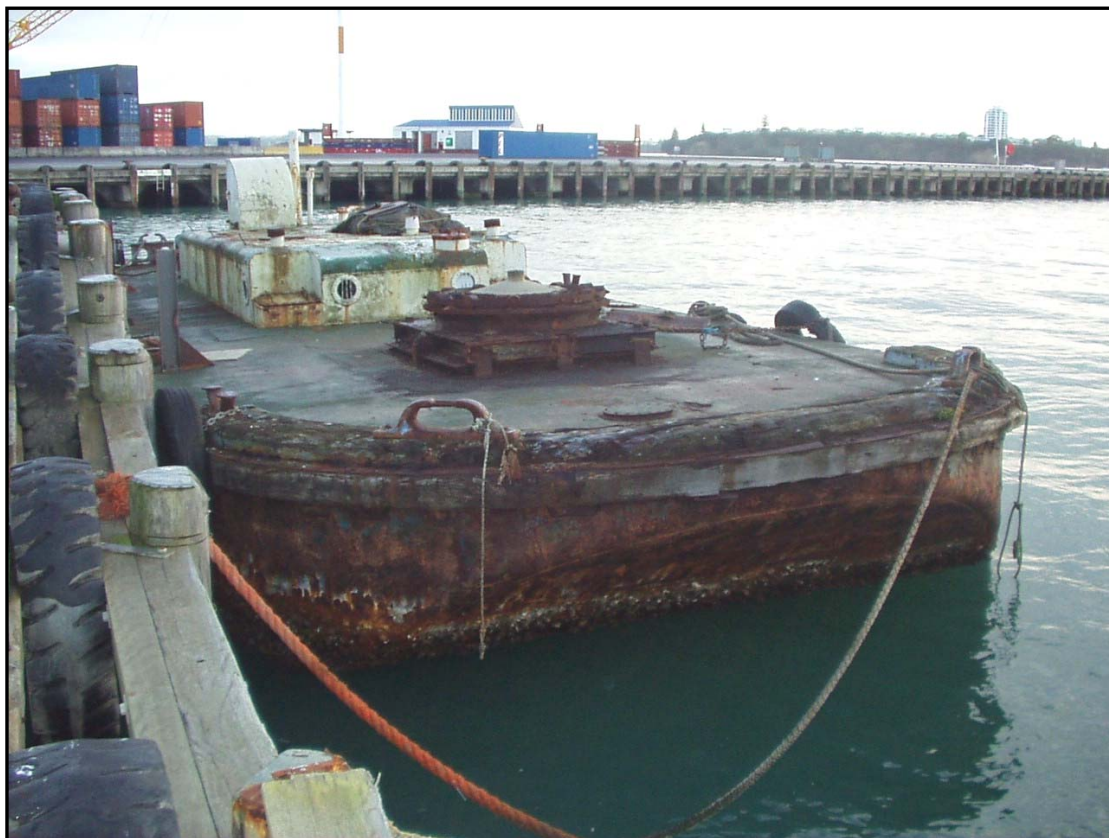
The welder was lying flat on the deck of the barge, welding stanchions to *Taniwhi*, whilst it was made fast alongside an open pile wharf. Whilst his left foot was touching one of the piles, a passing vessel caused the barge to move suddenly, crushing the welder's foot between the barge and the pile.

Photo of open pile wharf

- The hazard is minimised by the provision of adequate sized fenders of sufficient quantity between the barge and adjacent wharves/other fixed or floating object to protect employees, or
- The danger to employees is eliminated by repositioning the barge so that the side on which employees are working does not abut a fixed or floating object.

- The procedure for provision of safe working areas on floating plant has been added to the Operations Manual, incorporating the provision of adequate sized fenders between adjacent wharves/other fixed or floating objects and the positioning of the floating plant such that the work area is away from adjacent wharves/other fixed or floating objects.
- The hazard – sudden movement of the vessel against wharf plies has been added to our hazard register.
- The hazard has been brought to the attention of employees as an item on the agenda at our staff toolbox meeting and by notice on the staff noticeboard.
